Appendix B
Greenwood 27
Monitoring Photos

**Pictures of Greenwood 27
Bank Stabilization Sites Before, During, and After Construction**

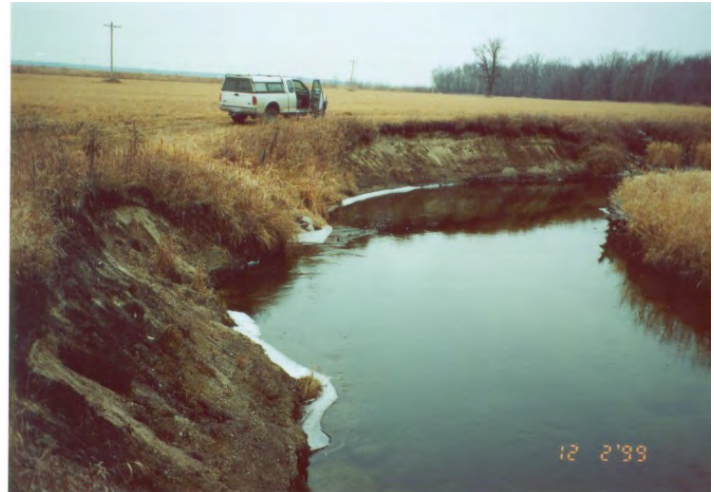
Site A Before Construction,
Bank Slumping

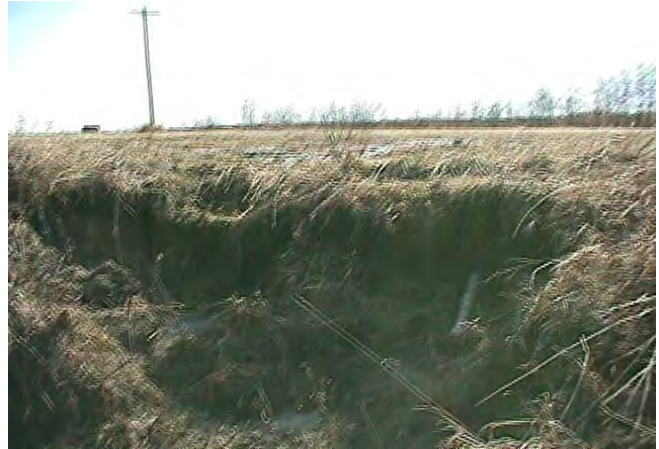
Site C
Bank Slumping Near Upstream
End of the Site

Bank slumping at Bank
Stabilization
Site C
1 year after construction
Malfunctioning Drain Tile?

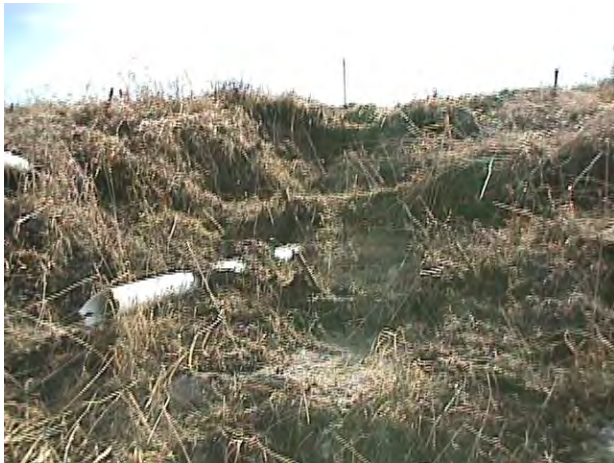
Bank Slumping at Bank
Stabilization
Site C
Pooling of water that is the Apparent
Cause of the Slumping

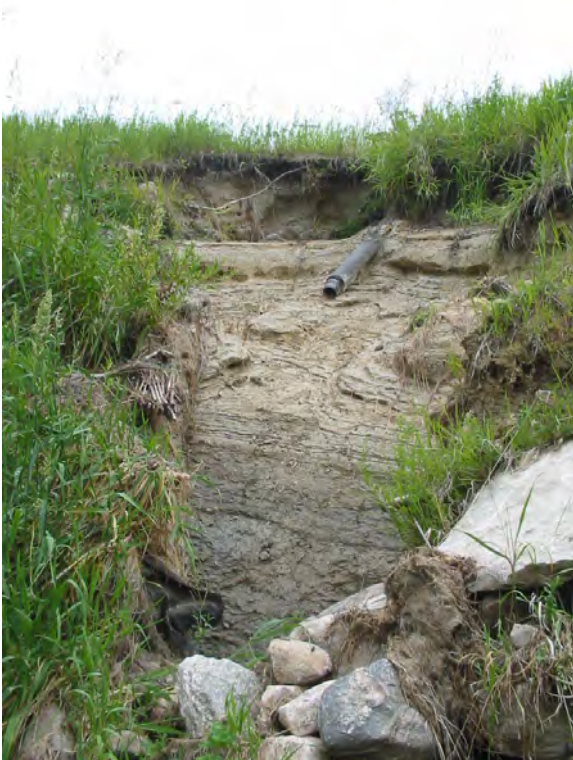
Erosion at Site C.

This was apparently caused by a drainage tile, the end of which was buried during the construction. Drainage from the tile caused the sloughing and erosion of the bank. This site was repaired in the summer of 2004.

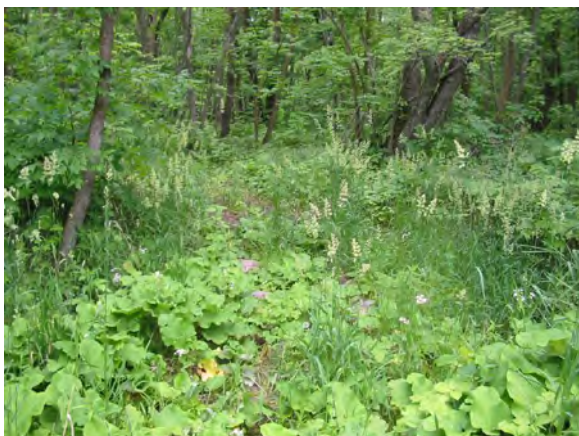
Floodplain Restoration Site H
Lots of Vegetation on Rock Structure

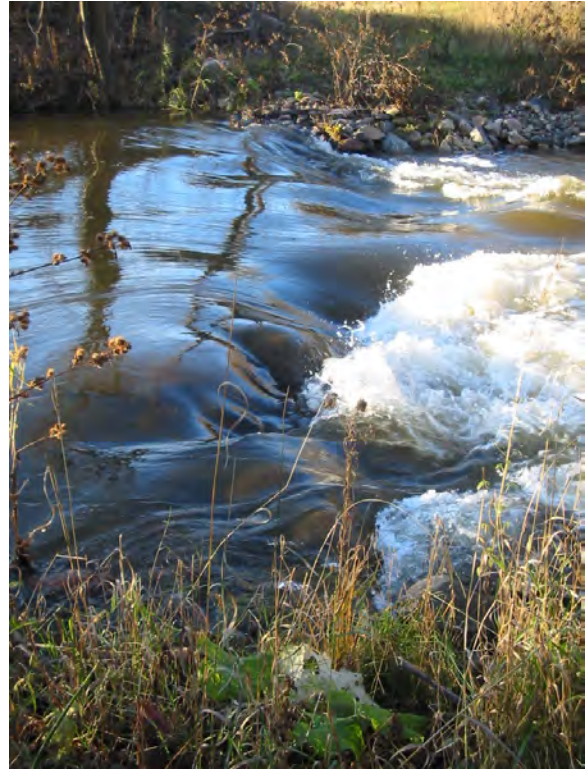
High Flow in November '04 at Site E

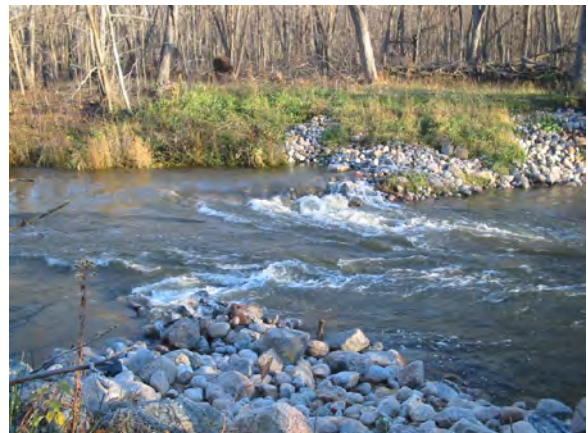
High Flow in November '04 at Site P

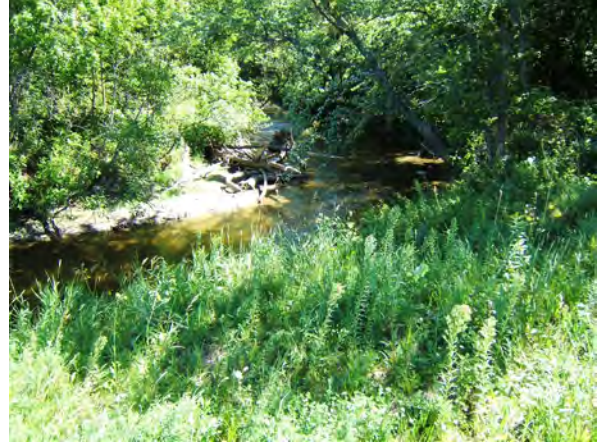
Site C, 2005 – Erosion Repaired
