Table of Contents

Letter from the President

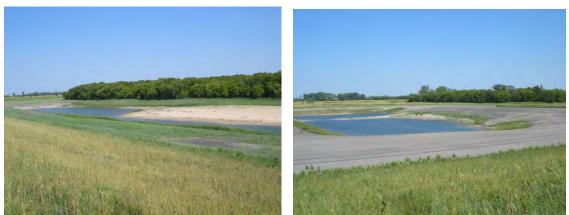
Borrow areas partially filled with runoff water

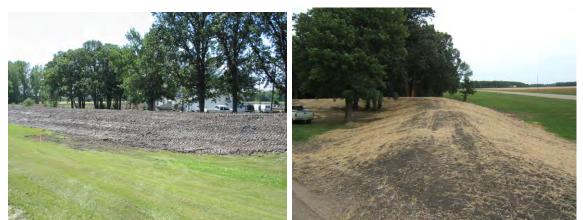
Shannon Schauer ring dike construction located in Section 27, Esther Township, Polk County. Near the Red River of the North.

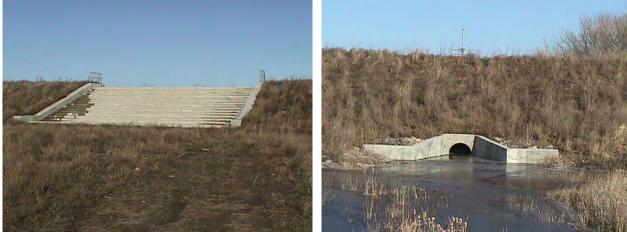
Emergency spillway

Principal outlet structure

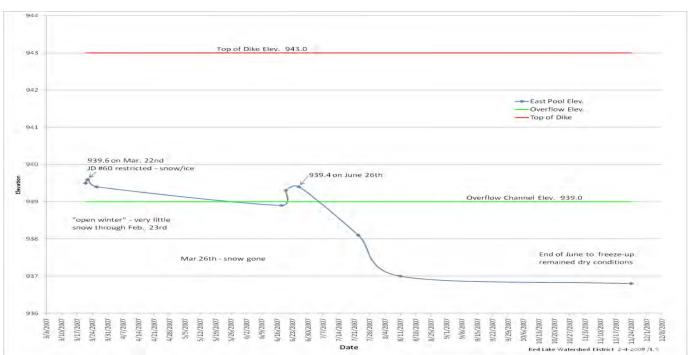
Parnell Impoundment - 2007 East Pool Elevations

In mid June the area received enough precipitation events to generate minor runoff. Excess runoff was stored in the East and West Pools by closing both the JD #60 /Lateral #2 weir and the west pool control gates. The gates remained closed for approximately eight (8) days and were opened when downstream conditions receded, and the channels were capable of receiving outflows from the impoundment.

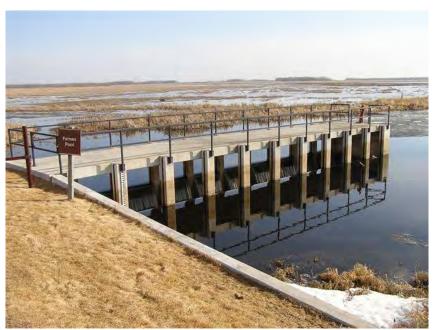
Stoplog Outlet Structure

This year the pool was in a scheduled "drawdown" condition. After Spring runoff, the stop-logs were removed and the screwgate opened to drain the pool. Agassiz National wildlife Refuge staff performs the actual operation of the outlet structure with cooperation from the Red Lake Watershed District (RLWD). During the drawdown period, staff from the RLWD, Agassiz NWR, MnDNR along with a MnDNR Professional Engineer, performed an inspection of the outlet structure. The metal stoplogs and channel iron stop-log slides have deteriorated over the years and it was recommended for them to be repaired/replaced.

This was not an emergency situation and the structure facility itself is "structurally sound" for use, until repairs are made in 2008. Also during the drawdown, there was a prescribed burn in the pool area. In early November, the screwgate was closed, the stop-logs installed and the pool was filled to the typical winter elevation. This was accomplished by storing the water being released from the Lost River Impoundment which is located East (upstream) of Elm Lake-Farmes Pool.

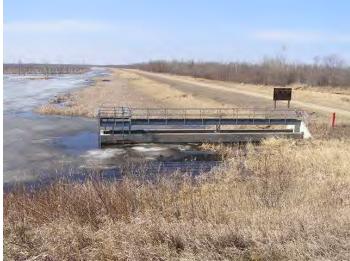
North Pool - Gated Principal Outlet Structure

The North Pool outlets into the Moose River (JD #21). The major components of the north pool are: 5 miles of diversion ditch, 4 miles of earthen dike with a top elevation of 1218.0, one gated outlet structure, one rock lined emergency spillway at an elevation of 1216.0. Approximately 1/3 (41.7 sq. mi.) of the total project drainage area (125.0 sq. mi.) drains to the Moose River.

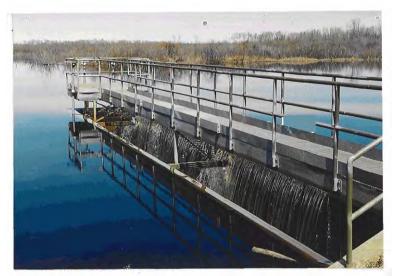
South Pool - Gated Principal Outlet Structure

The South Pool outlets into the Mud River (JD #11). The major components of the south pool are: 3 miles of diversion ditch, 9 miles of earthen dike with a top elevation of 1220.0, 4 miles of earthen dike between the north and south pools, one gated outlet structure, two rock lined emergency spillways at an elevation of 1218.0. Included between the pools is an interpool structure which may be used to pass water between the pools. Approximately 2/3 (83.3 sq. mi.) of the total project drainage area (125.0 sq. mi.) drains to the Mud River.

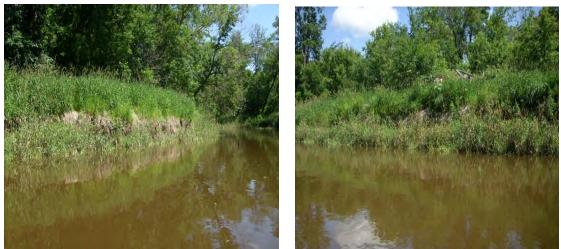
Sediment Bars

Removing of sediment bars and slumped areas was again a top priority for The District in this ditch system this year. Inspection of State Ditch 83 was again conducted by a boat again this year because of lack of adequate access by roads or trails. We looked for areas that needed work and ways to access the area with as little destruction as possible. Lady luck was again on our side again this year, with most of the summer being dry and water levels being very low in the ditch it made for excellent working conditions again this year. Working with the landowners The District was able to spot clean 2.2 miles on the west side of State Ditch 83, removing sediment, slumps, and debris from up to 18 different sites.

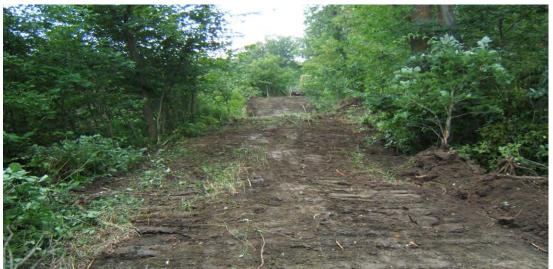
Access Road

first made on the top of the old spoil bank. This access road will now be maintained yearly and will be used for ditch inspections and any work that needs to be done. Areas to be worked on were then staked, cleared of trees and brush, and a bench was then cut for the backhoe to sit on.

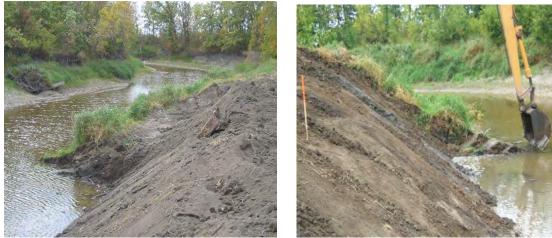
Downstream end of sediment bar

Upstream end of sediment bar
