Red Lake Watershed District

**2014
Annual
Report**

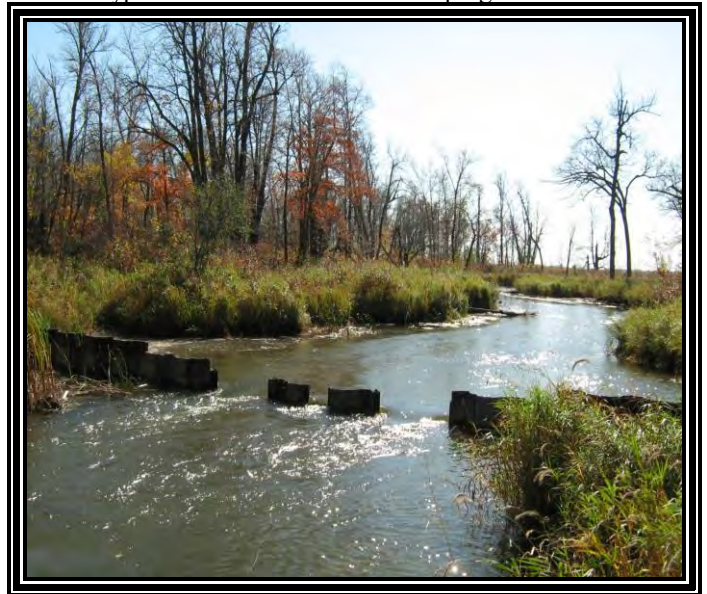
Typical Fall Drawdown with Stoplogs Removed

The Pine Lake control structure is a sheet pile dam with 2 – four foot wide adjustable stop-log bays. The stoplogs can be adjusted between elevations 1281.5 to 1283.5. There is also 26 feet of fixed crest weir at elevation 1284.0, and 65 feet of fixed crest weir at elevation 1284.5. Based primarily on lake elevation, stop-logs may be removed from the dam to allow additional outflow until the lake recedes, and then they are replaced to the typical summer or winter elevation.

The dam is also designed with a small fixed crest weir at elevation 1282.5, which is one foot lower than the normal summer stop-log elevation. This was an innovative design in the early 1980's, and allows for minor outflows that provides stream flow maintenance. This is very important for keeping some flow in the Lost River especially during periods of low flow. Factors to consider when adjusting the stop-logs are: monitoring “inflows” to the lake, existing lake elevation, downstream conditions and predicted runoff. Staff personnel at the Sportsman's Lodge are very helpful in reading the lake elevation gauge located inside the business and a local resident records rainfall data at the lake.

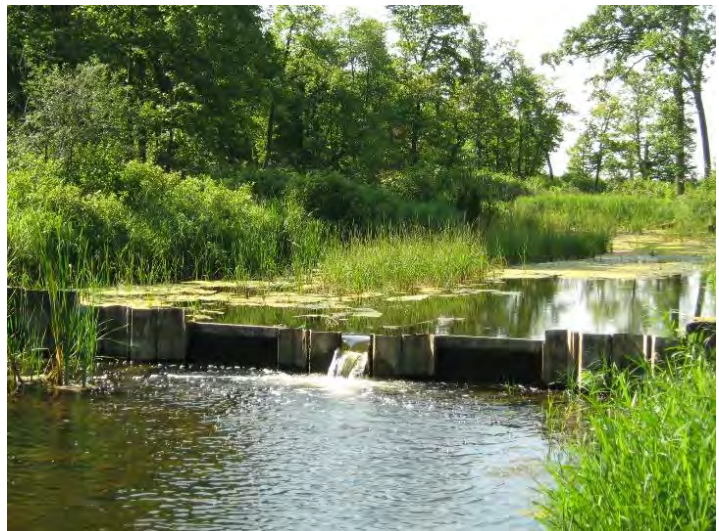
Good example of the “low flow” notch – designed to provide streamflow maintenance to the Lost River during extended periods of dry conditions and low water levels

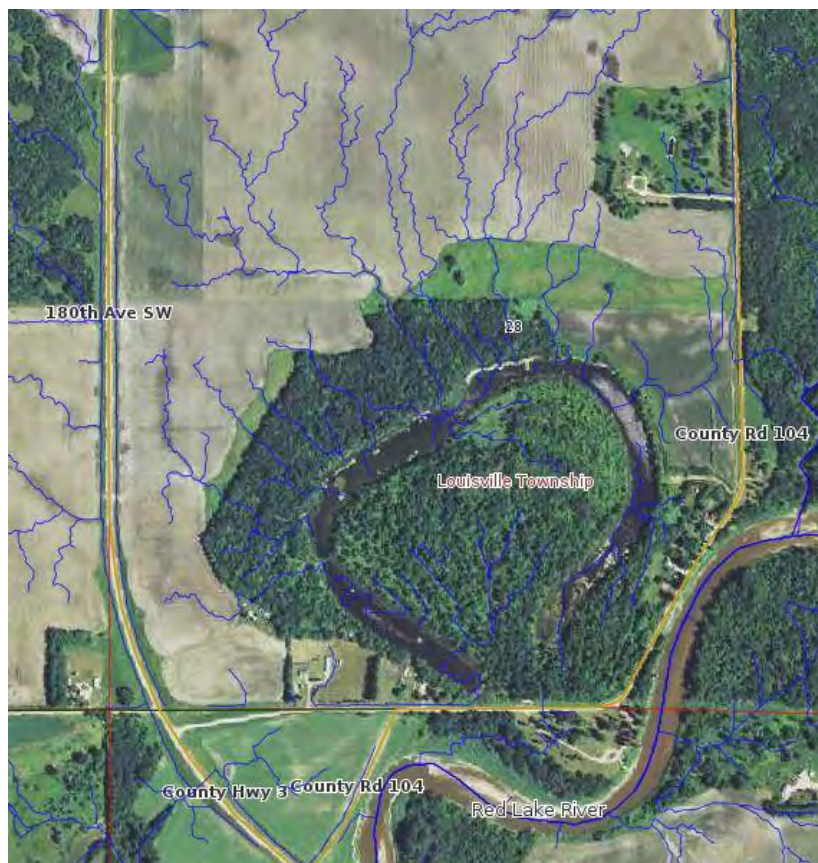
Overland flow (blue lines) as shown in the prototype web site map viewer.

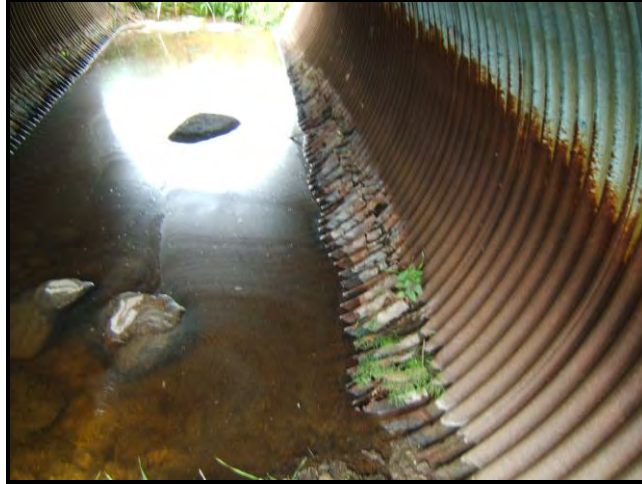
Rusted out culvert under a township road in branch 13 of JD 72 that had to be replaced

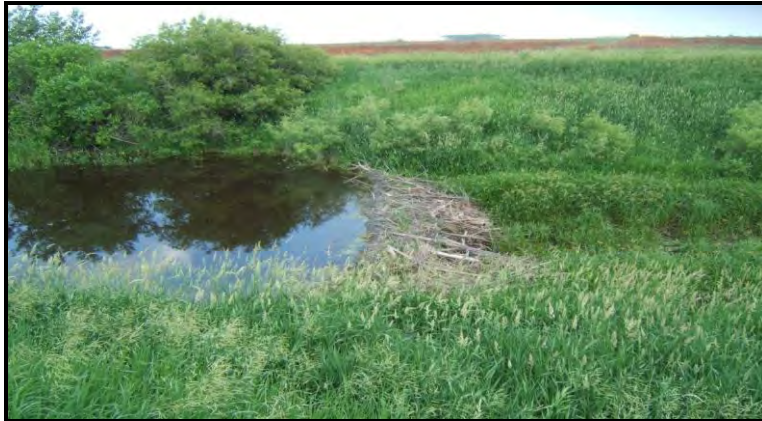
Freshly built beaver dam

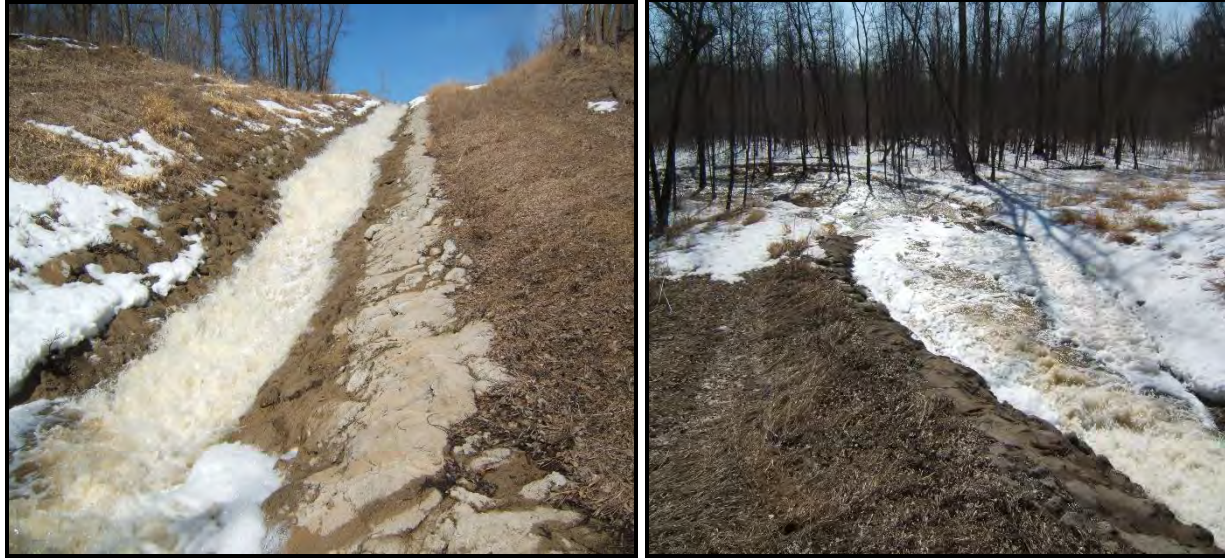
Spring runoff water flowing down the rock chute and into the plunge pool on RLWD Ditch 10 (Project #161)

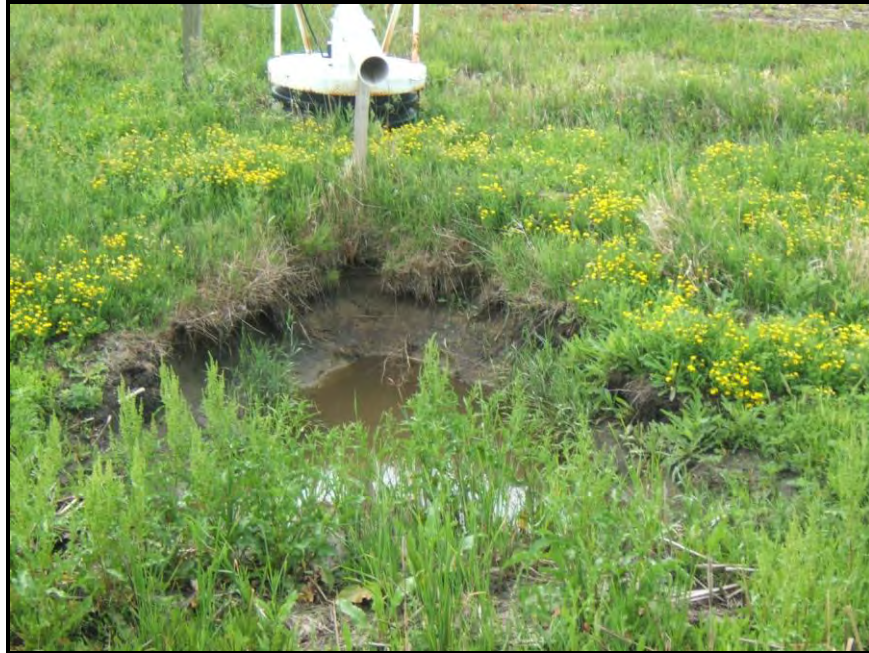
No erosion control at the outlet of a tile pump

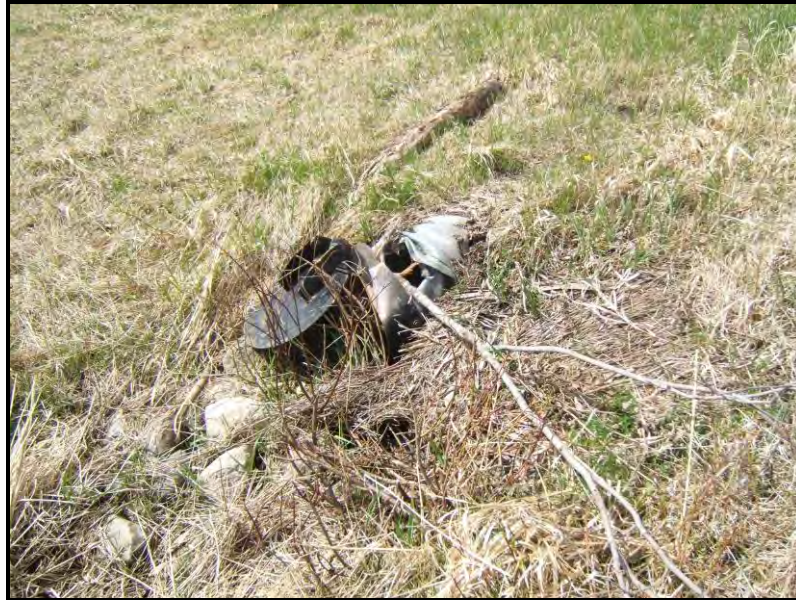
Side inlet pipe and trap destroyed by a mower

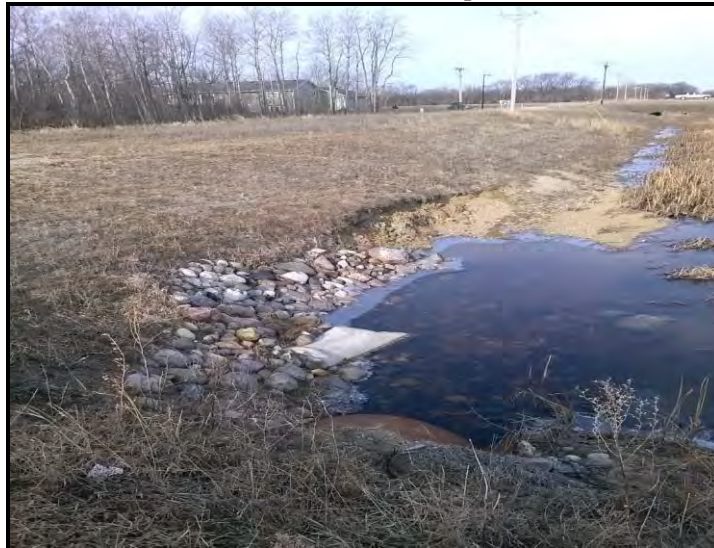
Erosion area caused by a storm water outlet

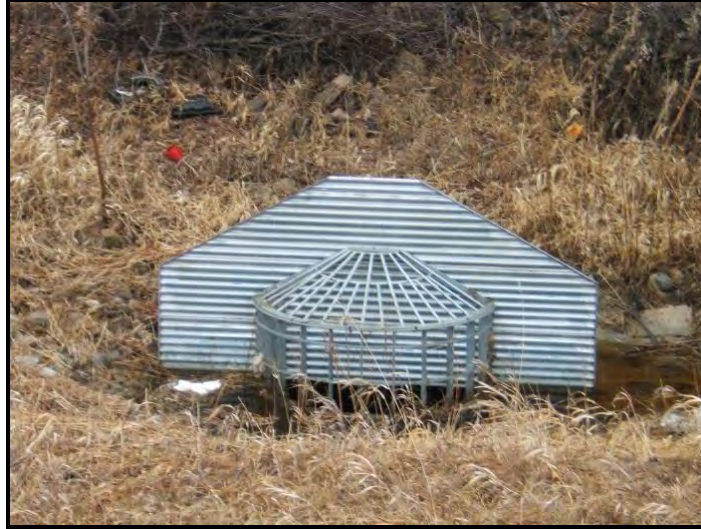
Cleaned trash rack
