Red Lake Watershed District

2015 Annual Report

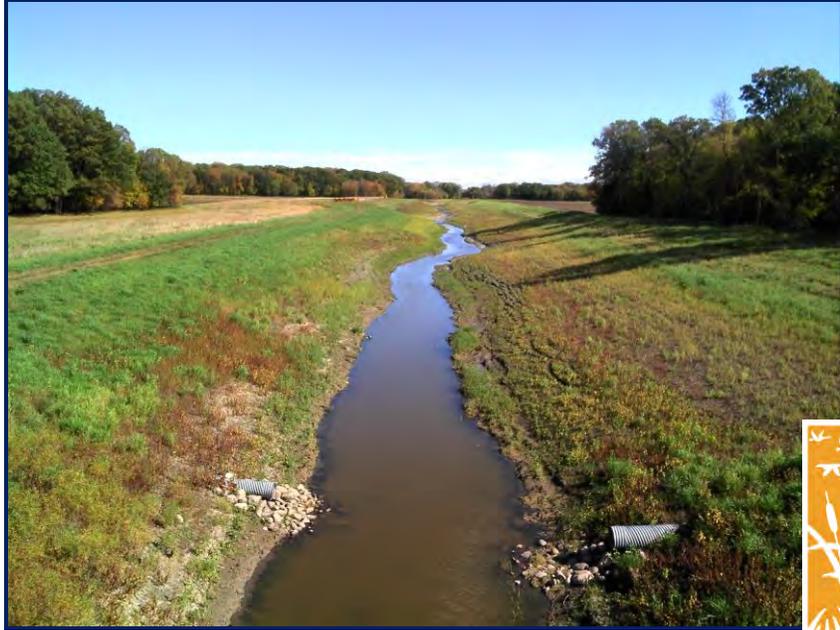
Stabilized channel looking upstream.

In the summer of 2015, it was noticed that an area near the eastern portion along the north slope was sloughing. At the recommendation by the Engineering staff, the Board of Managers elected to repair the slough which was completed early summer.

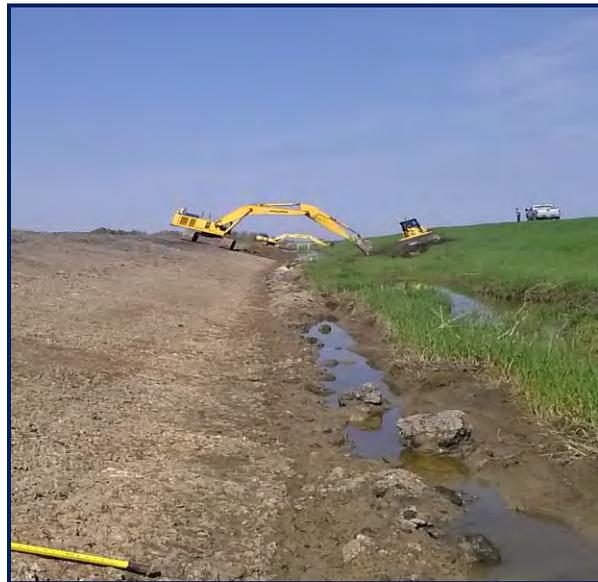
Channel excavation in the first mile of the project.

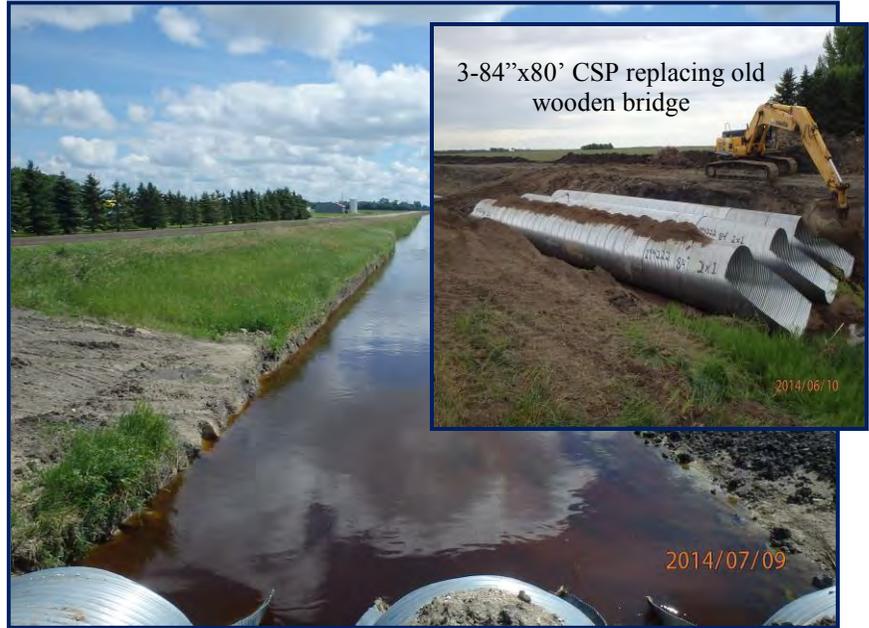
Finish work complete. Ready for seeding.

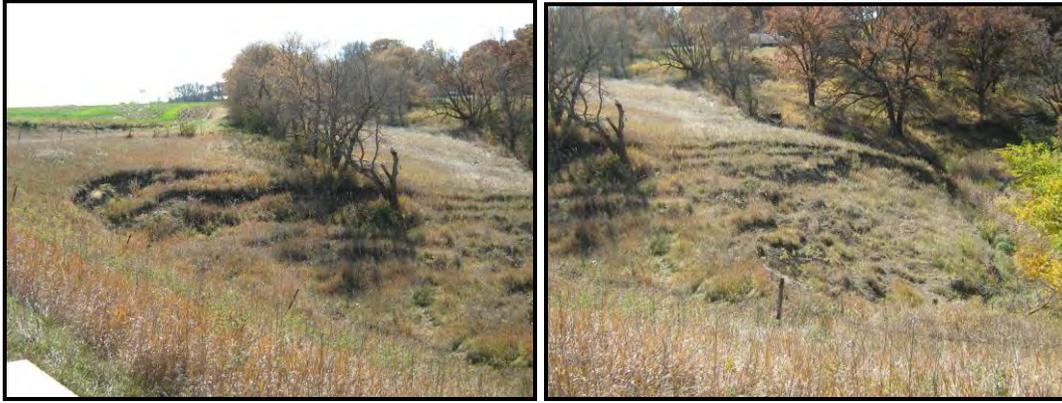
Latendresse Dam – Red Lake County – Slope failure & metal control structure has deteriorated

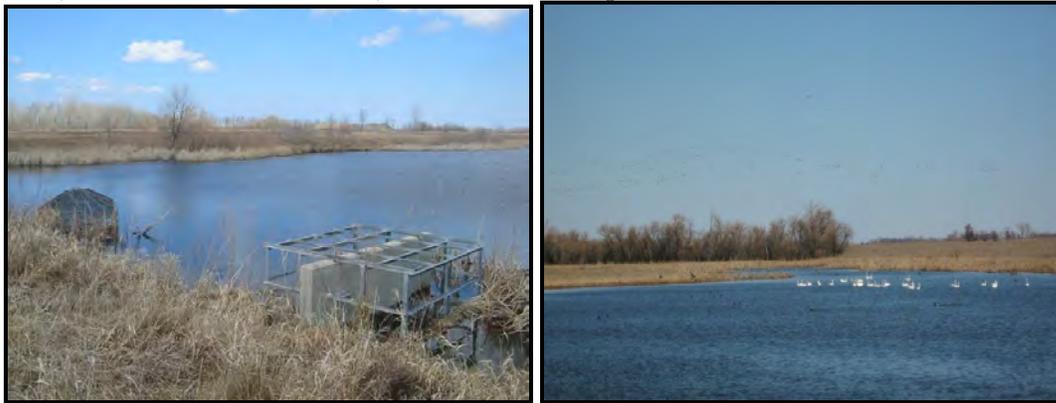
Odney / Flaot Dam - Polk County – scheduled for repair in 2016 – metal structure has deteriorated

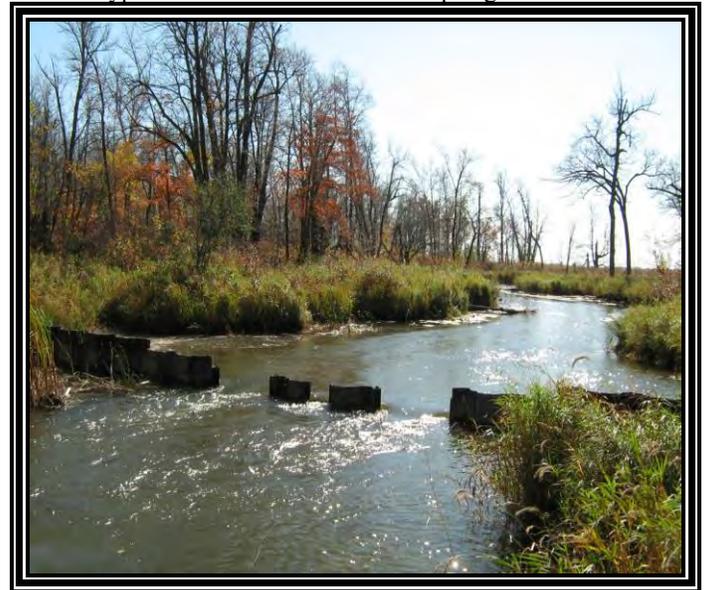
Typical Fall Drawdown with Stop-logs Removed

The Pine Lake control structure is a sheet pile dam with 2 – four foot wide adjustable stop-log bays. The stop-logs can be adjusted between elevations 1281.5 to 1283.5. There is also 26 feet of fixed crest weir at elevation 1284.0, and 65 feet of fixed crest weir at elevation 1284.5. Based primarily on lake elevation, stop-logs may be removed from the dam to allow additional outflow until the lake recedes, and then they are replaced to the typical summer or winter elevation.

The dam is also designed with a small fixed crest weir at elevation 1282.5, which is one foot lower than the normal summer stop-log elevation. This was an innovative design in the early 1980's, and allows for minor outflows that provides stream flow maintenance. This is very important for keeping some flow in the Lost River especially during periods of low flow. Factors to consider when adjusting the stop-logs are: monitoring “inflows” to the lake, existing lake elevation, downstream conditions and predicted runoff. Staff personnel at the Sportsman’s Lodge are very helpful in reading the lake elevation gauge located inside the business and a local resident records rainfall data at the lake.

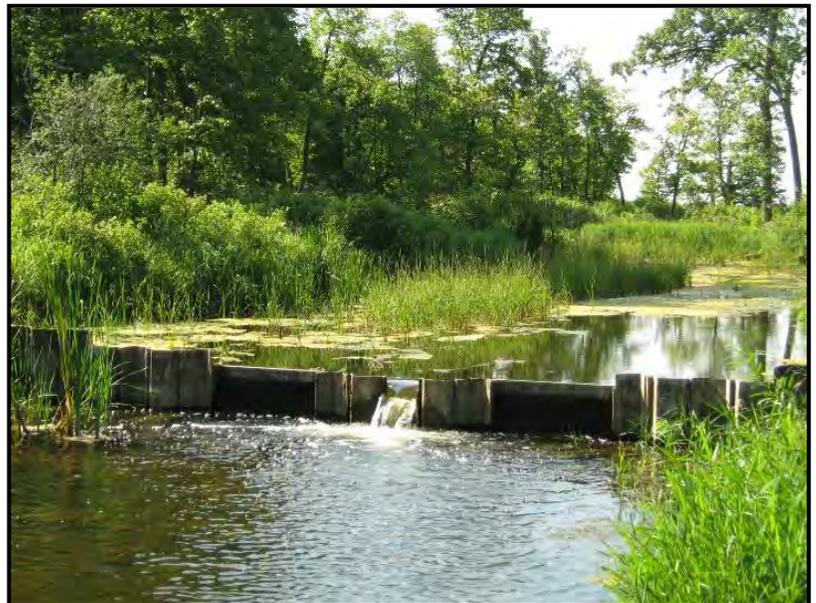
Good example of the “low flow” notch – designed to provide streamflow maintenance to the Lost River during extended periods of dry conditions and low water levels

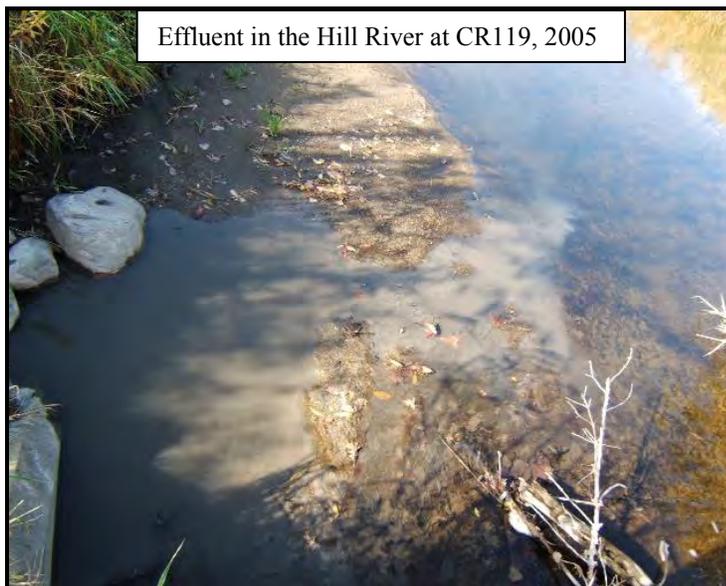
Effluent in the Hill River at CR119, 2005

Septic effluent was once again found to be entering the Hill River at the CR119 crossing, north of Brooks. District staff smelled and photographed effluent entering the river on multiple sampling visits. This problem has been identified in the past (2005) and Red Lake County staff were notified of the problem at that time. The effluent was sampled on one occasion. County officials were notified that the problem is still occurring. The analysis of samples collected from the effluent revealed very high concentrations of total phosphorus (8.44 mg/l), orthophosphorus (3.1 mg/l), and total Kjeldahl nitrogen (6.14 mg/l). Ammonia and total suspended solids concentrations were also high relative to the concentrations that were found in the river that day.

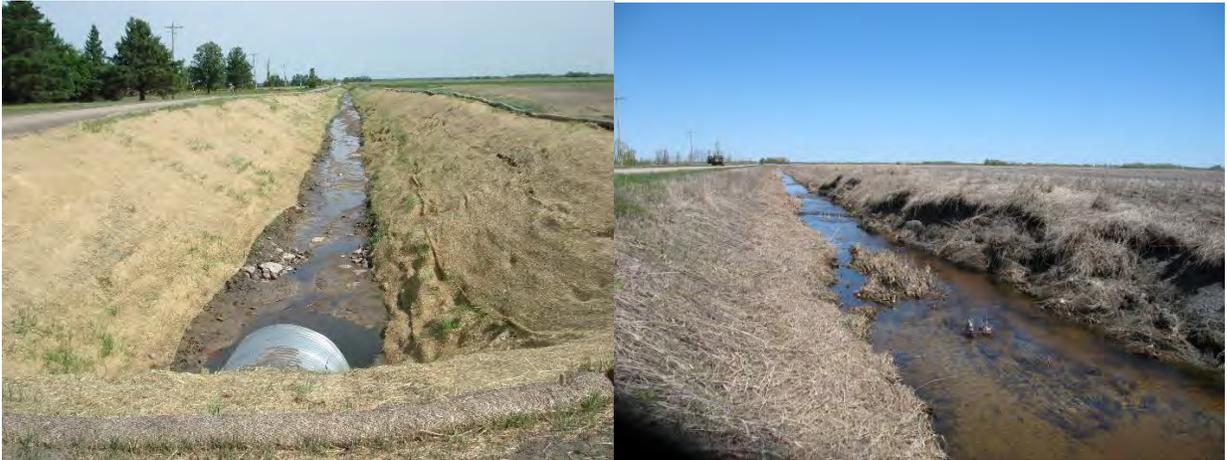
Repairs to Stabilize JD 72 Channel.

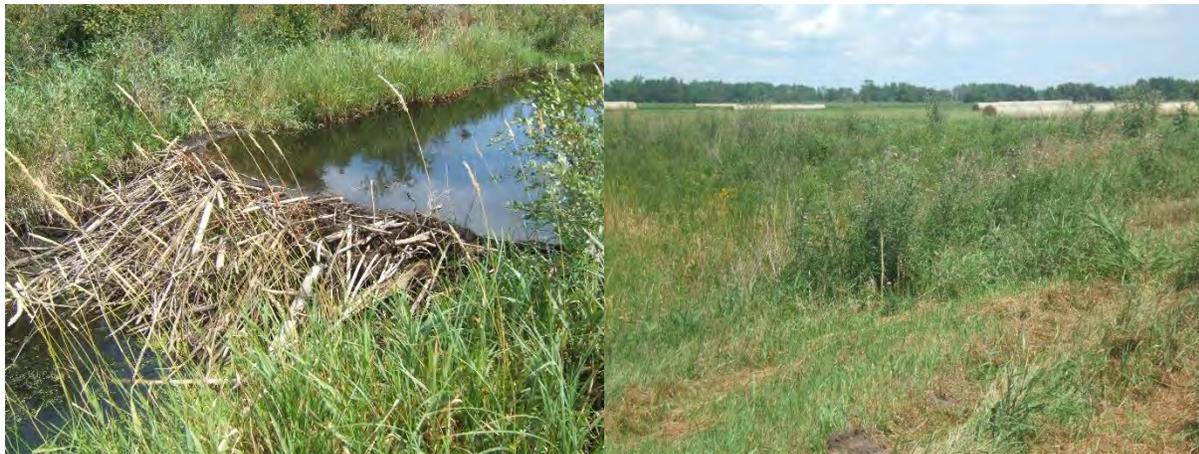
Seemingly annual beaver dam.

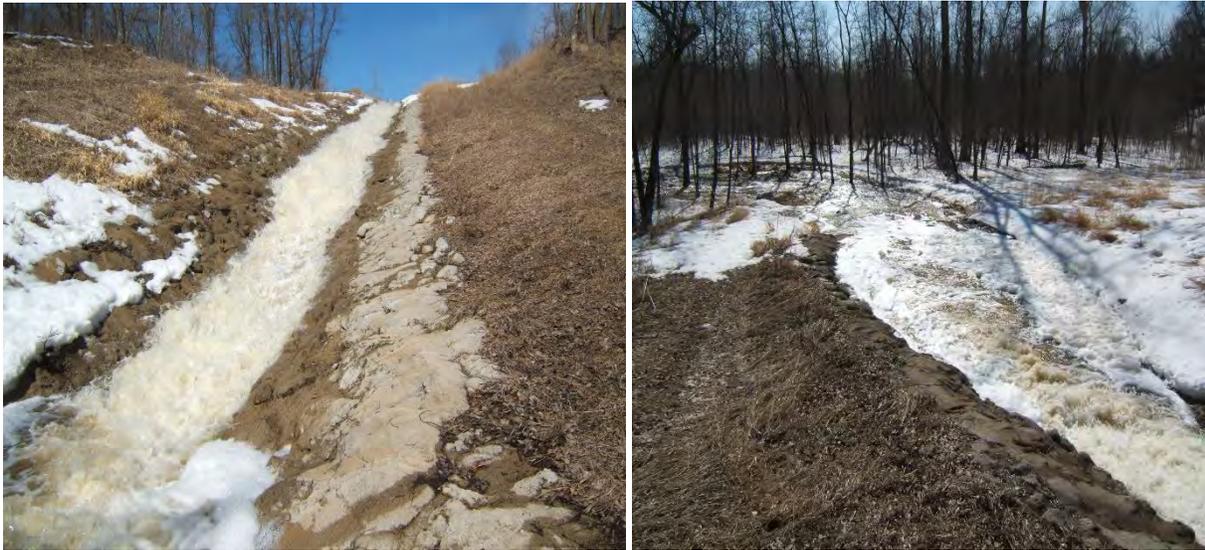
Spring runoff water flowing down the rock chute and into the plunge pool on RLWD Ditch 10.

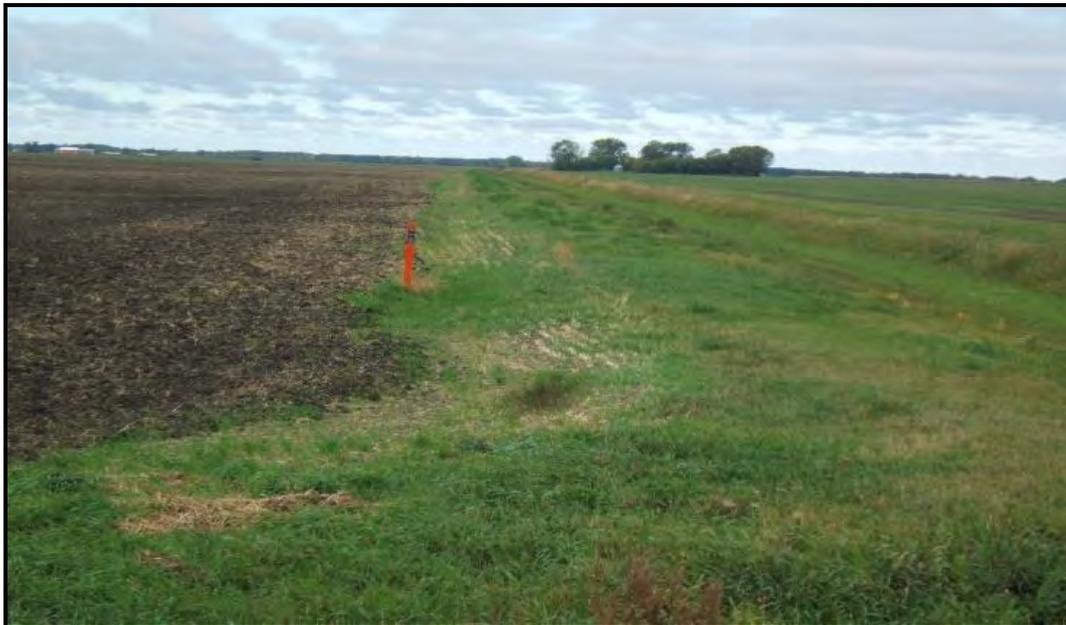
Reseeded right-of-way. Visible wheat stubble infraction.
