RED LAKE WATERSHED DISTRICT

January 24, 2019

Agenda

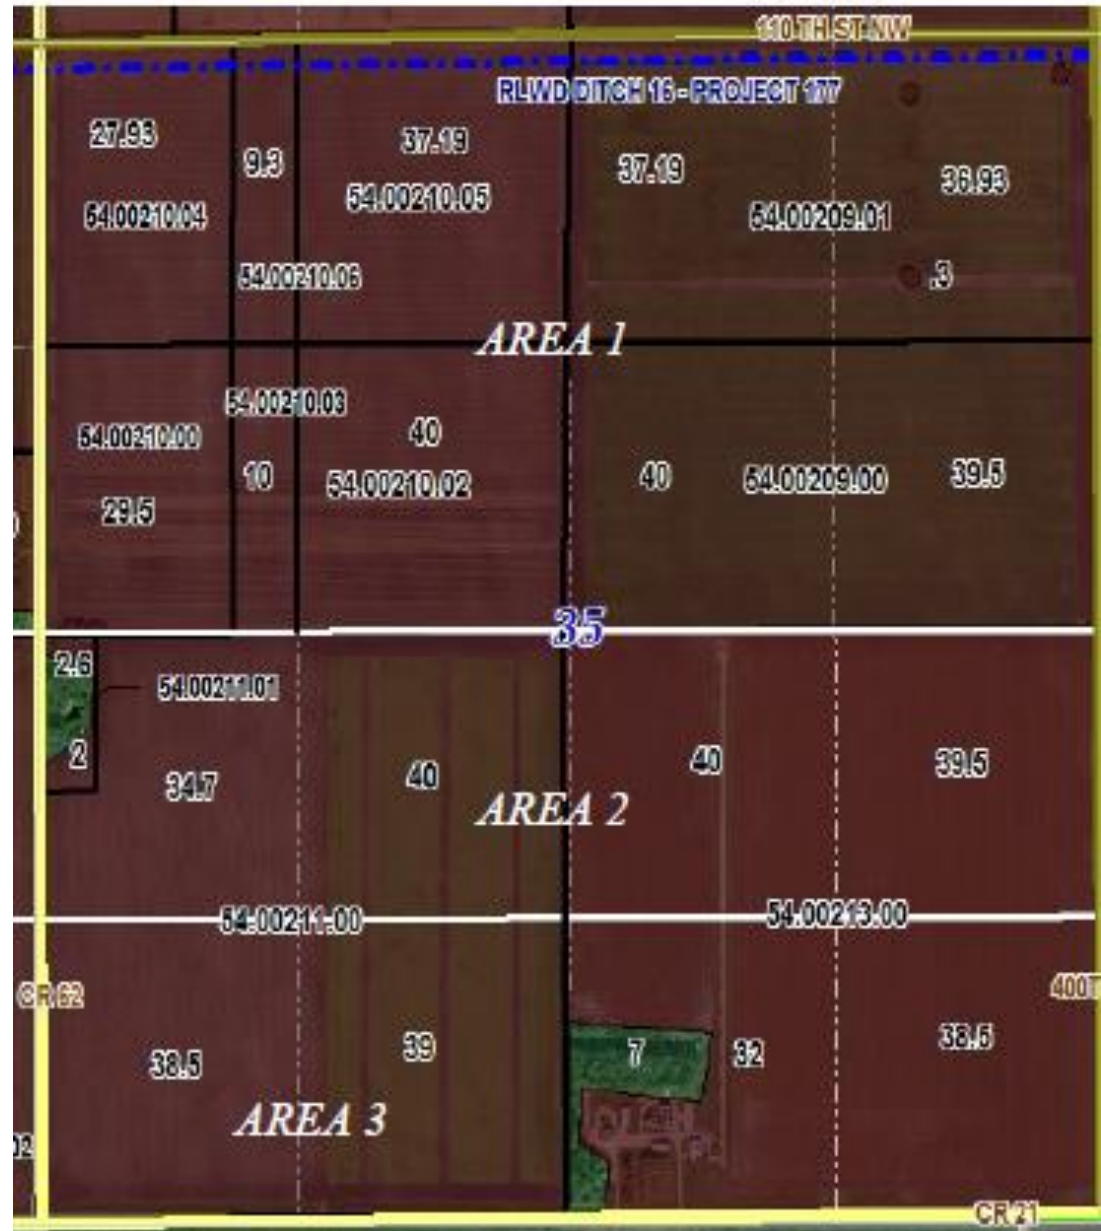
Plat Map

- (1) Identifies Parcel Identification Number
- (2) Benefit Acres are listed by 40 acre tracts
- (3) Identifies different land use
- (4) Identifies converted and non converted wetlands
- (5) Identifies roads
- (6) Identifies areas with different benefit rates

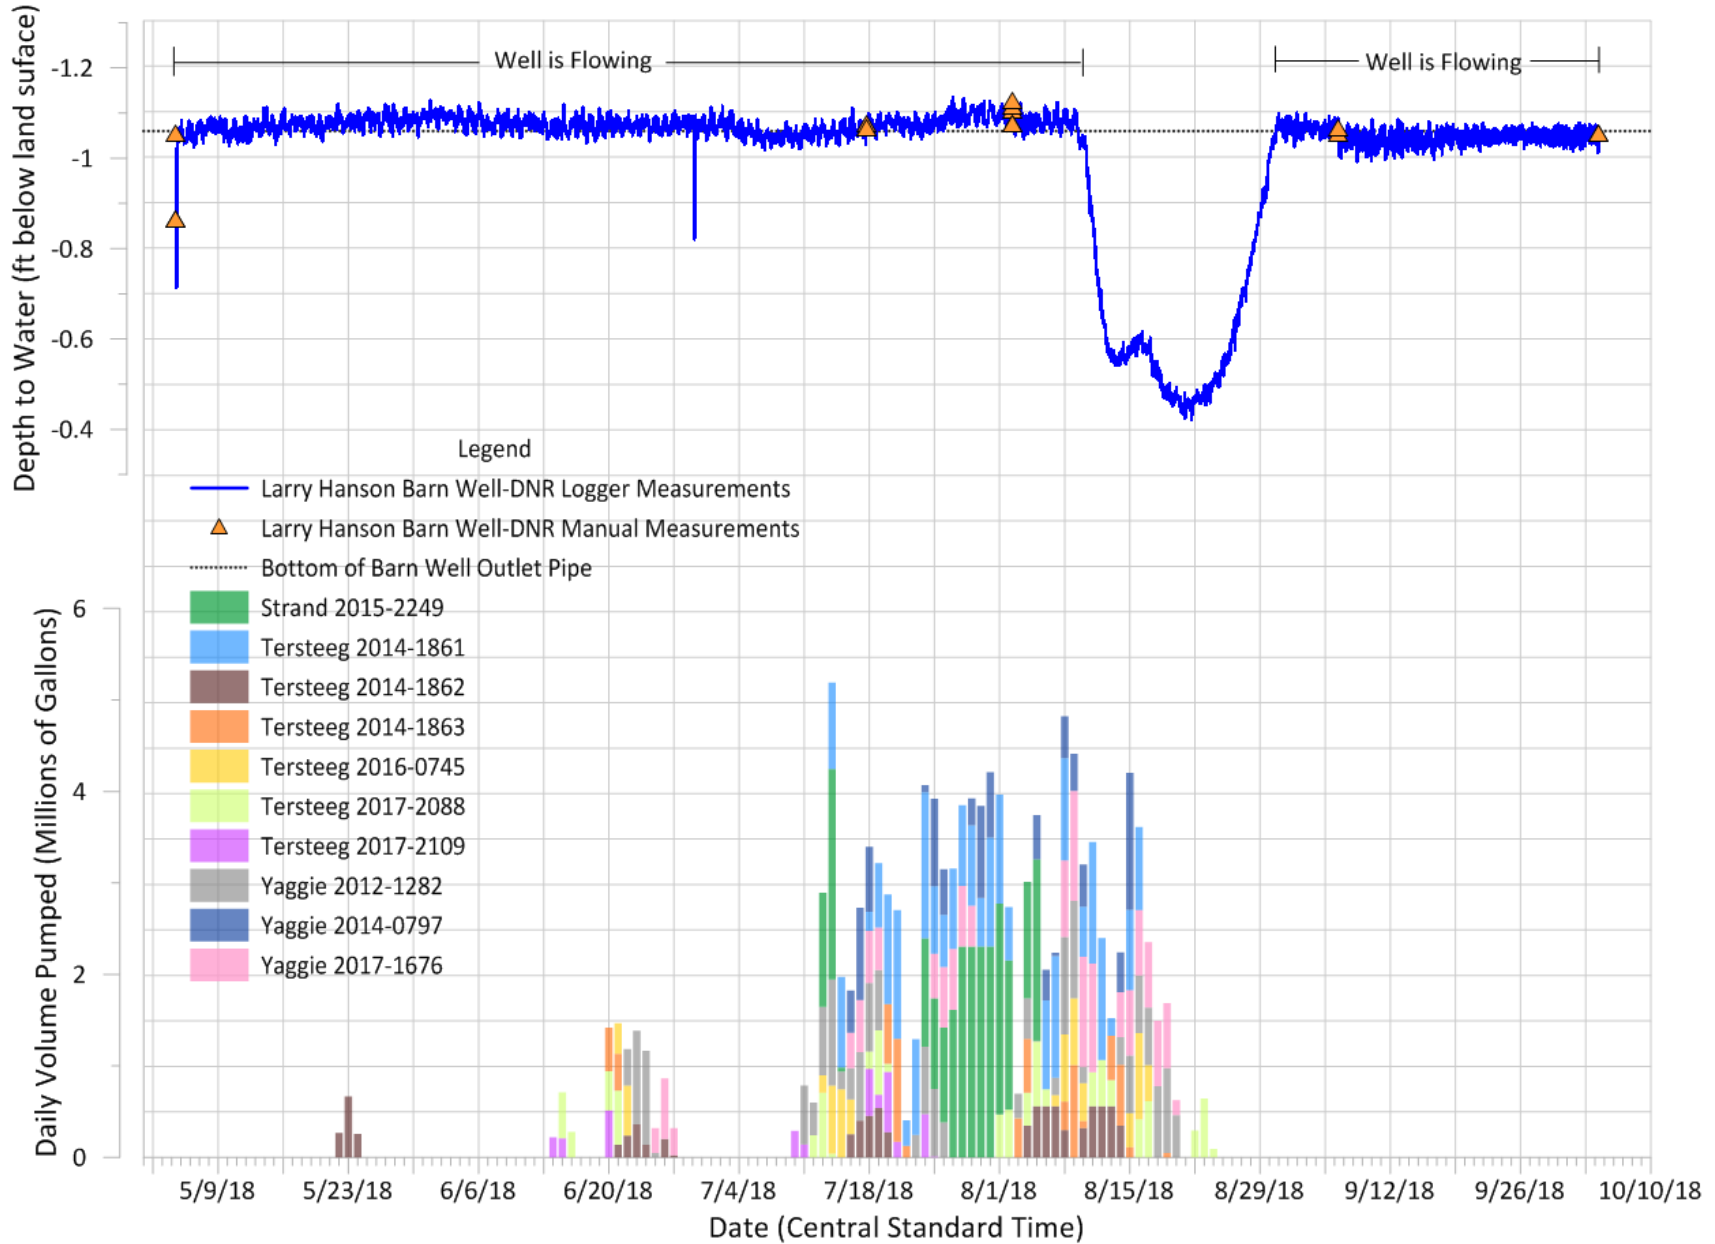
Figure 6: Hanson Barn Well hydrograph and daily reported use by nearby irrigation wells.

Note: Negative depth to water values indicate the water level is above land surface.

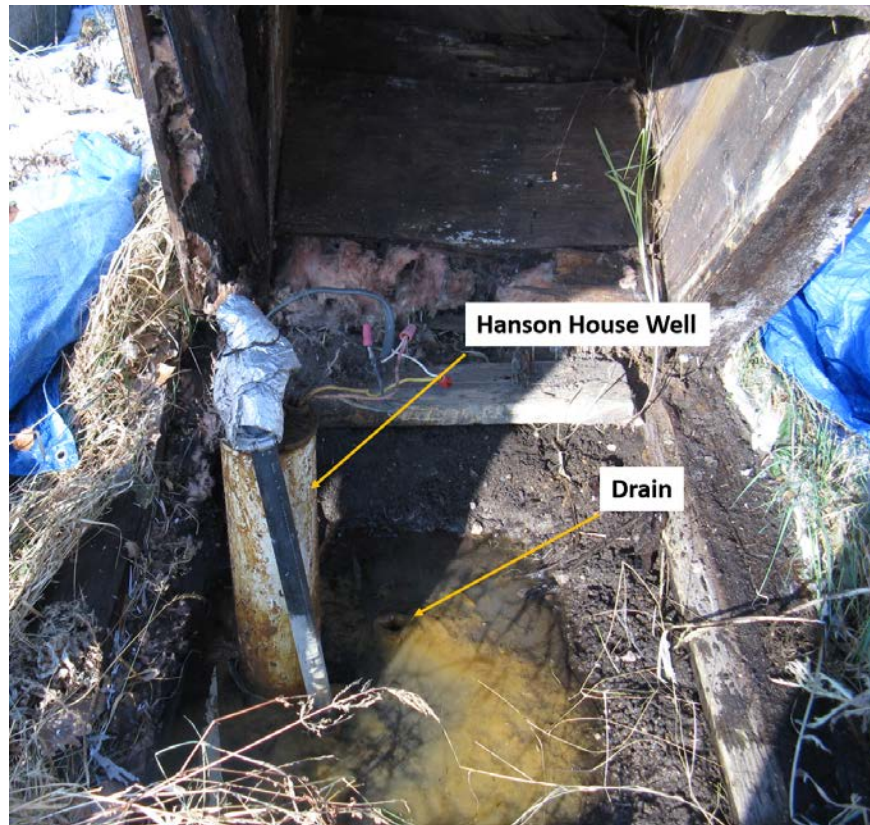
Photo B1: Hanson House Well on November 13, 2017.

Photograph taken on 11/13/2017 by DNR staff facing north.

Mr. Hanson initially contacted the DNR in October 2017 after noticing the reduction in flow discharge from his two flowing wells over the last three to four years. However, he was not out of water at that time and did not submit well interference forms. Mr. Hanson reported that he started pumping sandy gray water in the house intermittently during the summer of 2017. DNR visited the property in November 2017 and observed the Hanson House Well had water upwelling alongside of the well casing indicating the well is not grouted or the grout washed out (Appendix B; Photo B1). There was also sediment build up on the top of the well casing (Appendix B; Photo B2) Mr. Hanson estimated the well to be 170 feet deep. On subsequent visits, DNR also observed water flowing out of the top of the Hanson House Well (Appendix B; Photo B6 and B10). Water pools around the well casing and flows into a drain hole that leads to a buried line that discharges towards the Poplar River (Appendix B; Photo B1 and B7).

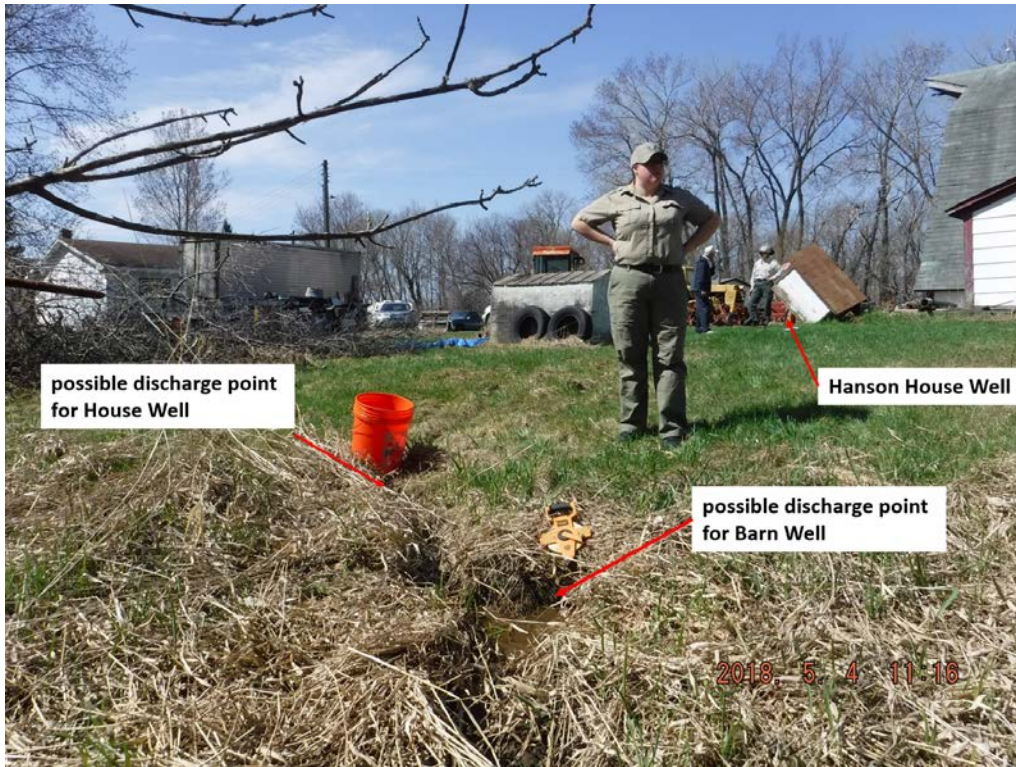
Photo B7: Discharge points on May 4, 2018.

Photograph taken on 5/4/2018 by DNR staff facing west.

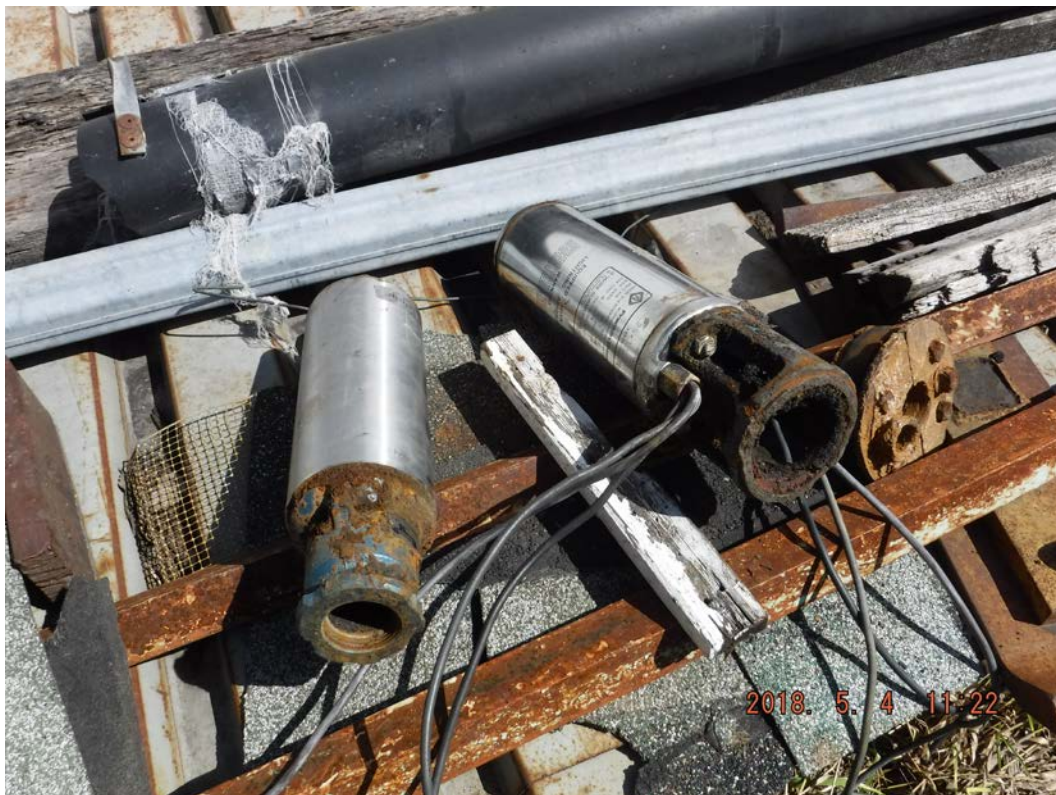
Photo B8: Original submersible pump on May 4, 2018.

Photograph taken on 5/4/2018 by DNR staff facing north.

On March 20, 2018, Anderson Well Drilling was contracted to replace the submersible pump (set at 40 feet deep) in the Hanson House Well. The original pump broke into two pieces as the driller was removing it. It also had sediment buildup (Appendix B; Photo B8). The new pump was set at 40 feet below land surface; the same depth as the original pump and appears to have resolved the out of water problem as Mr. Hanson did not run out of water in 2018 irrigation season.

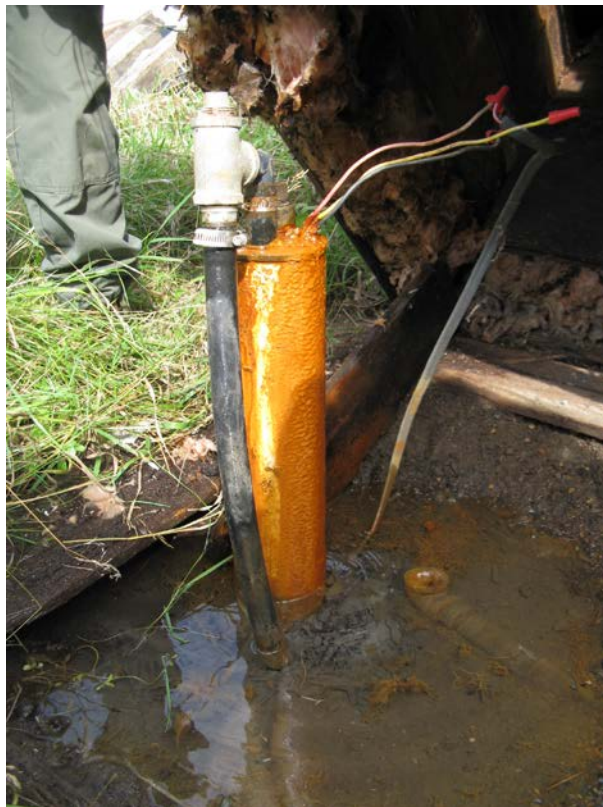
Photo B10: Hanson House Well on September 6, 2018.

Photograph taken on 9/6/2018 by DNR staff facing northwest.

- Clear water was seen discharging from and pooling around the House Well (Appendix B; Photo B10).
- Clear water was observed from the barn spigot which is connected to the House Well (not the Barn Well) according to Mr. Hanson (Appendix B; Photo B11).
- Sandy gray water was collected from the outside spigot of the house which is connected to the House Well (Appendix B; Photo B12).

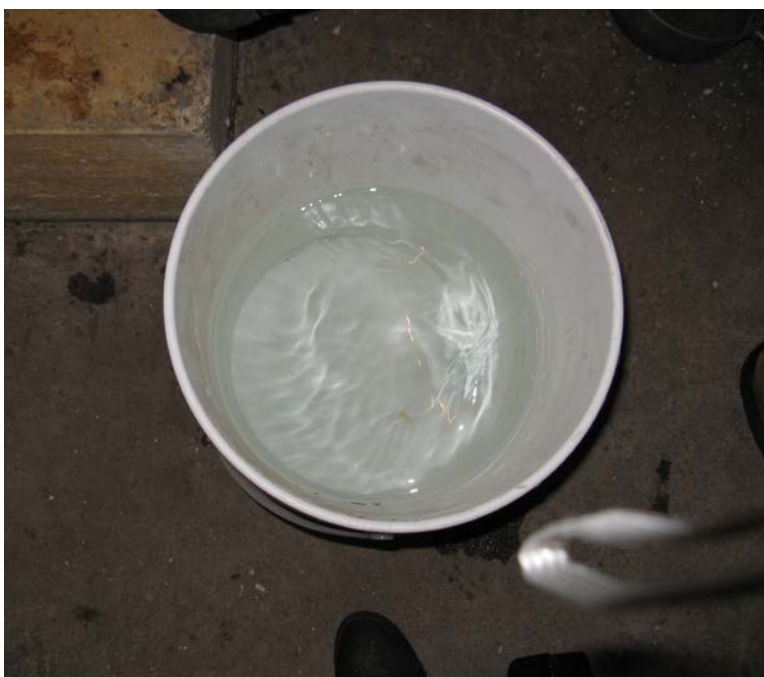
Photo B11: Hanson House Well water sample taken from inside the barn on September 6, 2018.

Photograph taken on 9/6/2018 by DNR staff. Water sample taken from hose near pressure tank connected Hanson House Well.

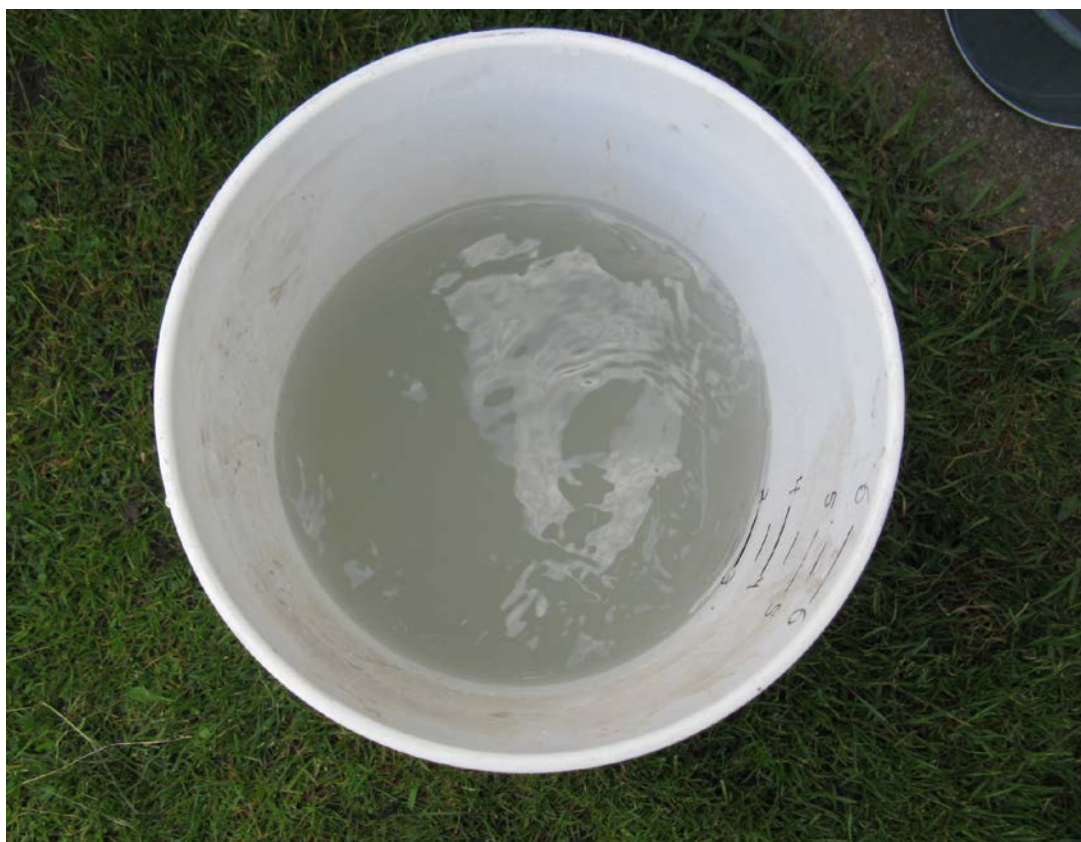
Photo B12: Hanson House Well water sample taken from spigot at the house on September 6, 2018.

Photograph taken on 9/6/2018 by DNR staff. Water sample taken from spigot at the house sourced from Hanson House Well.
