Pine Lake

Red Lake Watershed District

Project History

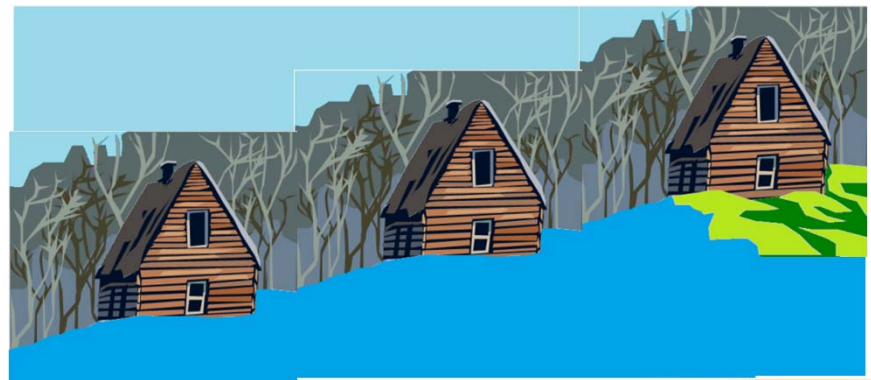
Highest Peak - 2009

- Highest recorded lake level of 1285.9 feet on April 11, 2009
- Lake exceeded or at the natural ground elevation of 52 cabins
- Lake exceeded or at the first floor elevations of 22 cabins

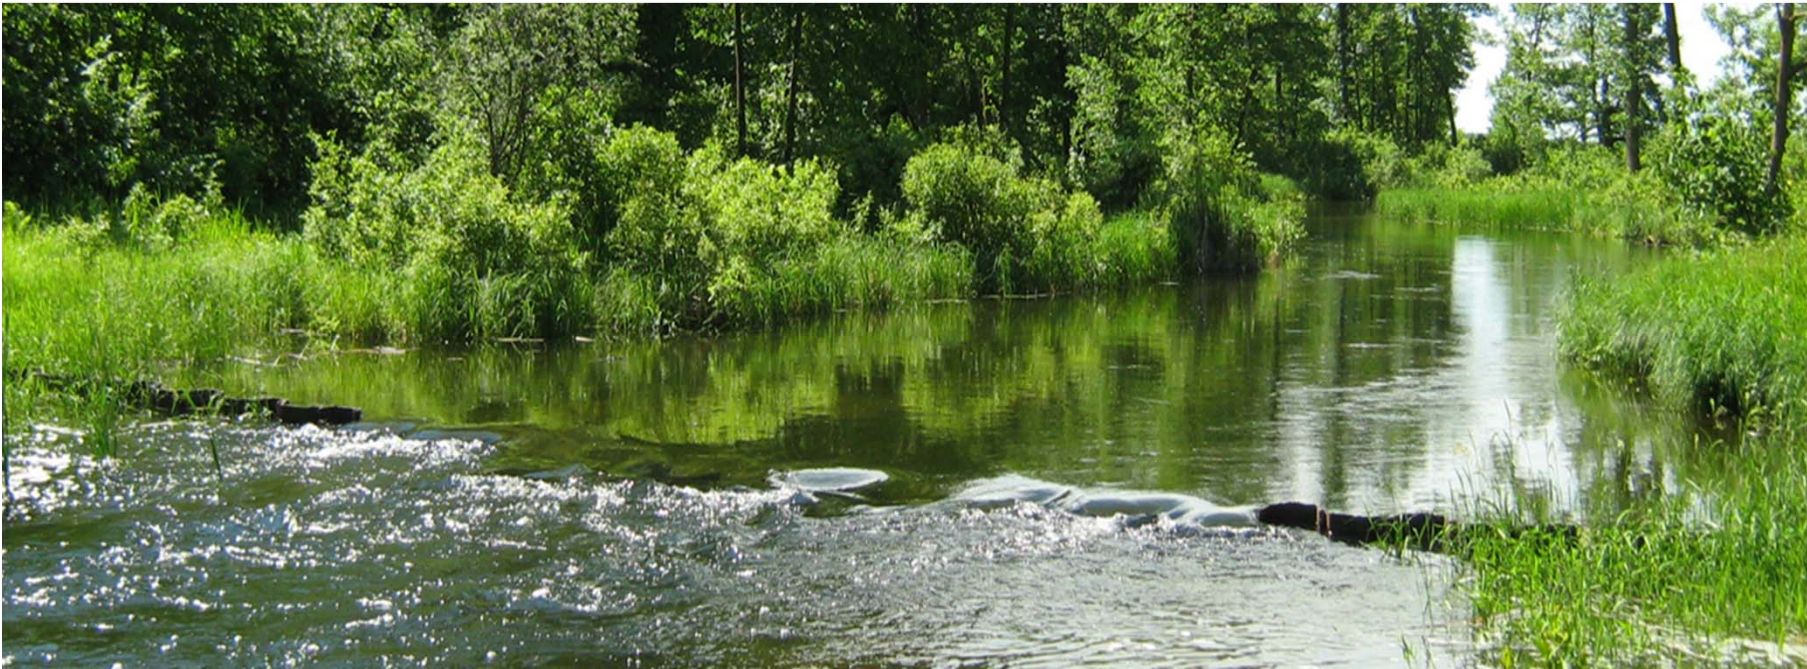
Hydraulic model: preliminary results

- Outlet structure has minimal effect on peak WSEs & discharges for 100-YR runoff events. It is actually the downstream Lost River channel that has the greatest effect on high Pine Lake outflows.

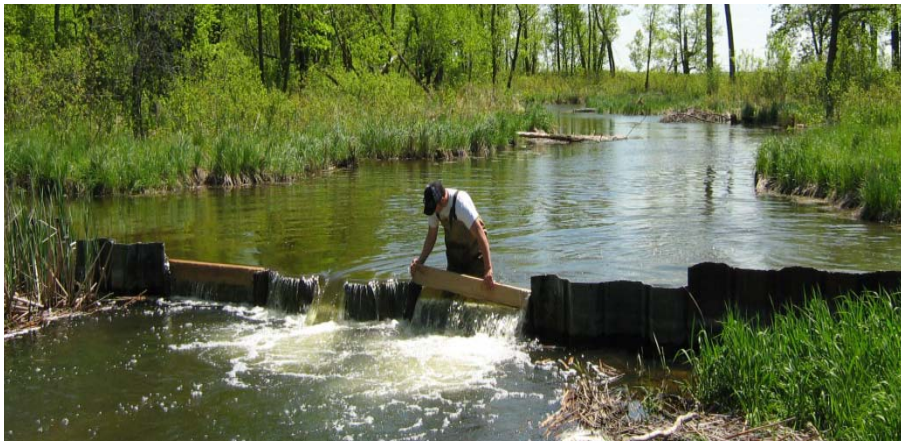
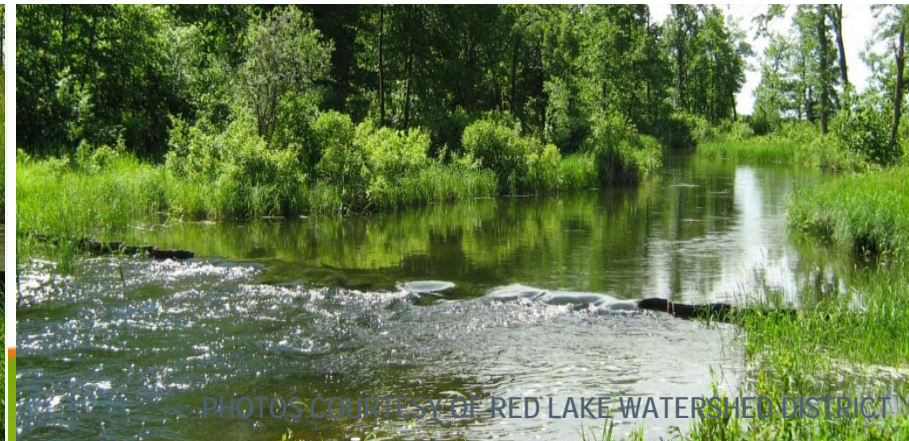
Benefits of New Outlet

- Operational Flexibility / Access / Response Time
- Higher Summer/Fall Lake Level
- Discharges lower DO water through gate

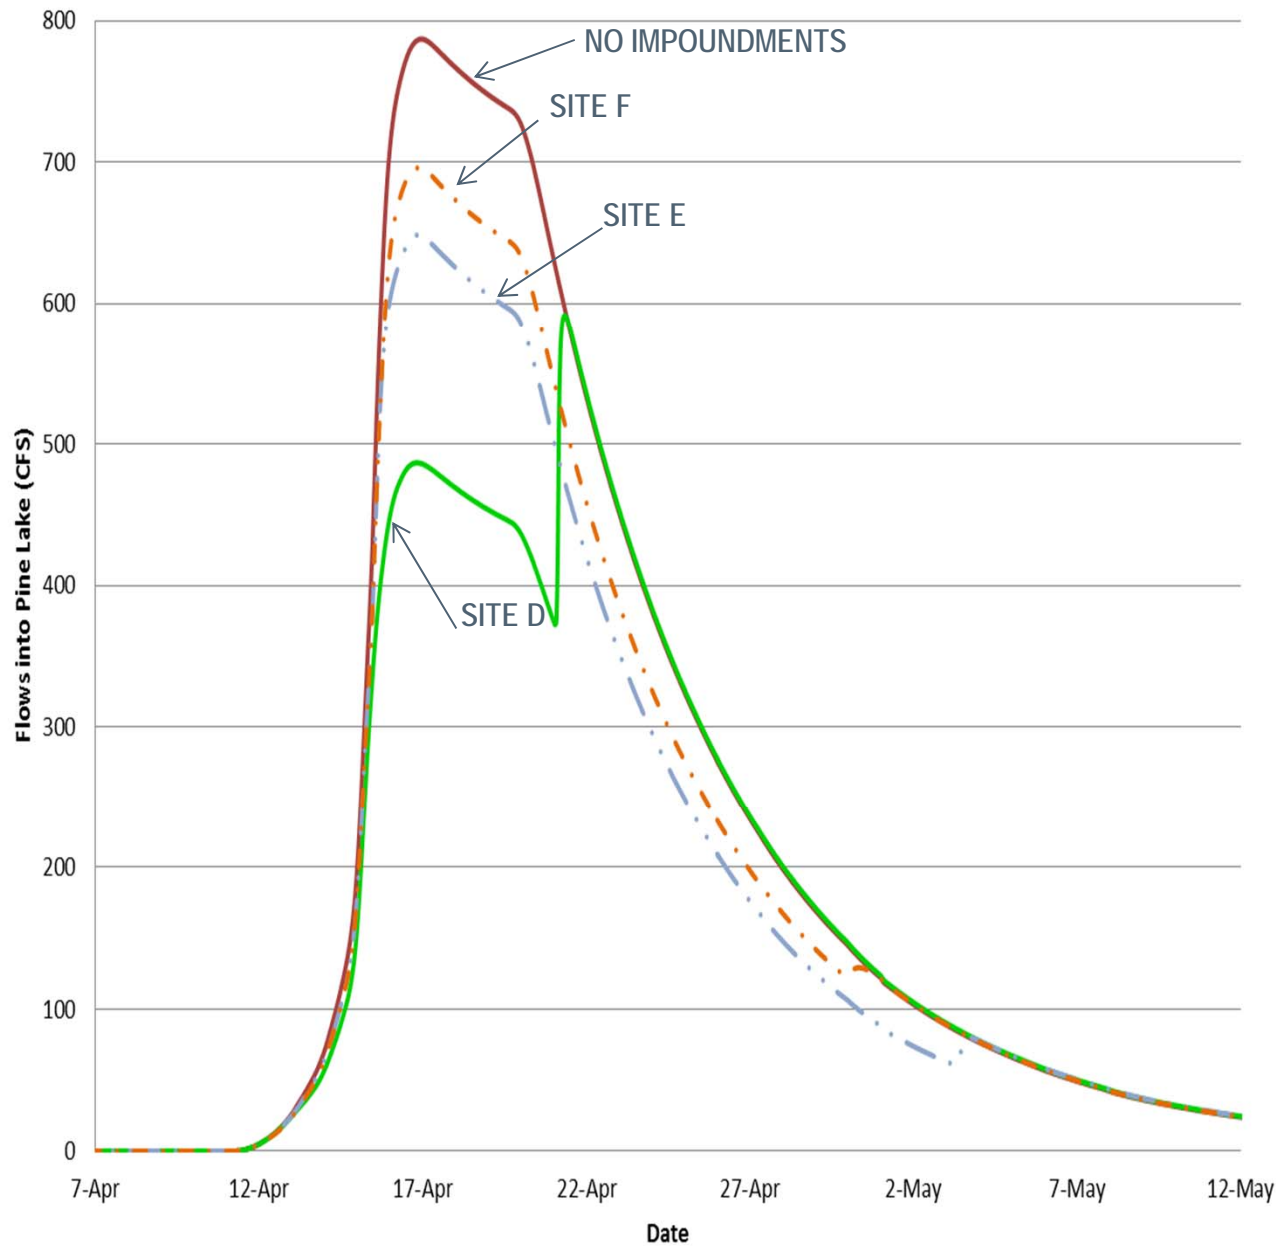
Flows into Pine Lake

SMPE 100-yr, 10 Day Runoff

Peak Discharge (CFS)
Existing	787
Site D	591
Site E	649
Site F	696

- Baseline
- Site D
- - Site E
- - Site F

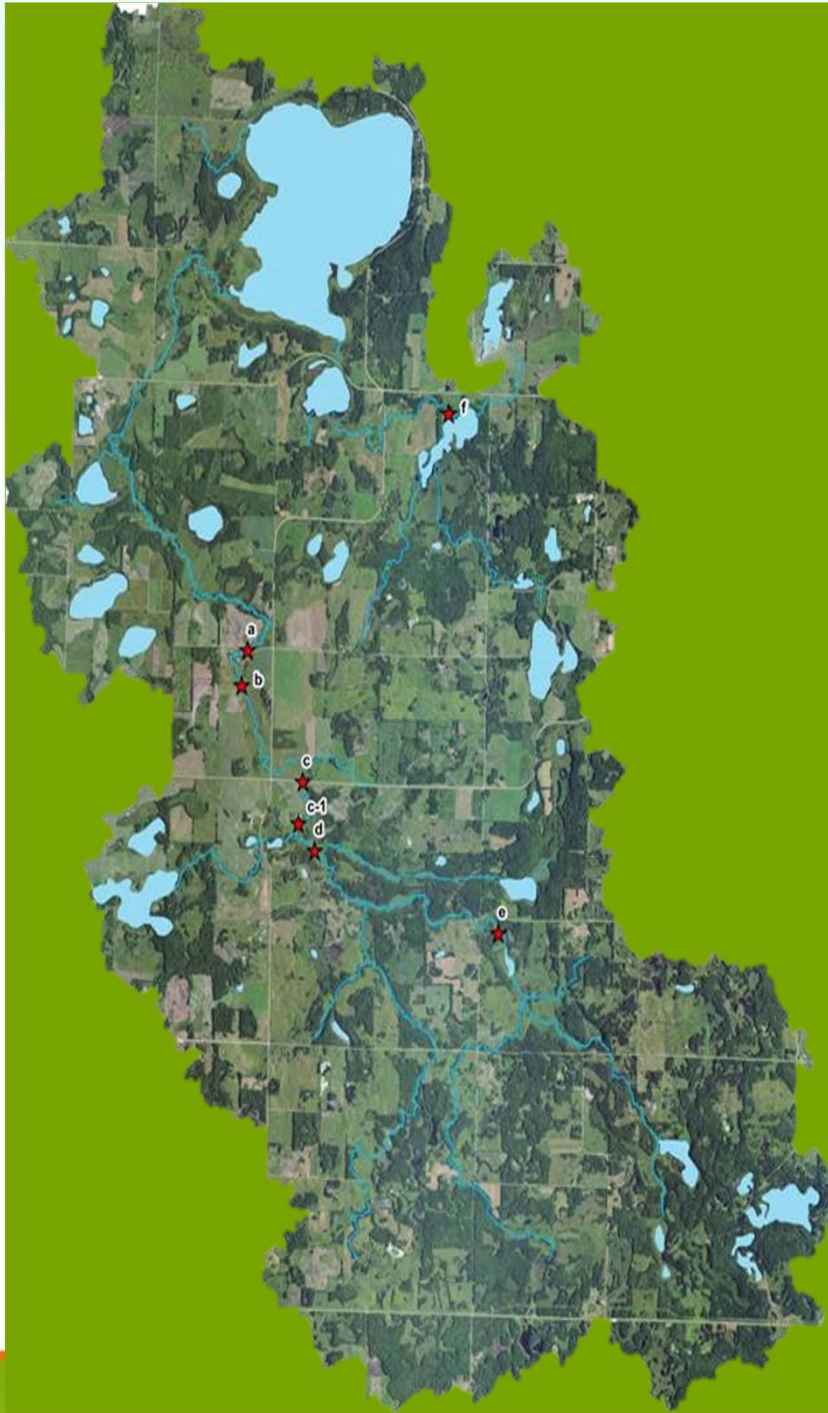
SITE F

- 1.6 Miles of Streams Impacted

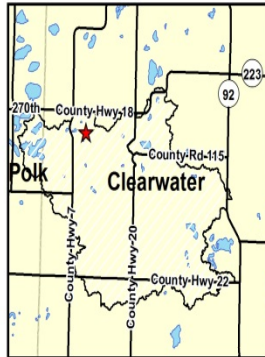
- Section Lines
- County Roads
- Structures
- Potential Site Location
- Embankment
- Site D DA
- Site Footprint
- Drainage Lines

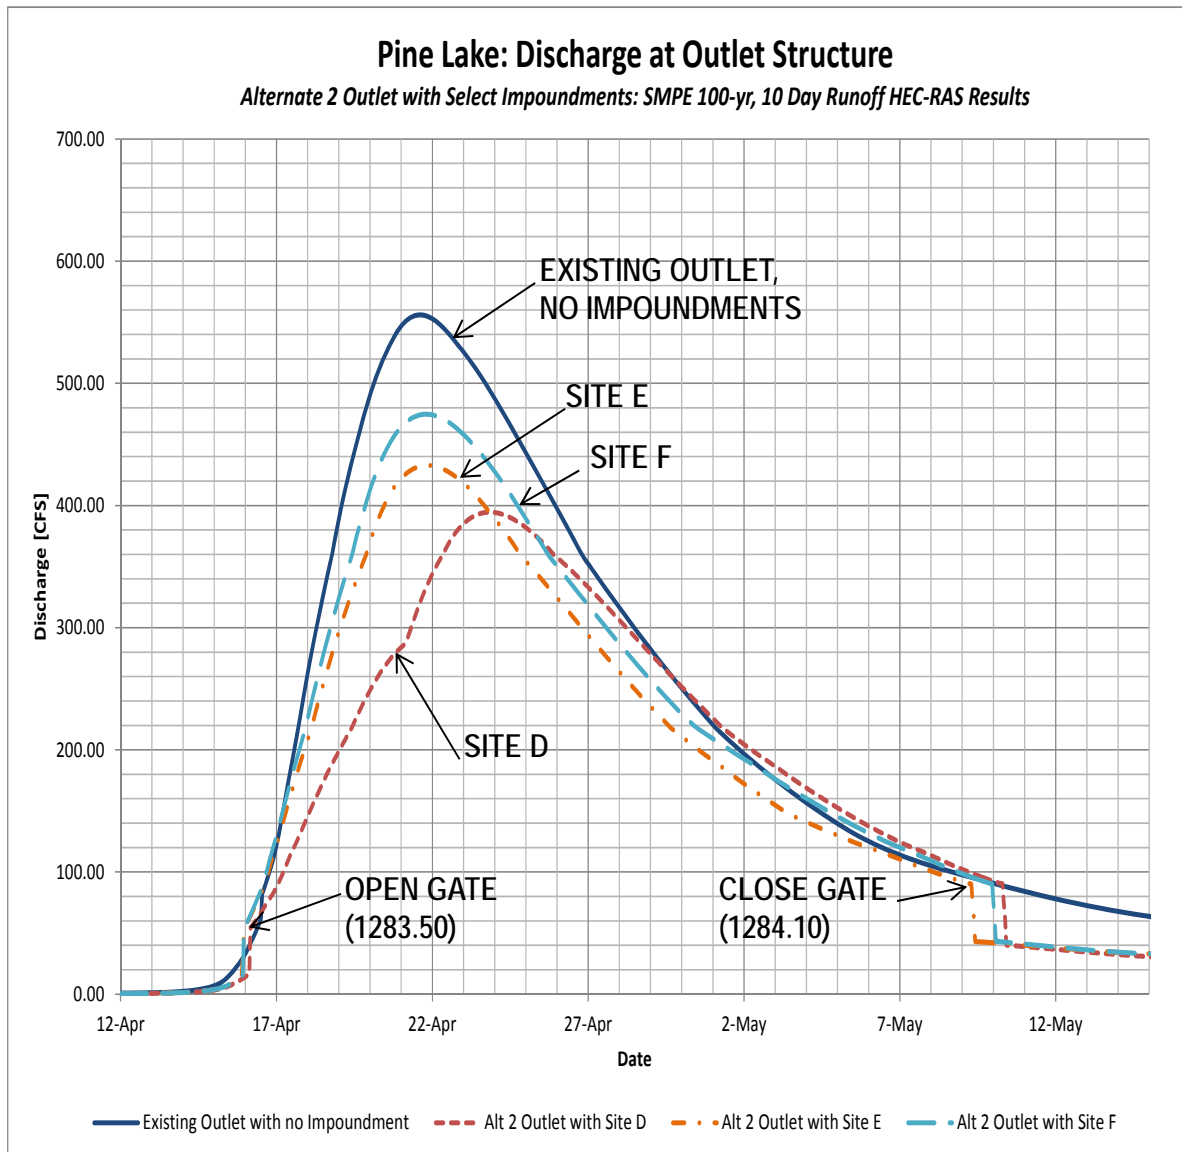
100 YEAR 10 DAY SNOWMELT ANALYSIS: DISCHARGE

Peak Discharge (CFS)	Approx FDR Value (AC-FT)
Existing	556	N/A
Site D	395	2,839

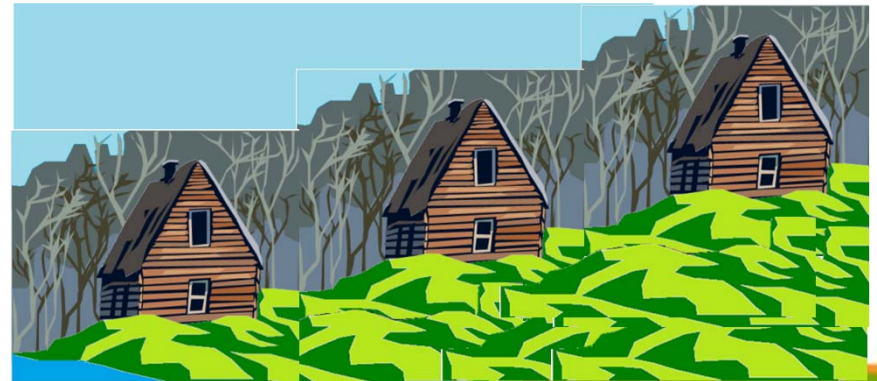
Current Summer Conditions

- Stop logs are in place
- Typical summer lake elevation of 1283.5 feet at the top of the stop logs
- Maintenance flows to Lost Creek with the low flow outlet – 1282.6 in 2013

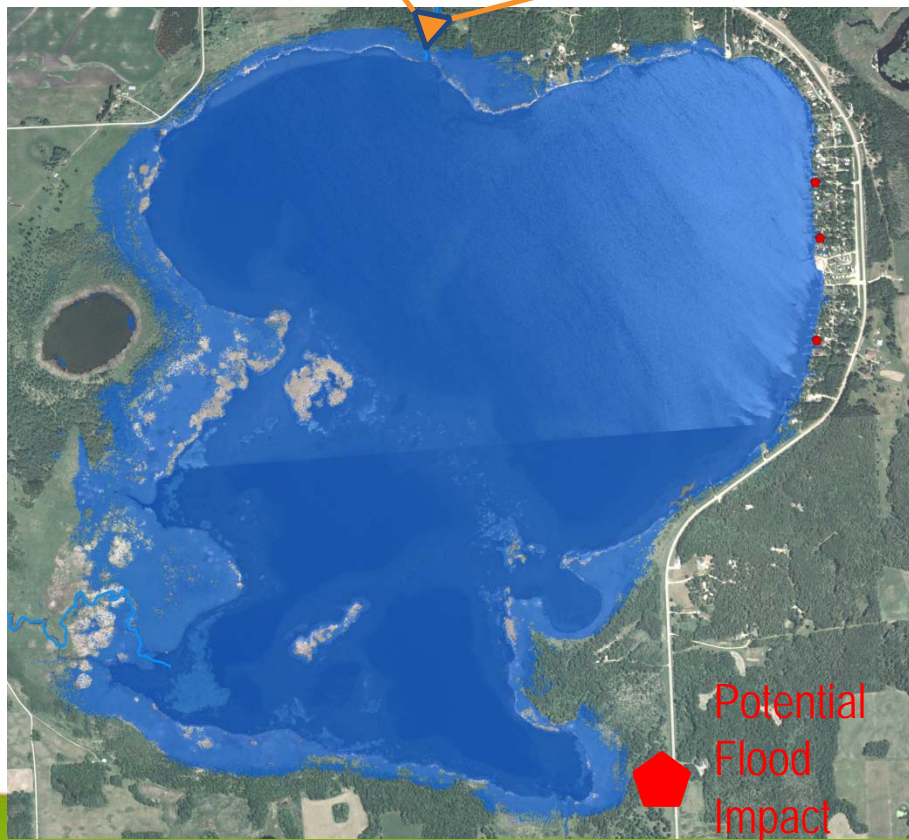
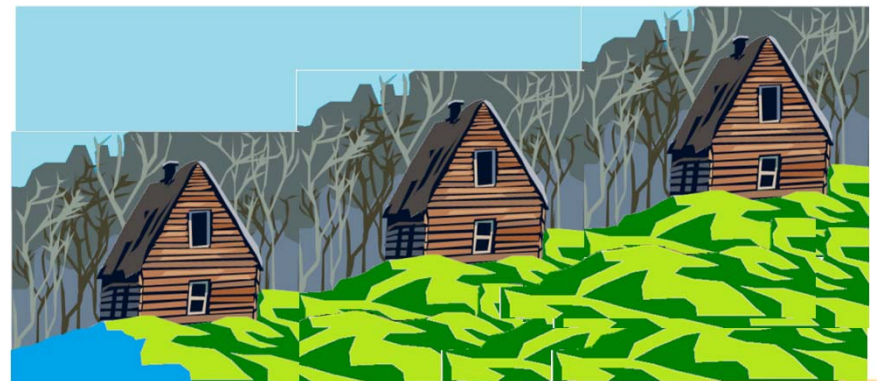
Current Minor Flooding Conditions

- Minor flooding concerns reported at lake elevation of 1284.4 feet.
- Stop logs have been removed when lake exceeds 1284.0 feet
- Water is at the 2nd stage of the outlet

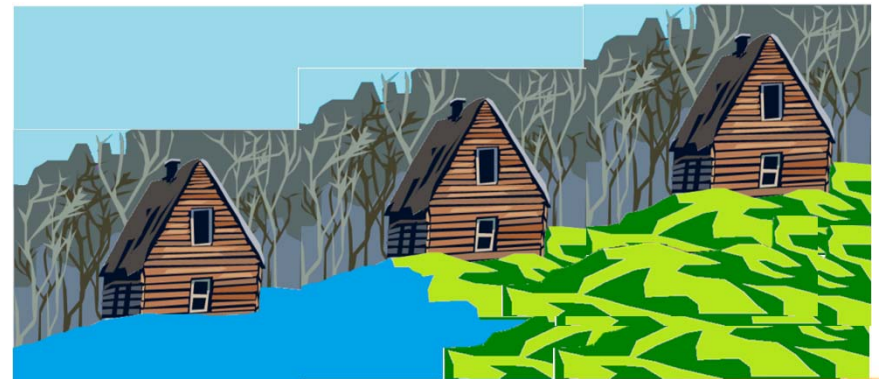
Current Major Flooding Conditions

- Major flooding concerns reported at lake elevation of 1285.4 feet.
- Cabins, half of the campground, and public access to lake is flooded
- Stop logs have been removed
- Outlet is submerged

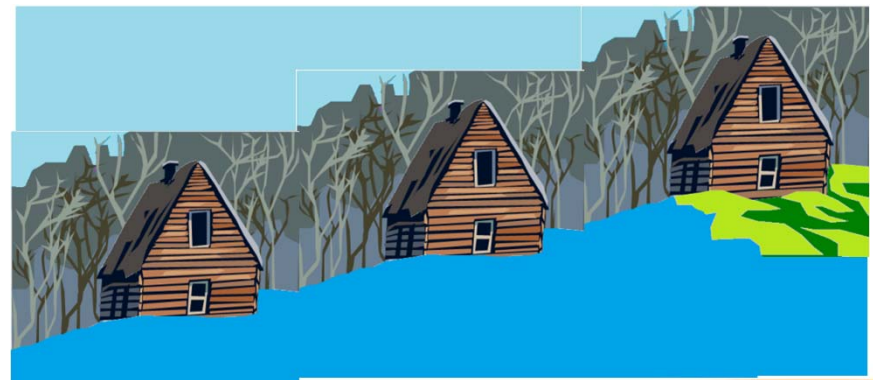
Highest Peak - 2009

- Highest recorded lake level of 1285.9 feet on April 11, 2009
- Lake exceeded or at the natural ground elevation of 52 cabins
- Lake exceeded or at the first floor elevations of 22 cabins
