RLWD Projects

Engineering Projects

Water Quality Projects

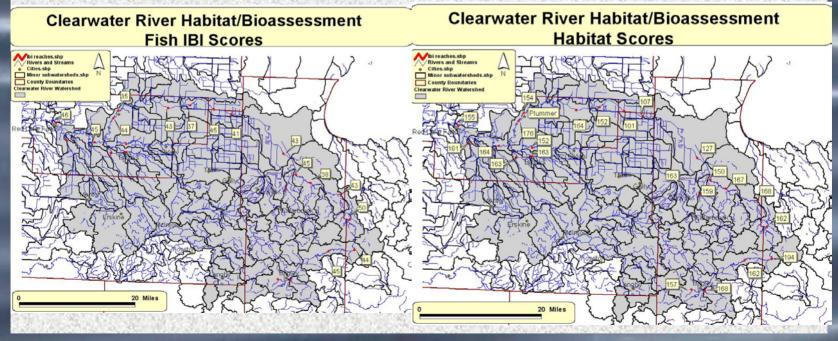
Clearwater River Habitat/Bioassessment

Index of biotic integrity for sites along the Clearwater River and its tributaries

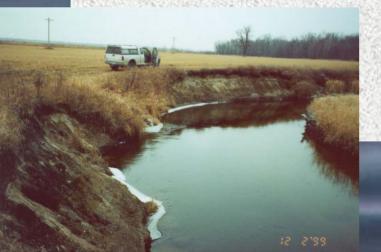
Clearwater River Bank Stabilization and Revitalization

- Streambank erosion
- Gullies were being formed across river bends through the flood plain
- Headcutting from channelized reach
- Need for bank and grade stabilization

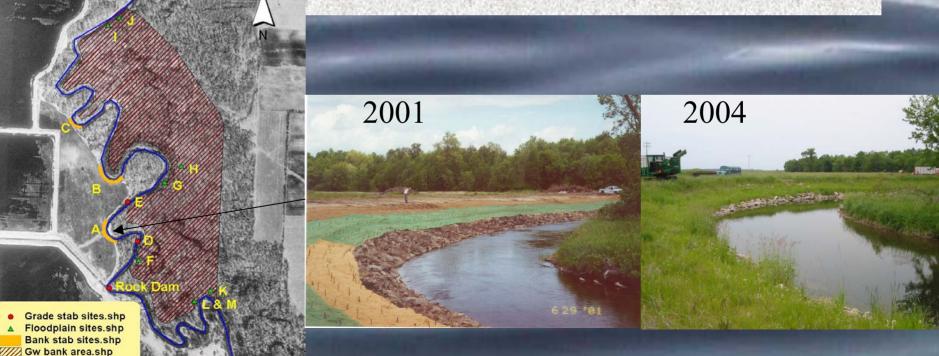
Banks were stabilized through reshaping, willow bundles and stakes, riprap, geotextile fiber, and seeding

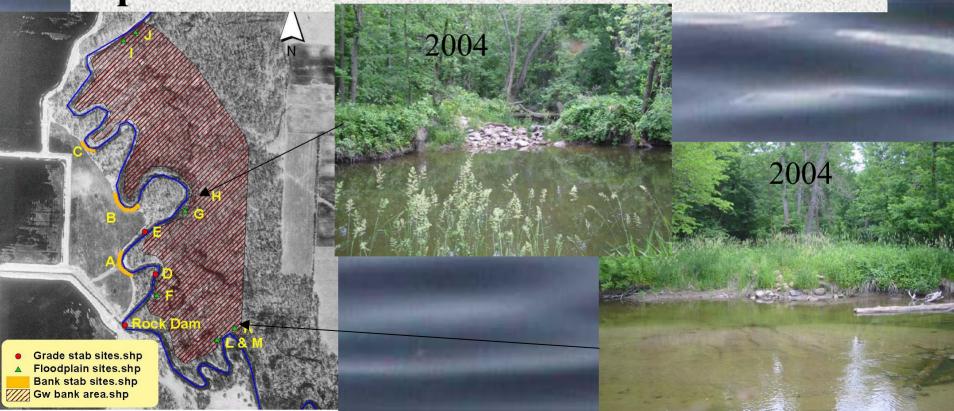
Rock dams were used to restore the flood plain

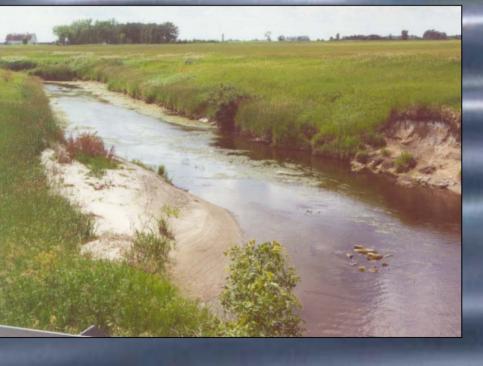
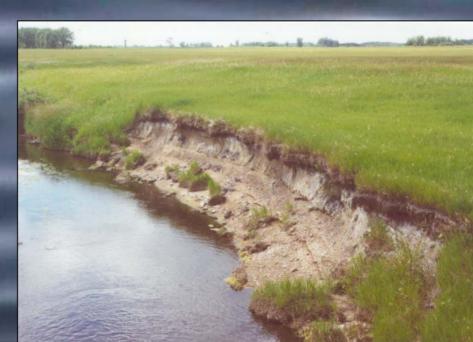
• Gully 6 – Lost River Erosion Control

Before

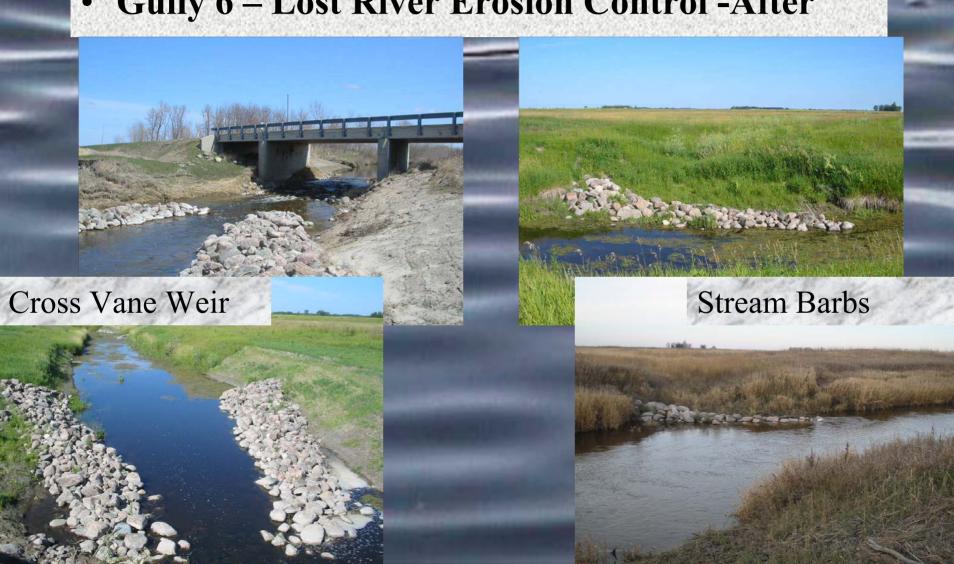
Gully 6 – Lost River Erosion Control -After

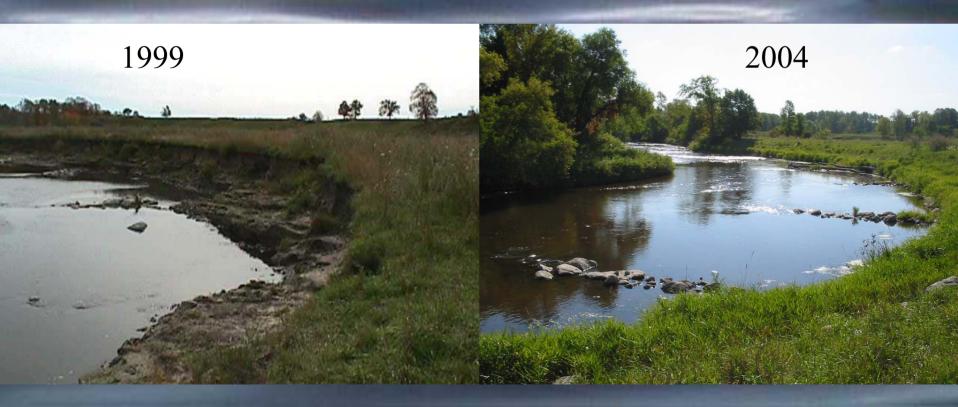
- Erosion Control at 4 Sites
- Example: Emardville Site

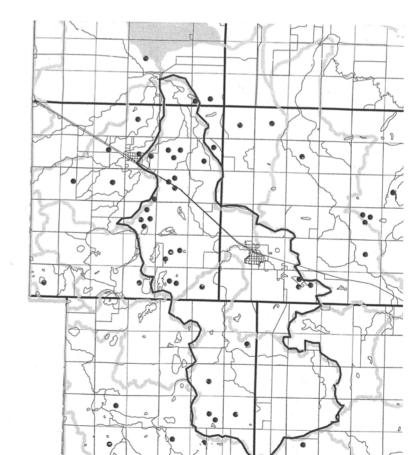
Silver Creek Buffer Initiative Projects

In the Watershed - 29 Projects – 637 Acres

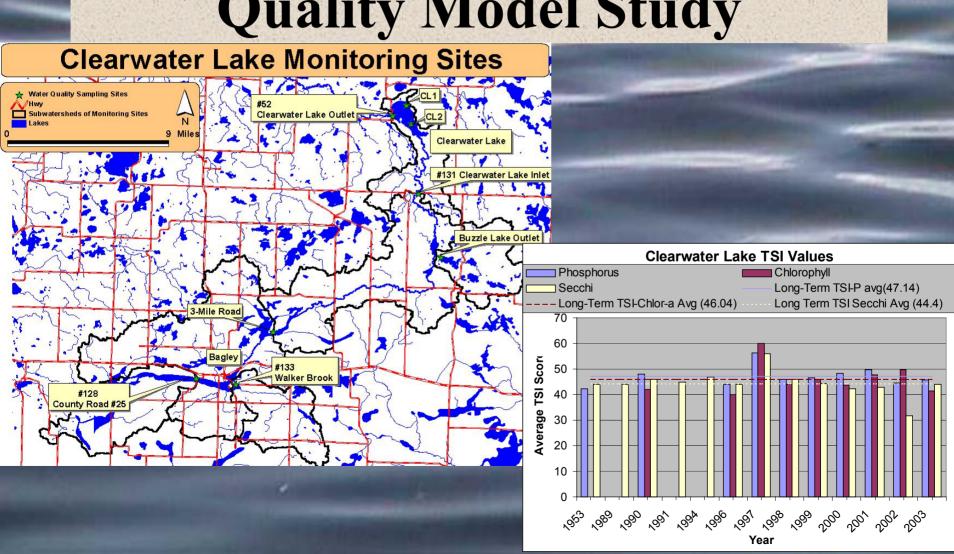
Clearwater Lake Water Quality Model Study water Lake Monitoring Sites
