# Red Lake River Watershed Farm to Stream Tile Drainage Water Quality Study

**Final Report**

**March 20, 2009**

Written By: Corey Hanson, Water Quality Coordinator, Red Lake Watershed District  
Flow Results contribution by HDR Engineering, Inc.

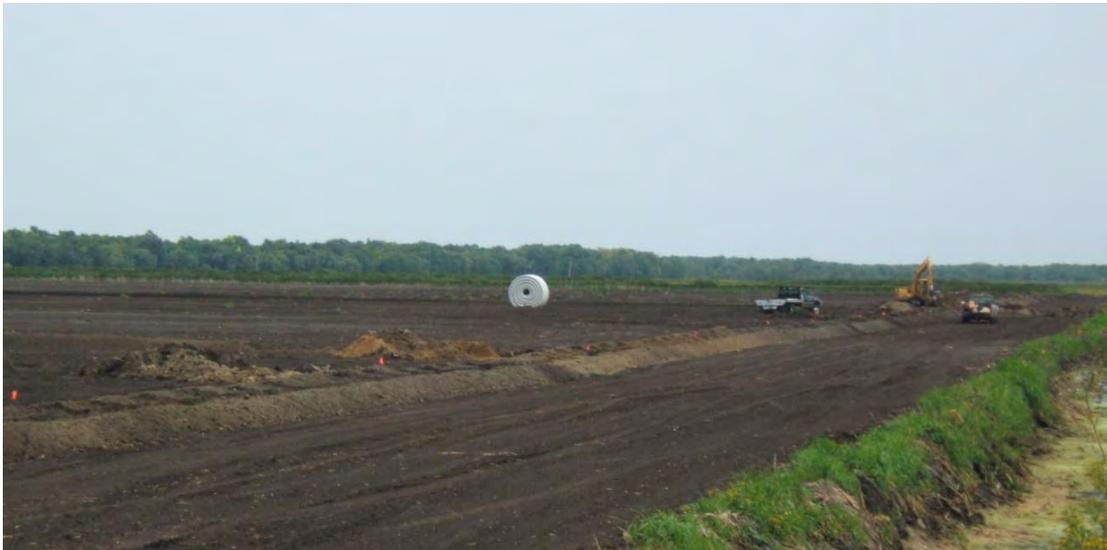
**Figure 1. Installation of wild rice paddy tile drainage**

Wild rice farmers and Red Lake Nation Department of Natural Resources staff point out the fact that main line tile drainage also has benefits for wild rice farming. Benefits are greatest when the main line of the tile system is directly connected to a water control structure. These benefits include but are not limited to:

1. More evenness of rice quality and maturity
2. Less ditch maintenance
  - a. No internal ditches (see photo on following page)
  - b. Less sediment loading
3. Fewer ruts during harvest (see photo on following page)
4. More control over drainage
5. No top soil loss
6. Ends of tile outlets don't get plugged if main line tile is used instead of internal perimeter ditches

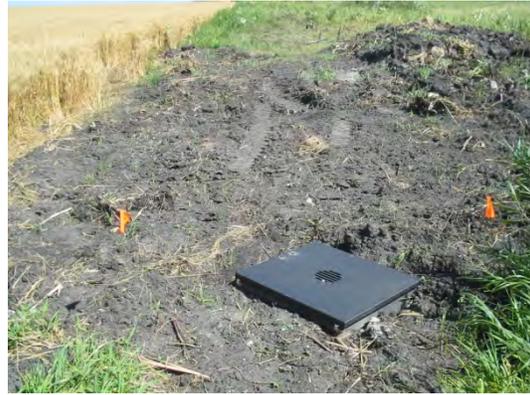
This is the water control structure that was installed on the end of a main line tile line. Field Drainage, Inc. of Brooks, Minnesota installed the structure. Water comes into the structure through the tile line, flows over a v-notch weir, and then exits the structure through a short length of pipe. A HOBO Water Level Data Logger is placed on the bottom of the field (upstream) side of the water control structure to collect a continuous record (1 measurement every 15 minutes) of water levels within the water control structure. This water level data can be translated into flow using a table and/or equation for calculating flow over v-notch weirs. A rating curve has been developed for the weir within this structure.

The tile drainage at this site was installed in 1995. The tiles were placed at about 40 inches deep with 120 foot spacing. The longest run of tile line in the field is  $\frac{3}{4}$  mile. The diameter of the outlet pipe is 8 inches.

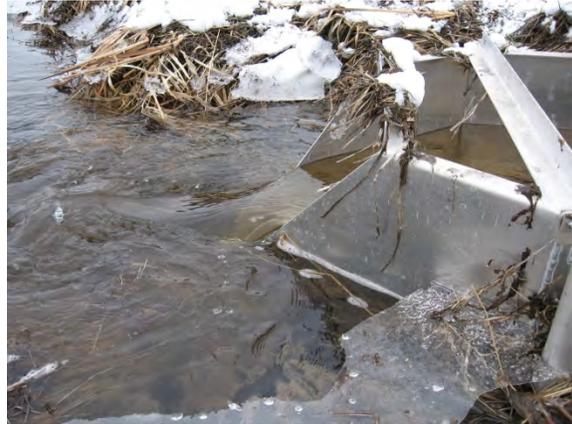
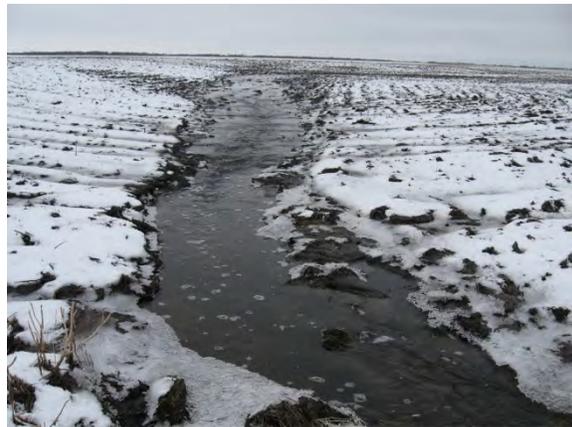
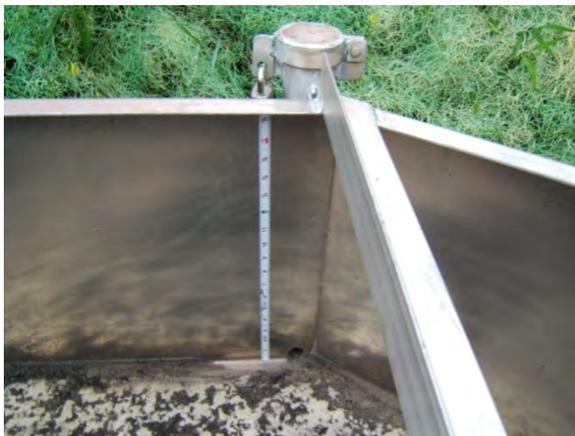
This monitoring site is used to monitor the surface drainage from the Bachand field. An h-flume was installed to catch and measure any surface runoff that comes from the Bachand field. Dip samples can be taken from the end of the structure. There is a HOBO Water Level Data Logger installed within the stilling well on the side of the structure to collect a continuous record (1 measurement every 15 minutes) of water levels within the flume. Level logger readings are correlated with manual measurements of water depth at the end of the flume. The water level data can be translated into flow using a table and/or equation for calculating flow through an h-flume.

The stilling well has a locking cap that is secured with a RLWD padlock. Some landscaping has been done to ensure that water coming from the field funnels through the structure. Erosion control fiber blanket was installed around the structure to minimize erosion from ground disturbed during installation.

The site is affected by backwater from the Hill River. A decision was made to raise the structure after the 2007 monitoring season in order to continue monitoring and have more confidence in the data. This was accomplished in the spring of 2008 and successfully maintained a level of head above the tail-water and reduce erosion.

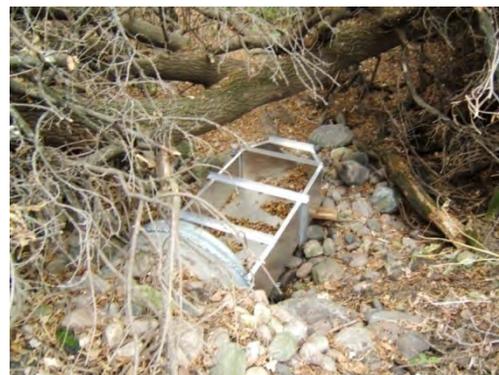
This site is located west of Yaggie 1 along a township road in Poplar River Township. There is more of a fall between the downstream end of this culvert and the Lost River than there is at the Yaggie 1 site. This topography allows for unobstructed flow through the h-flume.

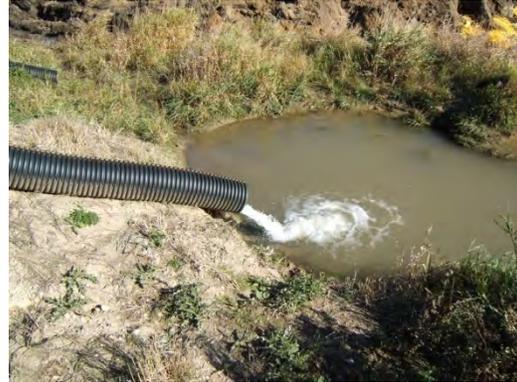
This is a Stanley Farms' pumped tile outlet. Samples are collected at the end of the black corrugated outlet pipe while the pump is running. The pump can be triggered to run by opening the cover to the reservoir and raising the float. A new pump was installed in the fall of 2005. Samples are collected from the pump that is closest to the road (first pump installed). This site is located where Sections 12 and 13 of Marshall County and Sections 7 and 18 of Beltrami County meet. The pumps are along the north side of Marshall County Highway 55/Beltrami County Highway 44 (gravel road) at the section line.

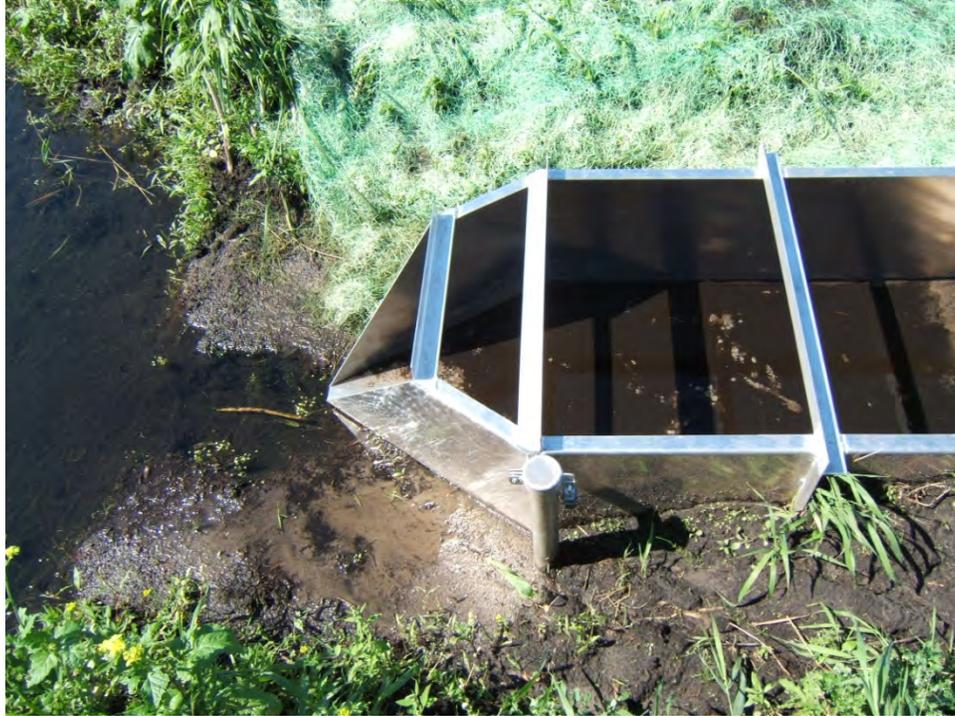
**Figure 14. H-Flume for Surface Flow Measurement at the Bachand Site**

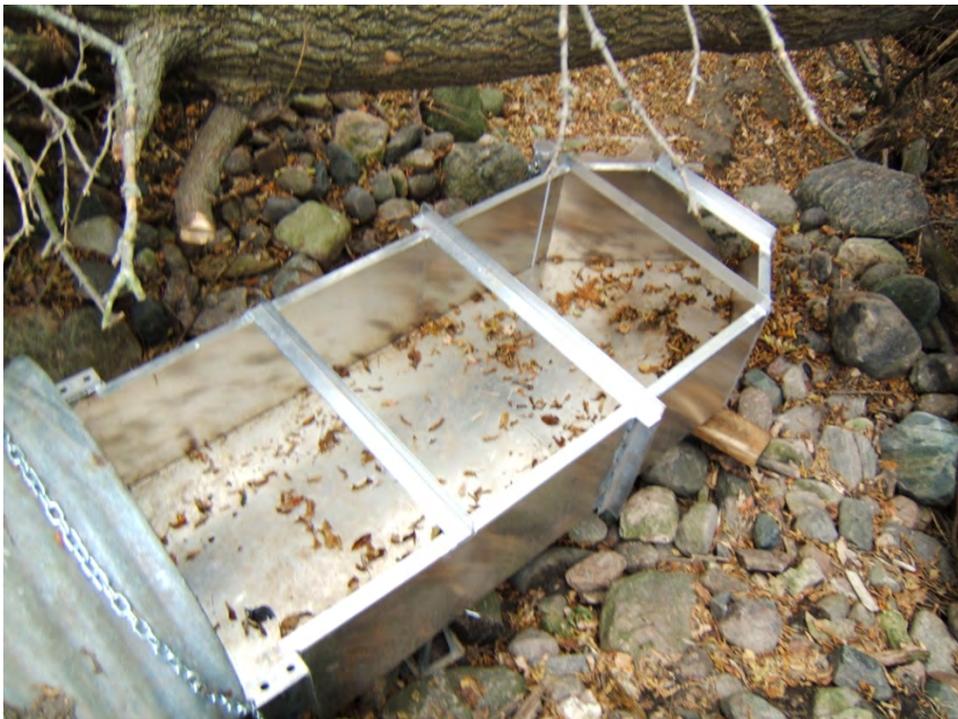
**Figure 17. H-Flume on Downstream End of Yaggie 2 Culvert**

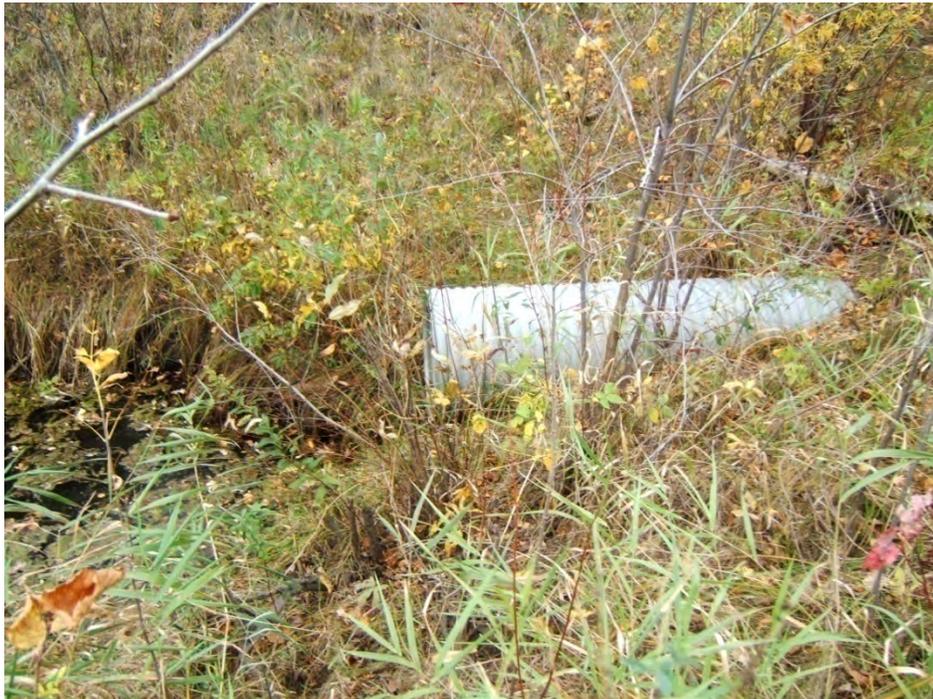
**Figure 19. Downstream End of Yaggie 1 Culvert**

University of Minnesota tile drainage research plot. When it was determined that the Swenson site would not work for accurate flow measurement without adverse affects to the farmer's crop, new sites were scouted for the project. The next choice was the Yaggie 1 site. The site is located on the north side of Section 1 of Poplar Township in Red Lake County, just east of the middle of the north end of the section. This monitoring site receives water from surface drainage on Kevin Yaggie and LeRoy Robert Carriere land. Initially, the outfall end of the culvert looked like a good place for a flume.

Unfortunately, when water levels in the Lost River rose during a runoff event shortly after we started monitoring, we learned that the river water rises to the level of the culvert. This would make unobstructed flow measurement impossible during periods of high flow. The downstream end of the culvert is lower because of the drop structure on the upstream end. This site was abandoned in favor of Yaggie 2.

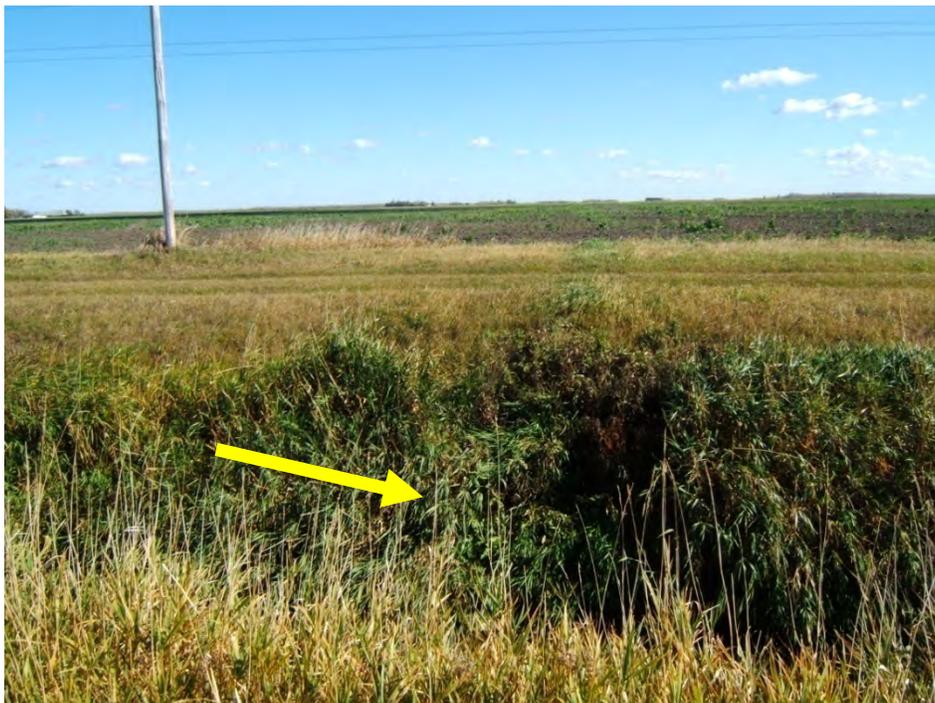
**Figure 21. Stanley GT1 Gravity Tile Monitoring Site**

These sites monitor water quality concentrations from gravity tile outlets on a Stanley Farms field. This field is drained by regularly spaced drain tiles that outlet into a township ditch along County Hwy 54. GT1 was initially the most visible and easily sampled of the tile outlets. It can be accessed by driving on a trail along the edge of the field that begins in Arnold Stanley's yard. It is approximately 890 feet north of the farmstead and south of the third power line pole north of the farmstead.

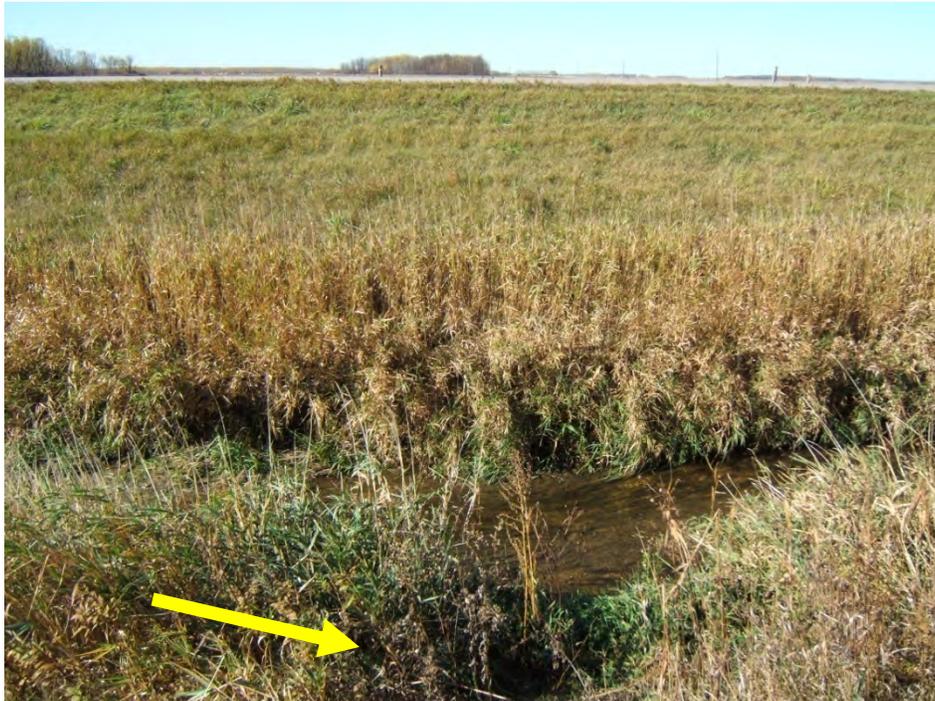
**Figure 22. Stanley GT 2 Alternate Gravity Tile Monitoring Site**

GT2 is located near County Road 55 on the north side of the field. It is northernmost tile outlet on this field. GT2 is not as easy to access as GT1 during wet periods. During wet periods, it is necessary to walk across a wet township road ditch and the water level in the receiving ditch may be high enough to cover the tile outlet. It was sampled more frequently because it runs longer

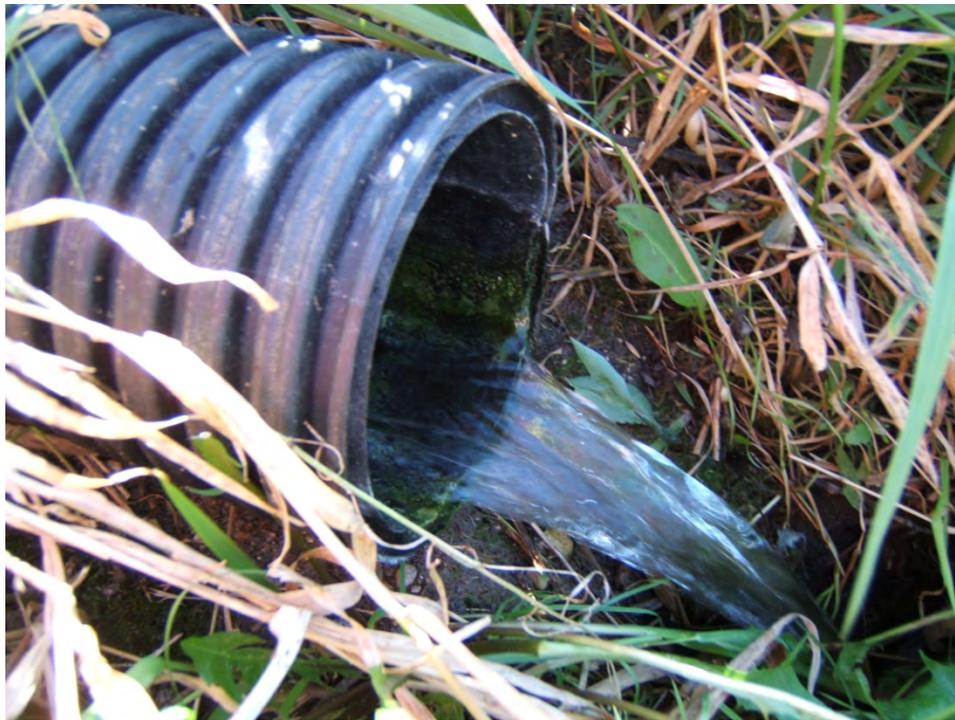
**Figure 23. Stanley GT2 Tile Outlet**

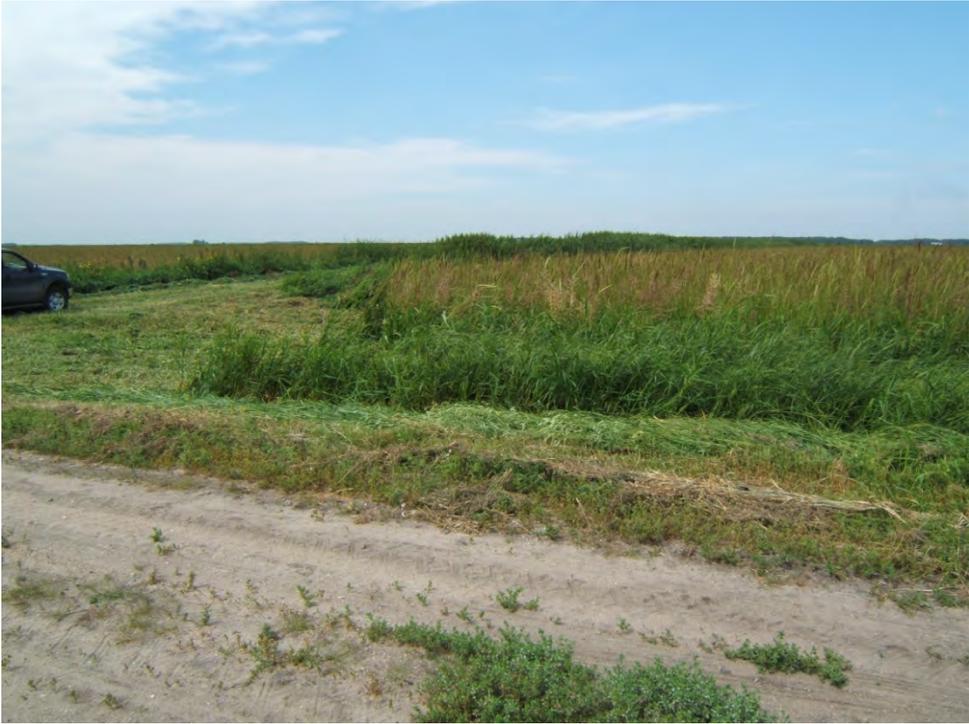
**Figure 31. Main-Line Tile Drained Paddy - Note the Absence of Ditches**

RLN Main Line Tile – Tile Drained Paddy with a Main Line Outlet and No Ditches

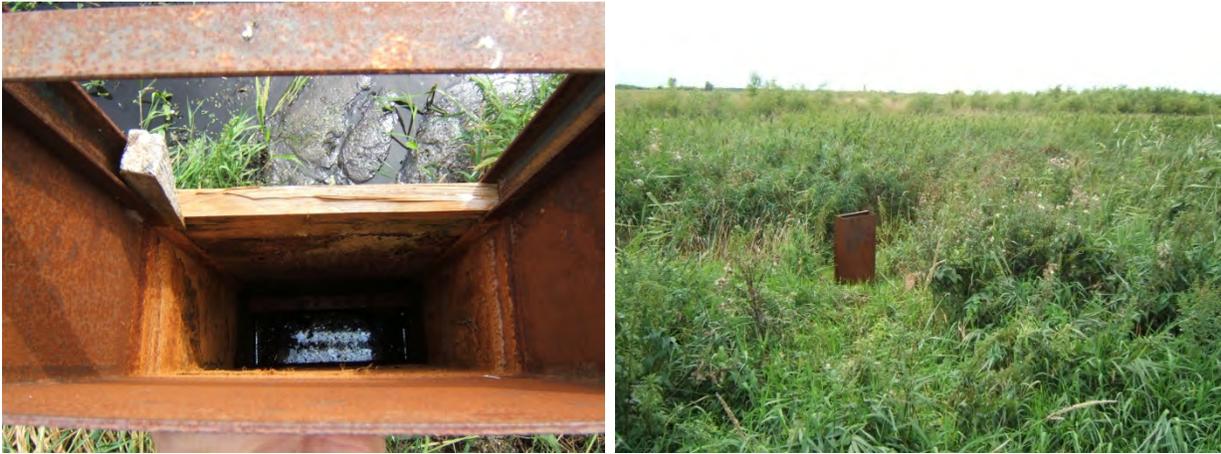
**Figure 32. Main Line Tile Outlet Structure**

This water control structure drains water from a paddy in which tile lines drain into a main line tile. The main line tile is directly connected to an outlet structure and surface drainage ditches within the paddy are eliminated. The main line tile is extended through the dike (which is a road) and the connected water control structure is on the opposite side of the dike from the paddy. The control structure releases water into a ditch that flows to the Clearwater River. The structure is located on the north side of the northwest corner of the northeast corner of Section 3 of Winsor Township in Clearwater County, along the south side of the road that runs along the border of Winsor and Hangaard Township. The system does not need interior surface ditching. So it does not have the erosion problems exhibited by the other paddy drainage systems.

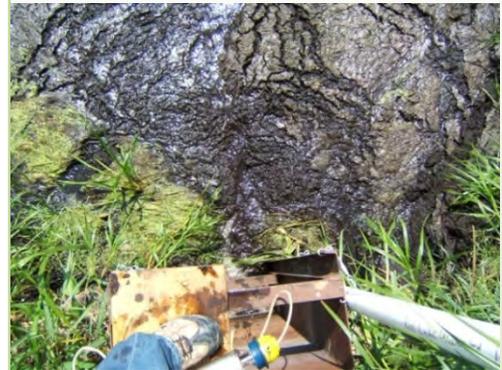
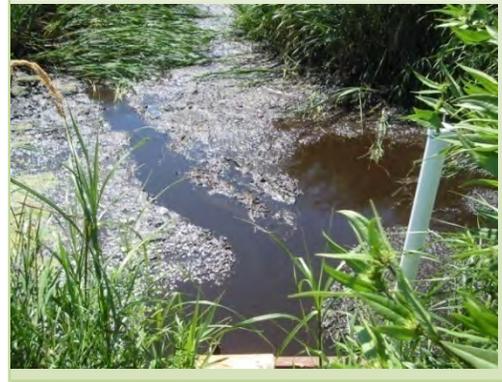
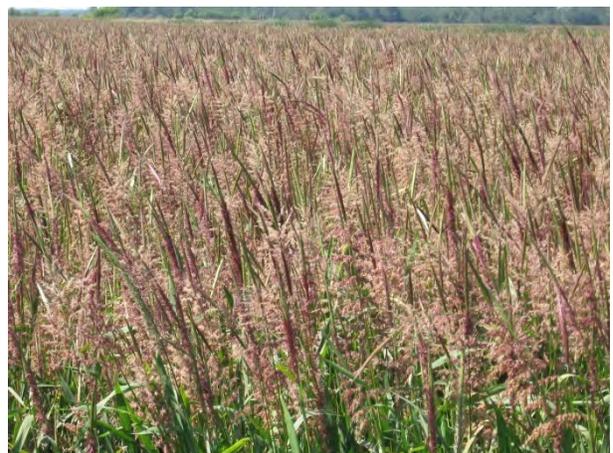
**Figure 39. Mud flowing through the outlet of paddy that has multiple gravity tile outlets and a perimeter ditch. Pattern tile does not help unless it is main line tile and eliminates internal surface drainage in paddies.**

Flow was measured at the outlet structure of the surface drained paddy in 2005. Total suspended solids and nutrient concentrations were extrapolated between sampling events and

multiplied by flow volumes to create a record of sediment and nutrient loading through this outlet.

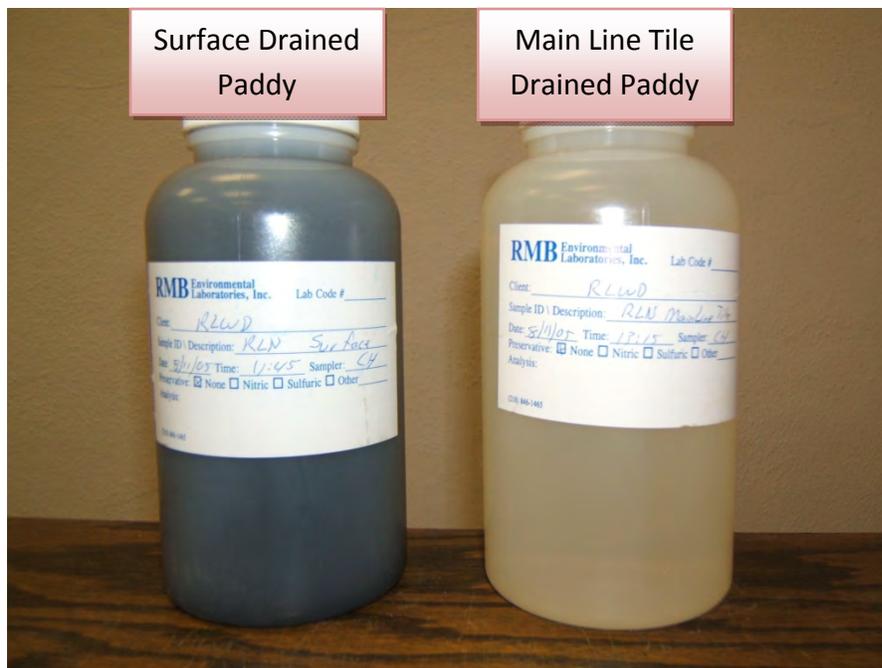
**Figure 41. Wild rice paddy surface drainage and main line tile water samples.**

A sample was collected for fecal coliform analysis from the Red Lake Nation Surface Drained Paddy monitoring site. The concentration was 720 col/100ml which is several times higher than the state standard of 200 col./100ml. This is cause for concern because the Clearwater River has been listed as impaired by fecal coliform where these paddies discharge into the river (Ruffy Brook to the Lost River) in the 2002-2008 MPCA 303(d) Lists of Impaired Waters. Also, a study conducted by Svedarsky et al in 1994 showed that fecal coliform concentrations increased drastically from upstream of the wild rice growing area. The concentrations **upstream** only averaged 3.3 and 10.7 cfu/100ml during the first and second halves of the drawdown period, respectively. On the **downstream** end of the wild rice growing area, however, concentrations were at 396.0 and 323.3 cfu/100ml, respectively during the first and second halves of the drawdown period.

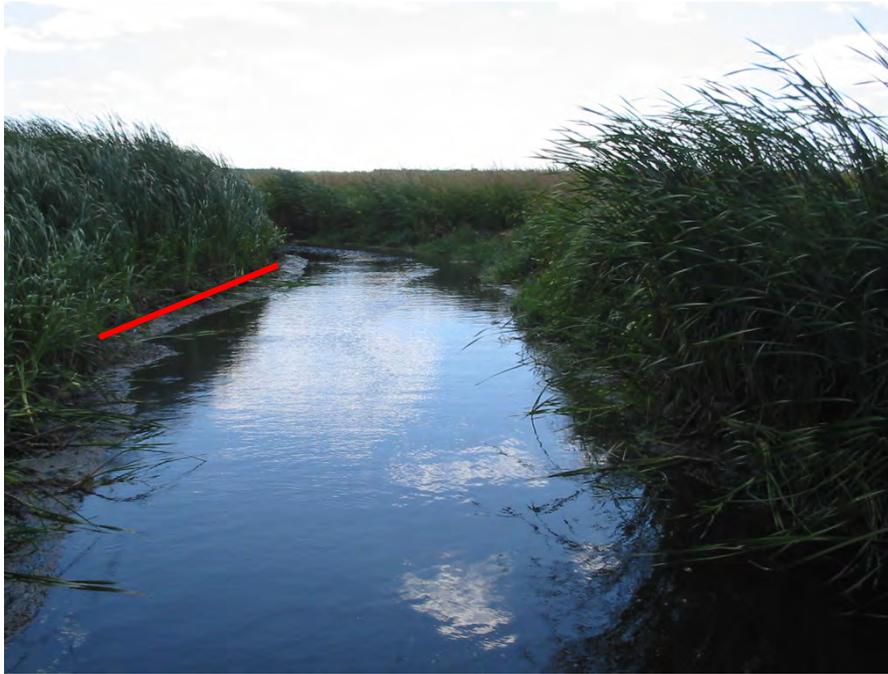
**Figure 43. The red line demonstrates the water level in surface drained paddy when turbidity and total suspended solids problems began occurring.**

Water quality in the wild rice paddies that still have internal perimeter surface drainage ditches was not as bad as long as some boards were in place and the water flowing through the structure was from the top of the water column. Once the boards were removed from the water control structure, more flow began within the ditches themselves and, thus, more erosion occurred, as demonstrated in the following photograph.

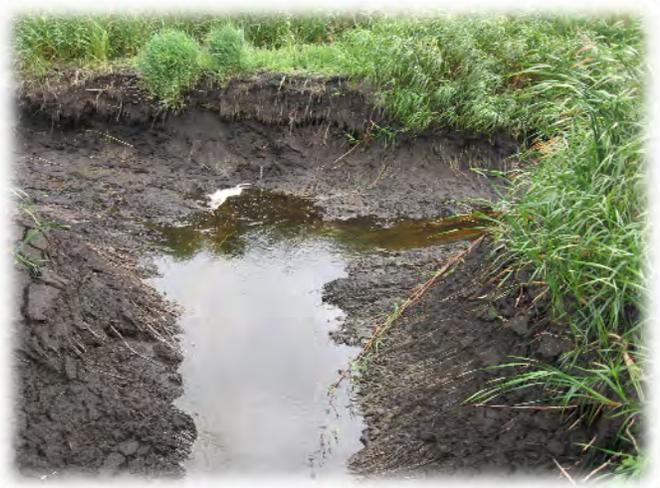
There are a number of tile drainage systems along the Clearwater River that feature main line tile, but are not hooked up to an outlet structure. So, there is some erosion that occurs between the tile outlet and the water control structure as shown in the photo to the right. These need to be hooked up to a structure or some kind of combination structure that can control both surface and tile drainage.

Expediting the process of getting these hooked up will achieve a great water quality benefit at a low cost. This would also benefit producers as these open-ended tile systems can get plugged by sediment and, sometimes, muskrats.

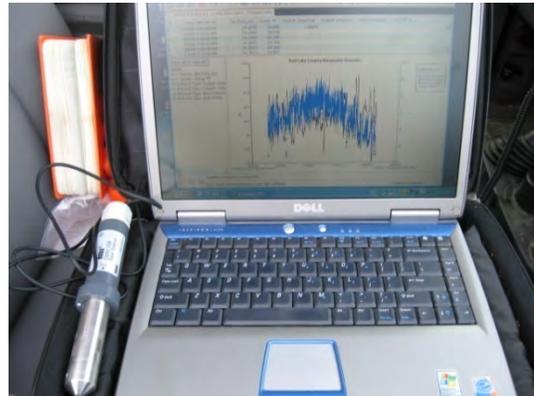
Figure 49. 60° V-Notch Weir Rating Curve and Equations

Flows were measured by directing surface flow through h-flumes and running tile flow over a v-notch weir within a water control structure. Onset HOBO water level loggers were used to collect continuous records (1 measurement every 15 minutes) of water levels within the flow measurement structures. This water level data can be translated into flow using a table and/or equation for calculating flow through an h-flume. The h-flumes had built-in stilling wells for installation of the water level loggers. The level logger in the tile water control structure was placed on the bottom of the structure. Gauge zero readings were established each year for each flow measurement structure. The gauge zero of an h-flume was set at the point where water is sitting at the edge of the lip of the structure, but is not quite yet flowing out of the structure. The gauge zero for the v-notch weir in the tile drainage water control structure was set at the bottom of the v-notch weir. Manual water measurements were collected with every site visit to get good correlations between manual water level readings and automated level logger readings. Rating curves were developed for the h-flume and v-notch weir flow measurement structures.

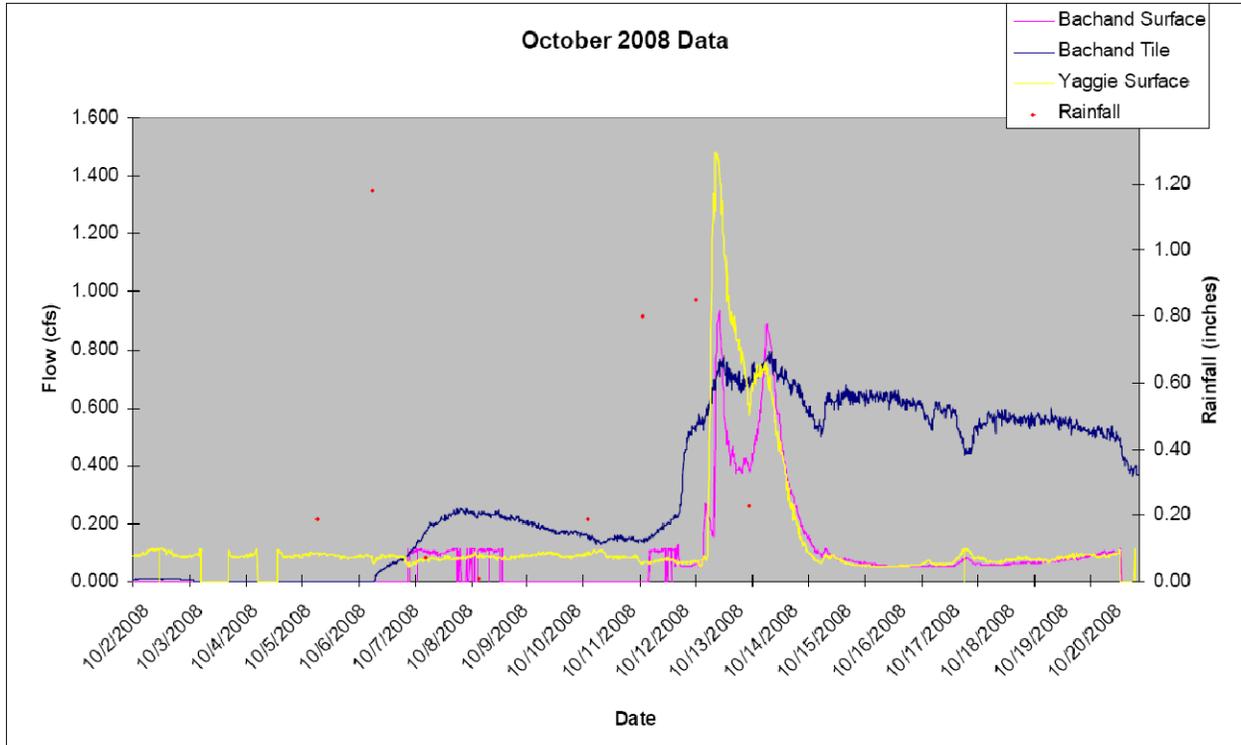
**Figure 68. Example runoff event hydrograph showing peak flows (before normalization)**

To arrive at this conclusion, peak flow rates from each drainage-way (Bachand tile, Bachand surface, combined Bachand field drainage, Yaggie surface) were normalized by acre and compared for 7 events. The peak flows from the field without tile drainage were almost always greater than peak flows from the tiled field.

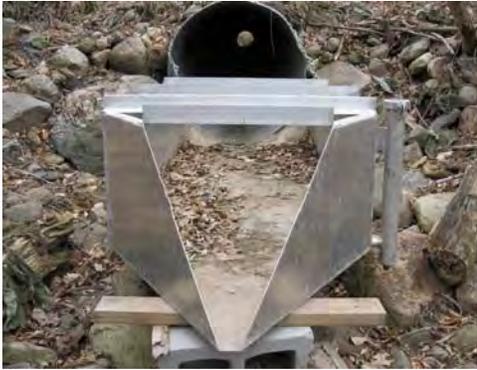
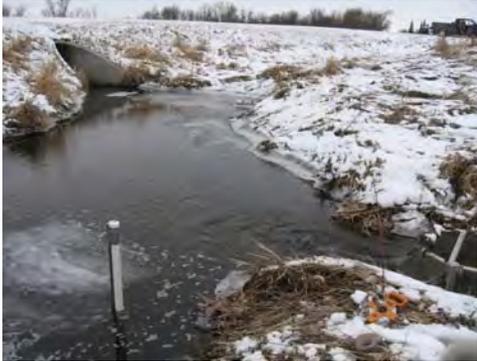
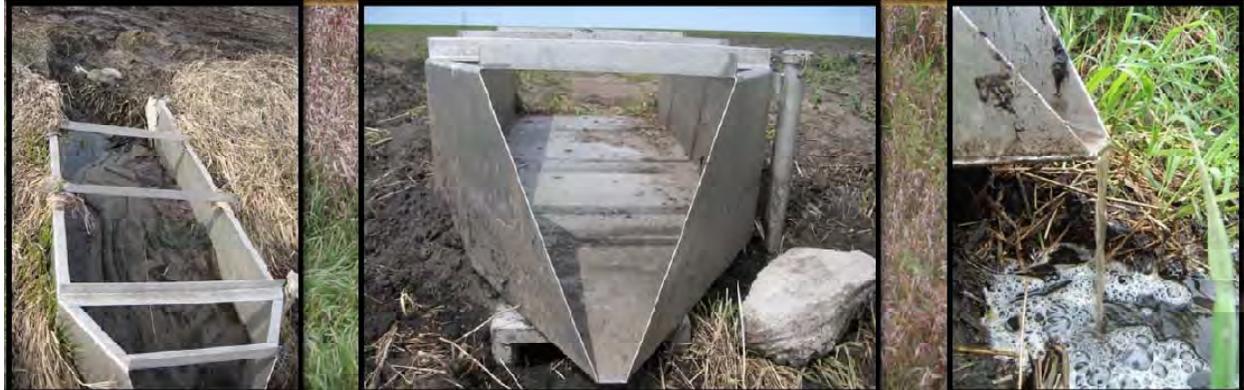
**Figure 75. Raising the h-flume**

Another, more successful safeguard against backwater was the raising of the surface drainage h-flume at the Bachand field. The inlet to the structure was also landscaped and stabilized to make sure that water flows into the structure.

Making sure the h-flumes were level was important, yet challenging part of achieving accurate results.

A water level logger was installed in the tailwater pool at the Bachand site.

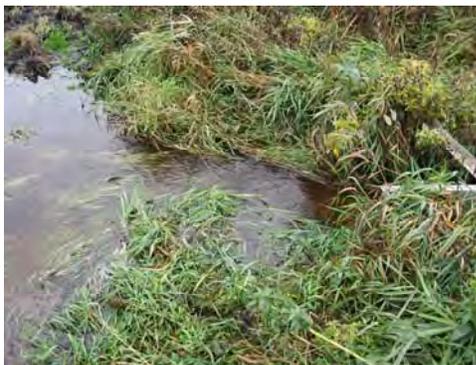
We needed to be sure that all flow went through the flumes instead of around or under them. Landscaping was done at the Bachand h-flume to funnel water into the flume.

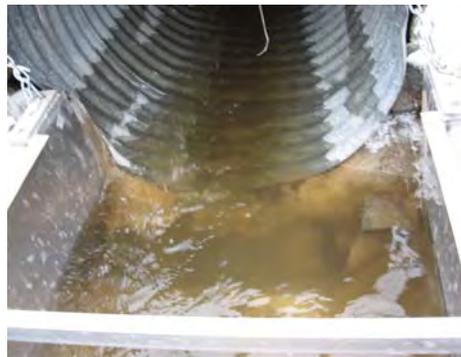
Quikrete® was used to “seal” the rear of the Yaggie 2 flume around the culvert so that water would not flow out of the back of the flume.

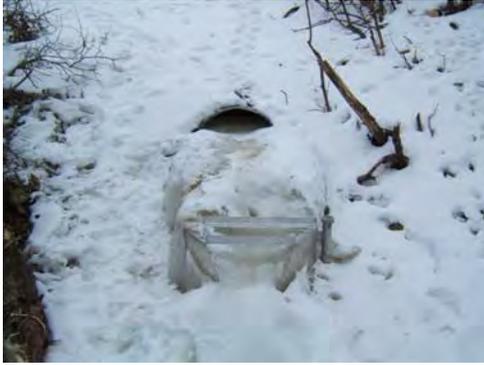
Over the winter of 2005-2006, ice storms filled the h-flumes with ice. There was some concern over whether or not this would obstruct spring runoff. The ice was fairly easily washed away during the spring runoff and the problem did not occur in any of the subsequent winters. Ice in the flumes did not affect the results of this study either, as flow monitoring did not begin until after spring thaw was completed. This study focuses on the relative effects of tile drainage. The gravity tile system in this field was not a factor during the winter and during spring runoff because the ground was frozen and the tile was not flowing.

The Yaggie 2 monitoring site accumulated much ice during the winter of 2005 - 2006

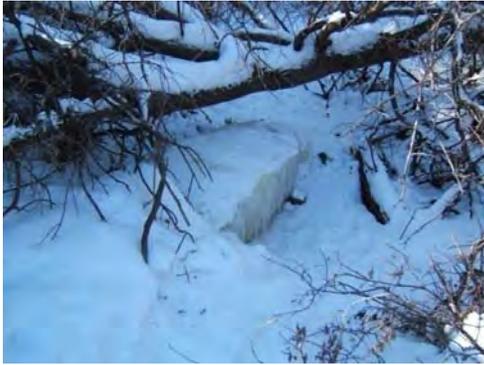
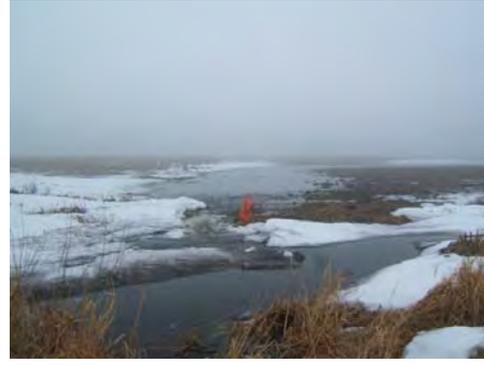
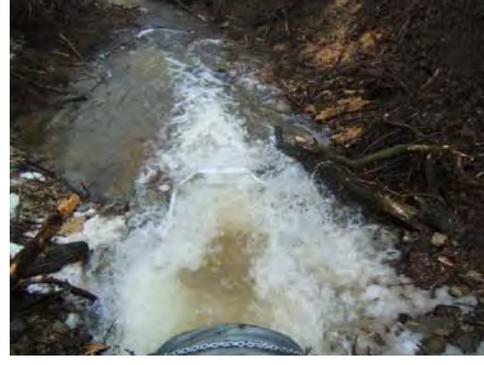
2006 spring runoff at Red Lake County monitoring sites.

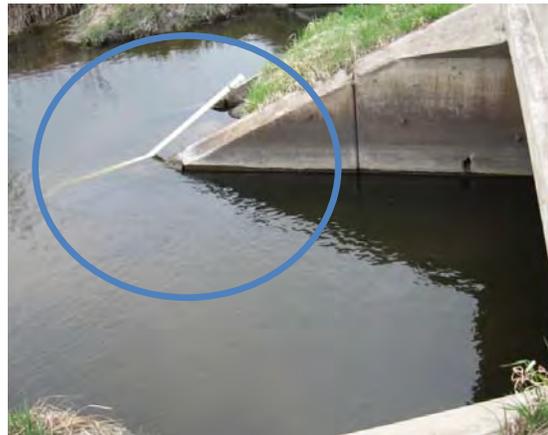
Due to curiosity about the amount of influence tile drainage can have on flow patterns in receiving waters, a HOBO Water Level Logger was also installed in the Hill River downstream of where drainage from the Bachand tile drained field enters the river. The logger data was referenced to manual measurements of water level collected by measuring down from a reference point. For this study, the reference point is given an arbitrary elevation of 100. The flow data from the Bachand Tile outlet appears to correlate with water level elevations in the river, but only in certain ways and at certain water levels. This introduces questions about whether or not the one variable (tile flow) is actually influencing the other (river water levels)

Water level logger installed in Hill River
