By: Corey Hanson, Water Quality Coordinator  
 For: June 11, 2009  
 Red Lake Watershed District Board Meeting

## Clearwater River Dissolved Oxygen and Fecal Coliform TMDL Study

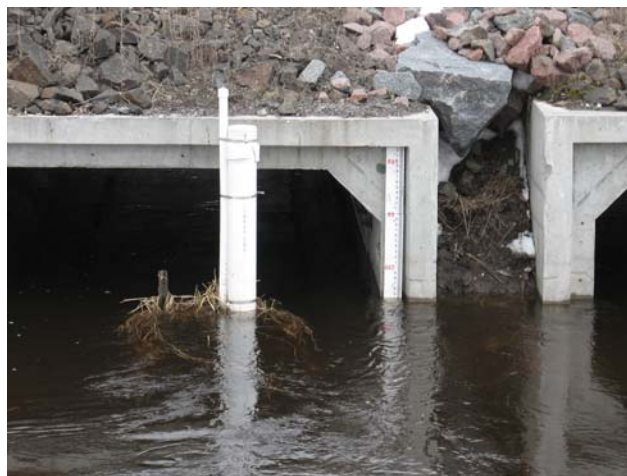
HOBO water level loggers were installed at the CD2 (stream gauge #71) and Brandt channel (at Hwy 75) monitoring sites. The deployment pipe for the TS300 turbidity logger at the CD2 site was frozen in early April, so the instrument couldn't be deployed. The pipe was later bent by the high amount of runoff, so the bottom length of pipe will need to be replaced before a turbidity logger can be deployed at the site. A TS300 turbidity logger was installed at the Brandt Channel monitoring site in early April.

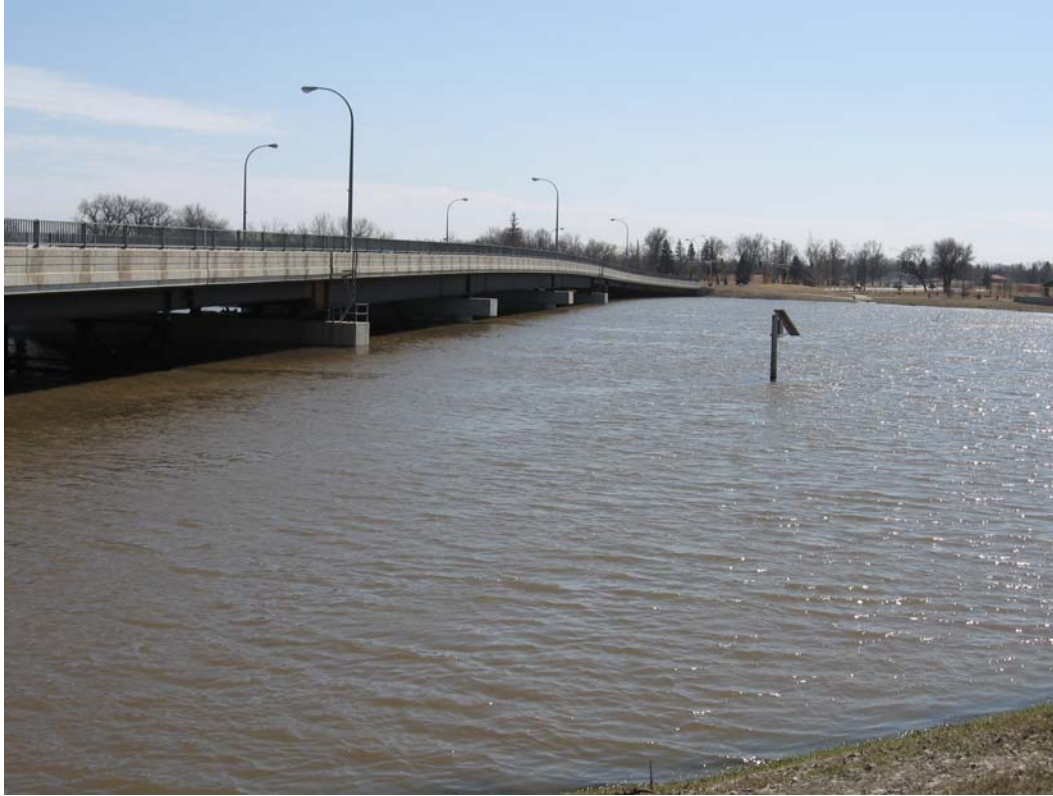
Figure 4. Red Lake River at the Murray Bridge crossing in East Grand Forks

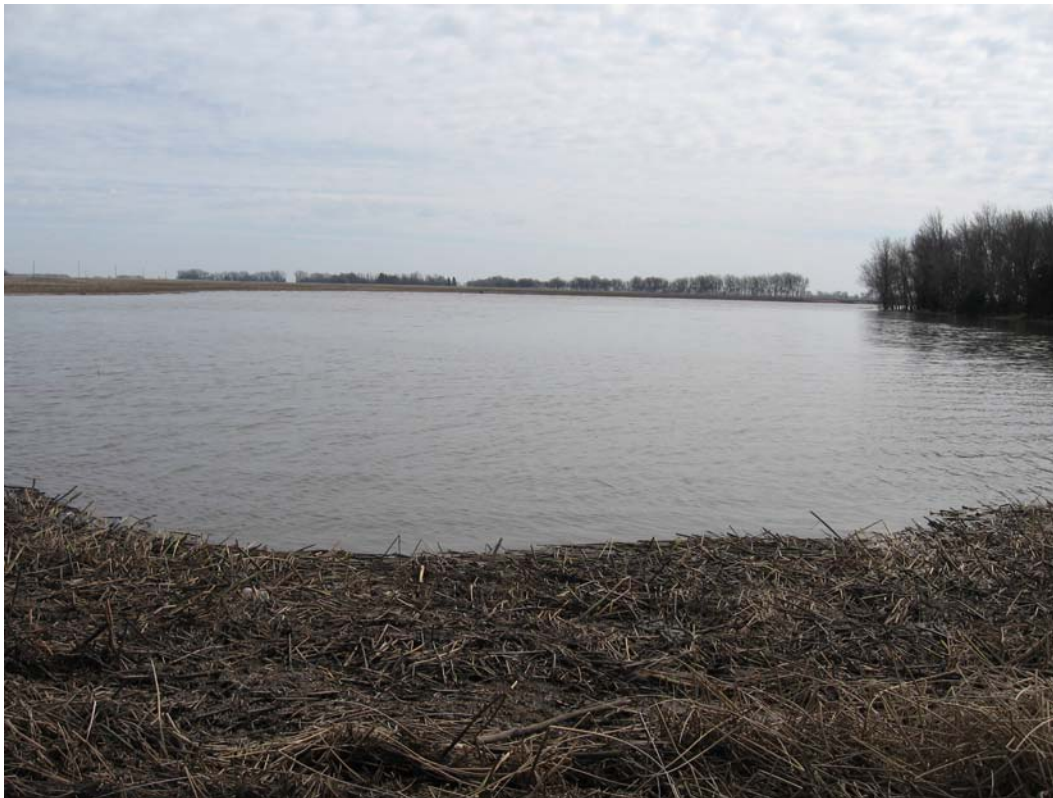
Figure 5. Grand Marais Creek at the Hwy 220 crossing

- Terrebonne Creek has been found to be impaired by high E. coli.
  - The dissolved oxygen impairment on Grand Marais Creek was extended from CD2 to the Red River.\*

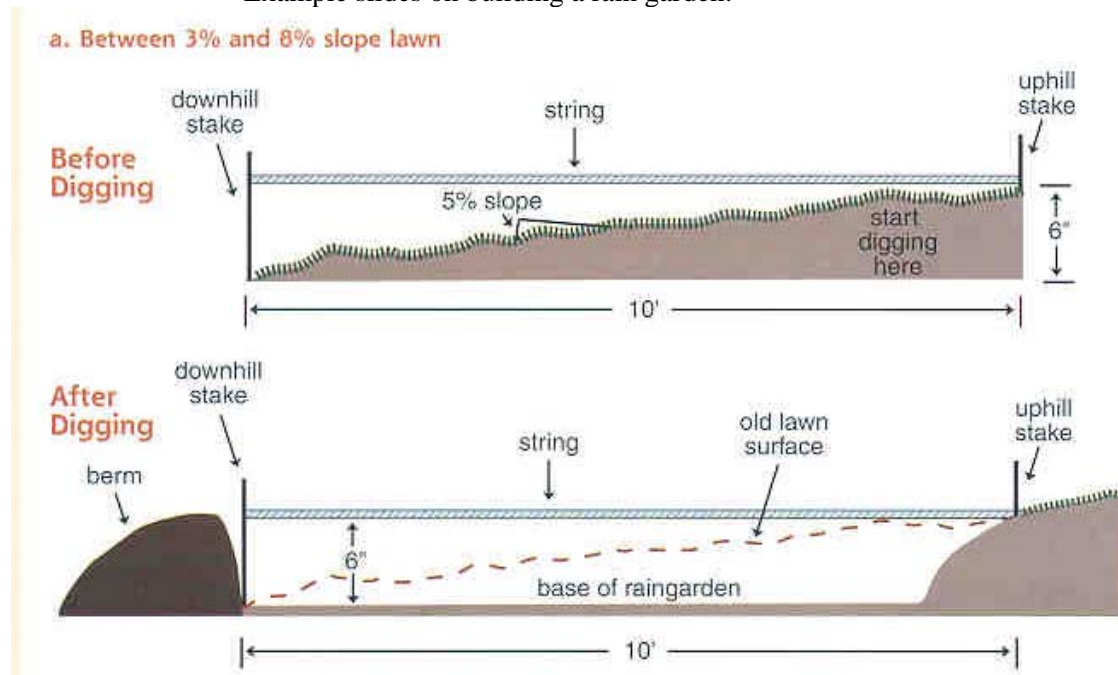
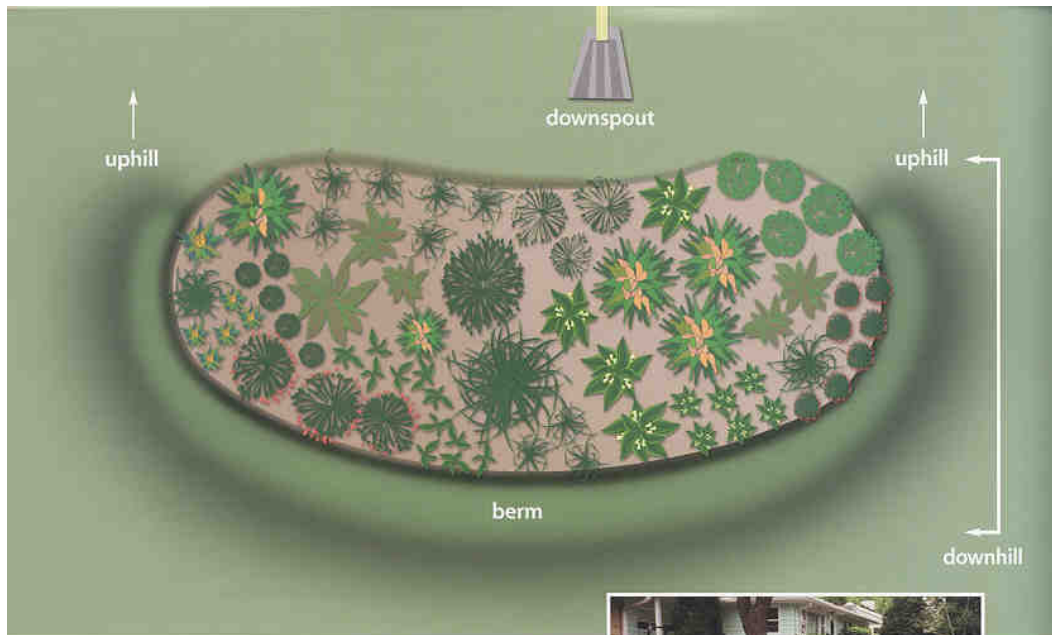
Figure 5 The top of the downhill part of the berm should come up to the same elevation as the entry to the rain garden at the uphill end.

Water flowing into the rain garden will naturally try to run off the downhill edge. A berm is needed to keep the water in the garden. The berm is a "wall" across the

On a gentle slope, soil from digging out the garden can be used to create the berm. This rain garden is 4 inches deep.
