RLWD MONTHLY WATER QUALITY REPORT

By: Corey Hanson, Water Quality Coordinator

For: October 13, 2011

Red Lake Watershed District Board Meeting

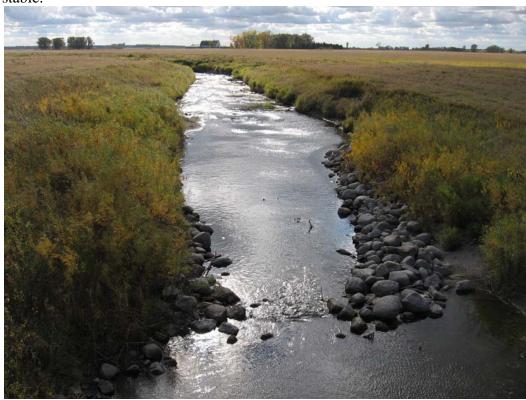
• Photographic monitoring of the Gully 6 erosion control project.

Vegetation is filling in around the cross-vane weir and the banks are looking more stable.
