Clearbrook Stormwater Pond

November 2012

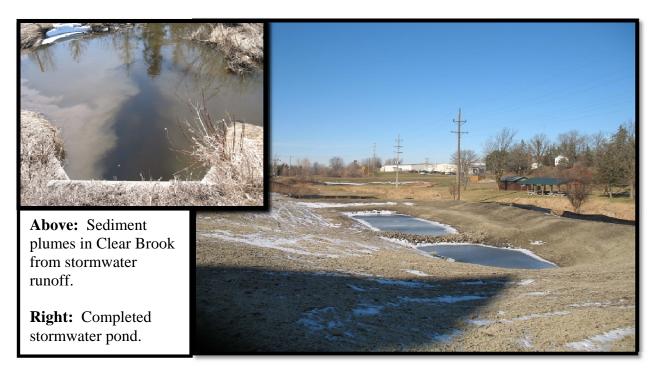
Construction on the first Clearbrook Stormwater Retention Pond (RLWD Project No. 160) was completed in November of 2012. It will treat runoff from the "North Downtown" portion of Clearbrook, 82% of which is covered impervious surfaces. The total construction cost of the project was \$43,674. The P8 model estimated that this pond will trap 65 pounds of sediment during a single 1 inch rain event and more than a ton of sediment on an annual basis.

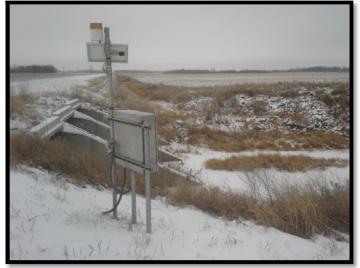
• A gauge has been installed on the Mud River at Highway 89. This site currently doesn't have telemetry, but it may be installed there in the future.

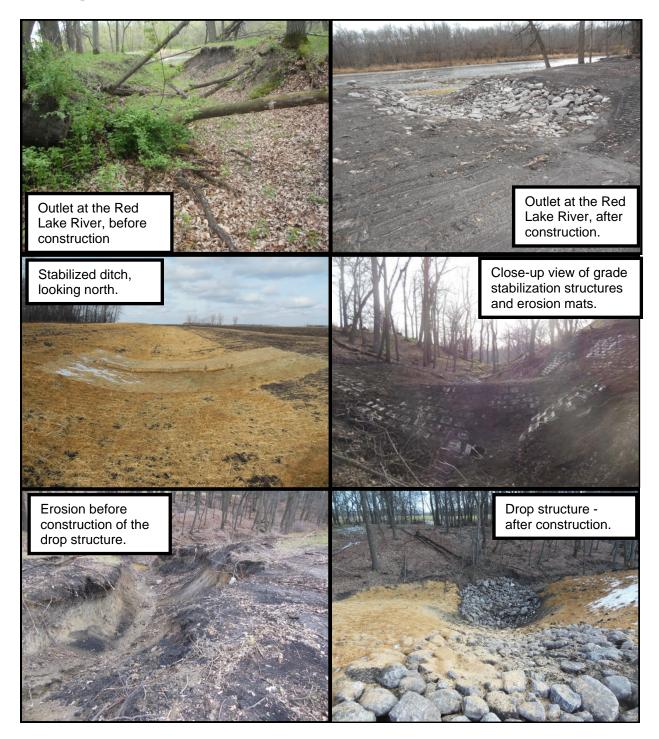
This fall, construction began on an erosion control in Red Lake County that will help keep sediment out of the Red Lake River. The outlet near the river was armored and stabilized. A drop structure and erosion control mats were used to stabilize the steep slope above the river. The ditch upstream of the outlet was also re-sloped and stabilized with bio-rolls.

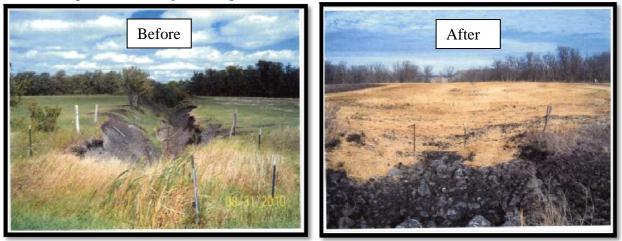
• The RLWD Board of Managers approved the request of the Red Lake County SWCD for cost share in the amount of \$6,934.25 for the Dave Schirrick Grassed Waterway with Drop Structure Project (see photos below).
