Grand Marais Creek Watershed Restoration and Protection Project

RED LAKE WATERSHED DISTRICT MONTHLY WATER QUALITY REPORT

May 2013

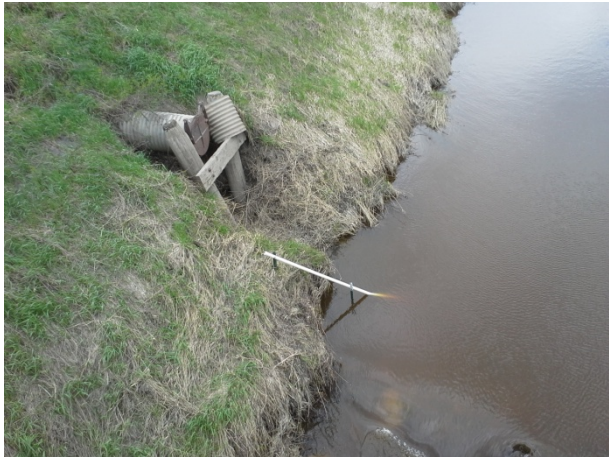
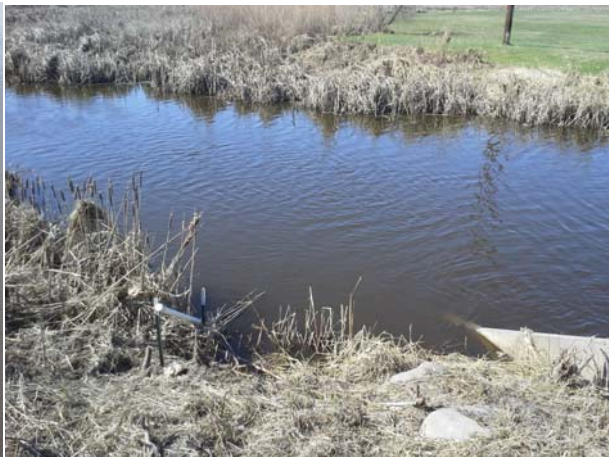
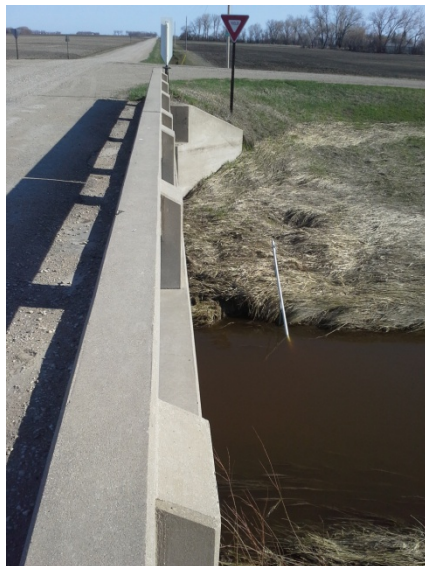
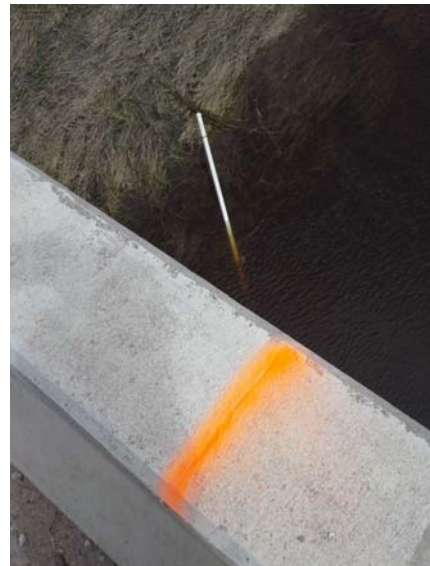
Red Lake Watershed District and Emmons and Olivier Resources staff worked together to plan stage and flow monitoring within the Grand Marais Creek and Angus/Oslo (JD1 and JD75) watersheds. Grand Marais Creek flow is already being monitored by a gauging station at the County Road 64 crossing that is operated by the Minnesota Department of Natural Resources. Stage will be monitored with HOBO water level loggers at four sites in the watershed. Stage will be monitored in County Ditch 2 at CR62, Grand Marais Creek at County State Aid Highway 19, Judicial Ditch 1 at 450th Ave NW, and Judicial Ditch 75 at CSAH 22. HOBO water level loggers were deployed at the Grand Marais Creek and County Ditch 2 sites on May 9th. Water level loggers (the ones that had new batteries installed in them this spring by Onset) were deployed at the JD1 and JD75 sites on May 24th.

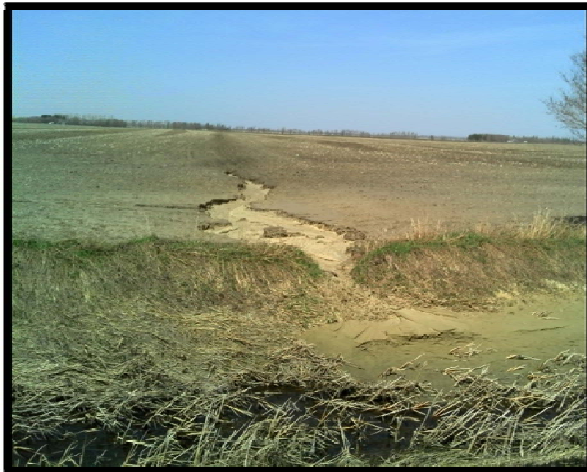
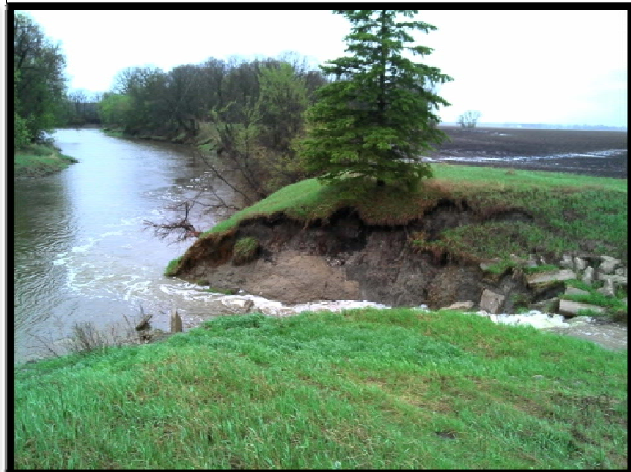
- Farmed Pool will be in draw-down this year and may be discharging more water than usual.
- Task 7 – Stressor Identification
 - The RLWD's Garmin Montana 650 GPS/Camera was used to photograph and map actively eroding spots (gully and rill erosion visible from the road) while traveling between monitoring sites.

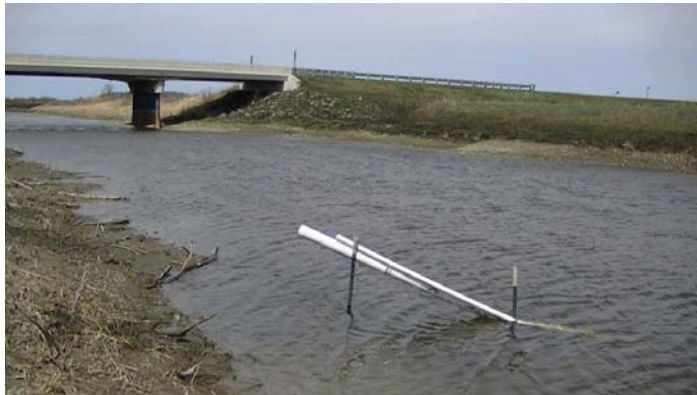
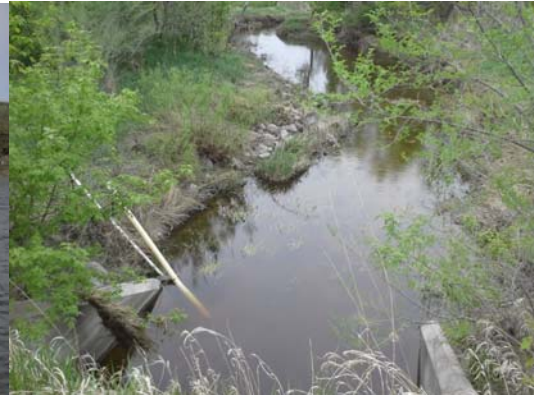
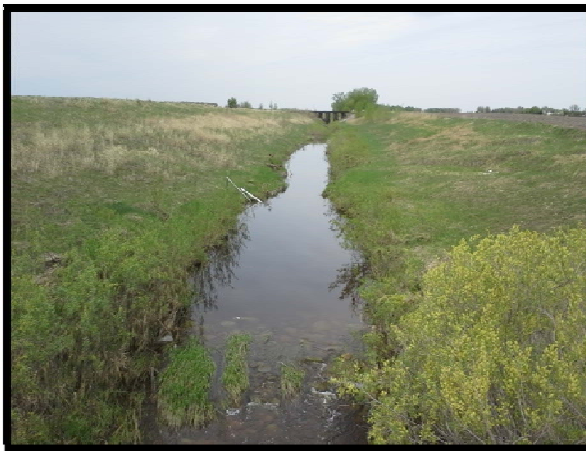
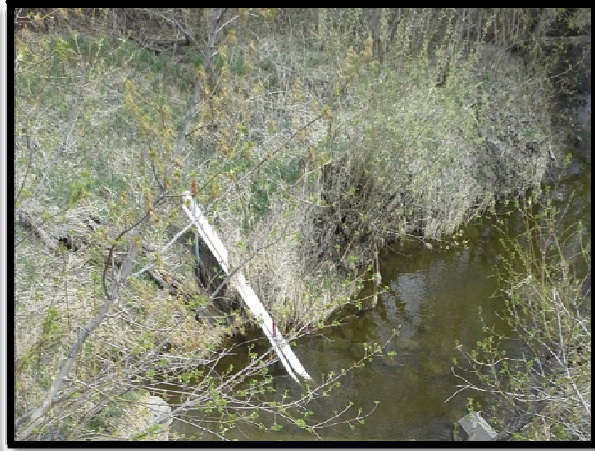
- Task 3 – Continuous Water Quality Monitoring
 - The new HOB0 optical dissolved oxygen logger was deployed in Kripple Creek.
 - Replacement RDO dissolved oxygen sensor caps were ordered for the two TROLL 9500 sondes with optical dissolved oxygen probes.
 - Last year's deployment pipes were removed from the 180th Ave Gentilly Creek monitoring site.
 - A dissolved oxygen logger deployment pipe was installed at the CSAH 27 crossing of the Red Lake River.
 - Eureka Midge and In-Situ TROLL 9500 dissolved oxygen loggers were deployed at 5 monitoring sites
 1. Red Lake river at CSAH 27
 2. Red lake River at the Highlanding Bridge
 3. Pennington County Ditch 96
 4. Cyr Creek
 5. Judicial Ditch 60

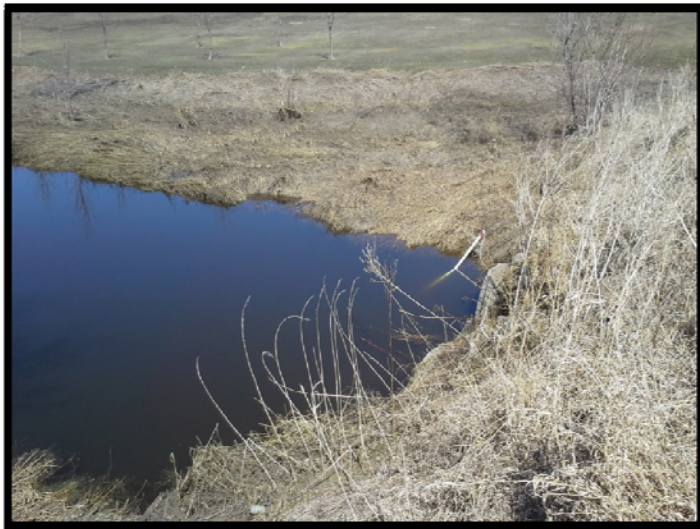
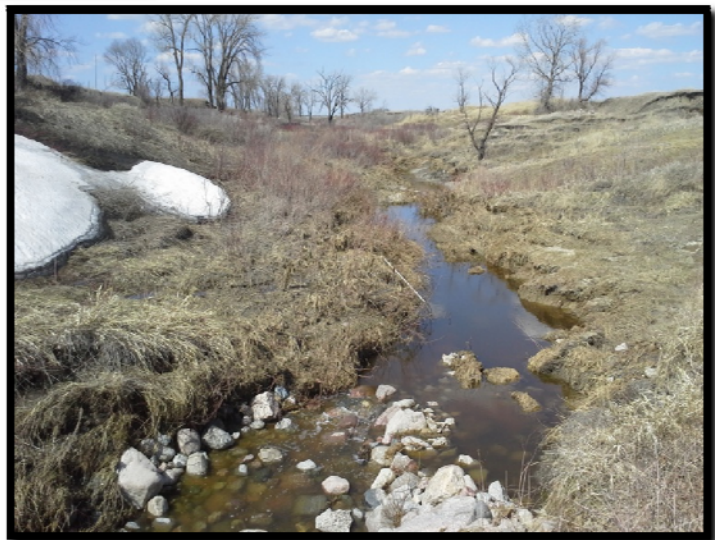
- Task 5 – Flow Monitoring
 - The Heartsville Creek HOBO water level logger was deployed.
 - The Burnham Creek HOBO water level logger was moved from the high-water pipe to the low-water pipe. Utilities have been marked at the site, perhaps in preparation for the installation of a DNR gauging station.
 - The CD1 HOBO pipe was knocked over by spring runoff, so it was fixed and the HOBO was re-deployed.
 - The CD96 HOBO water level logger's deployment pipe was lowered further into the ditch once runoff slowed down and the water in the ditch became shallow enough to wade safely.
 - The HOBO water level logger pipe near the CSAH 27 crossing was lowered further into the water.
 - A HOBO water level logger was deployed at the Smiley Bridge (CSAH 7) crossing of the Red Lake River.

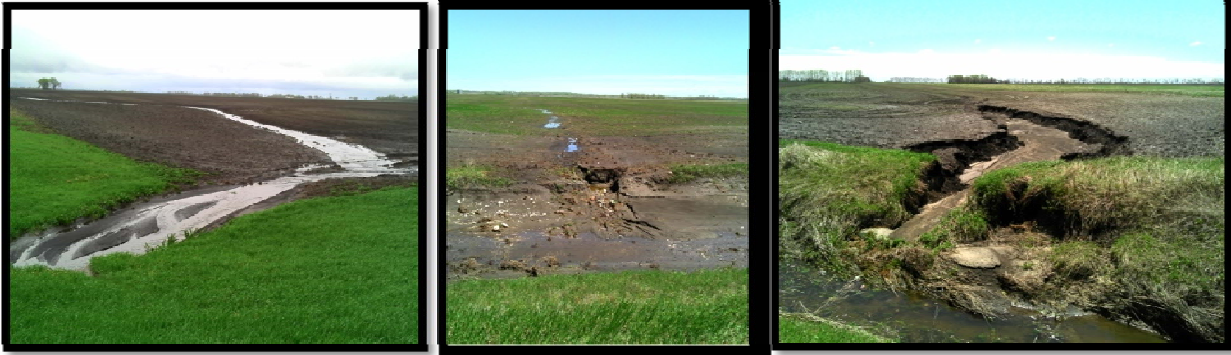
- Task 7 – Stressor Identification
 - The RLWD’s Garmin Montana 650 GPS/Camera was used to photograph and map actively eroding spots (gully and rill erosion visible from the road) while traveling between sites.

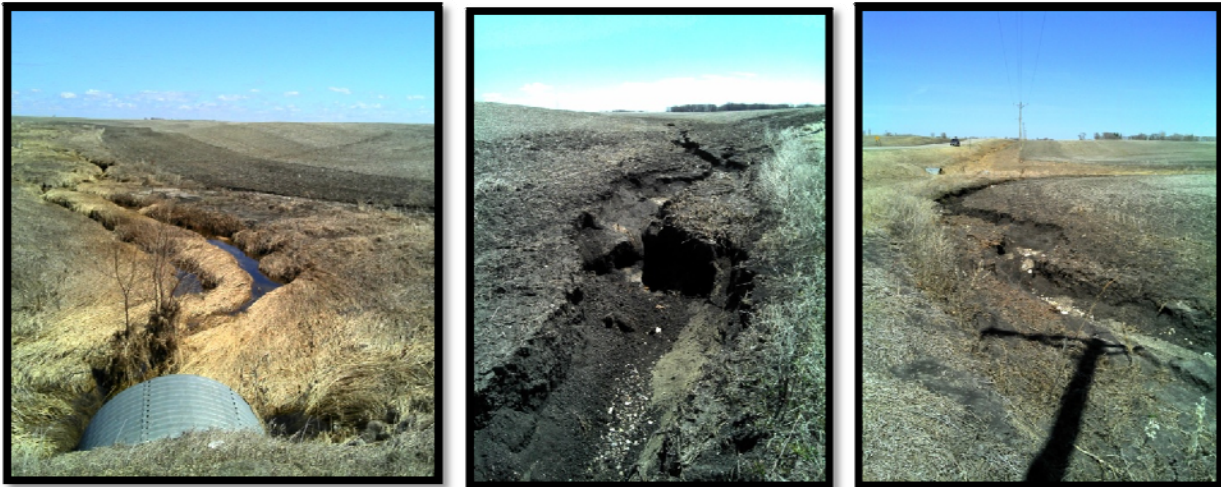
- A significant gully was found along a field was found along CSAH 9 (north of the CSAH13/CSAH9 intersection) near a ditch that flows into Browns Creek.

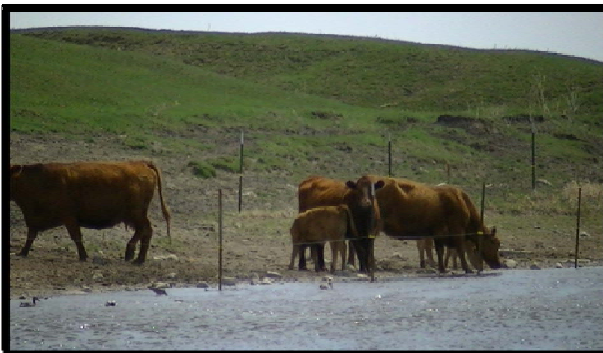
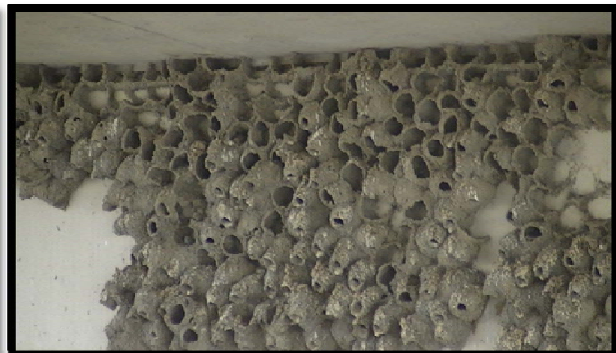
- There is a lot of sloughing, erosion, and sedimentation occurring along Polk County Ditch 1. Much of which is visible from the CR64 crossing.
- Not only is there a herd of cattle with direct access to the Red Lake River upstream of the CSAH 27 Bridge, but there also are countless cliff swallows that “swarm” around the bridge.

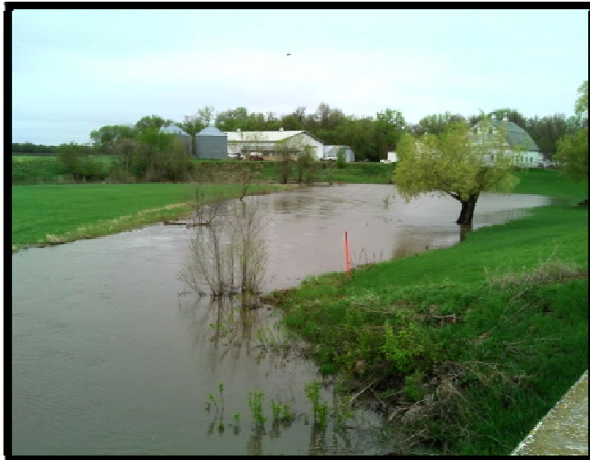
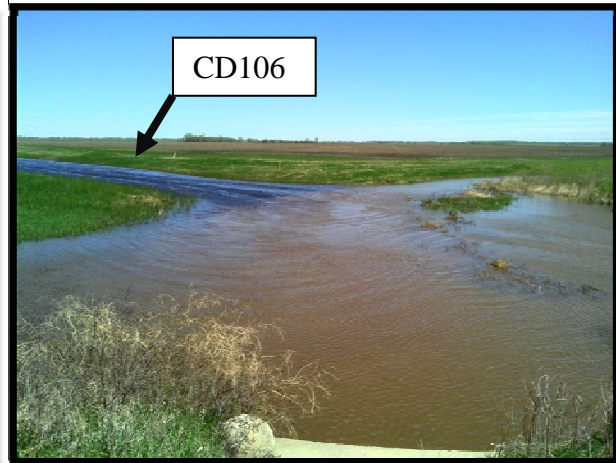
Longitudinal sampling was conducted along Burnham Creek. The lower half of Burnham Creek was sampled during a rain event on May 21st and sampling continued upstream the next day. Turbidity (397.1 FNU) and total suspended solids (264 mg/L) levels were very high on the lower end of the watershed, but gradually got better upstream and were very low (0.4 FNU,) at Highway 32. Turbidity increased from 9.1 FNU to 44.2 through the Spring Gravel Dam washout area downstream of Highway 102 (to 180th Ave). Turbidity then increased significantly to 81.9 at the next crossing (190th Ave). So, the planned Burnham Creek grade stabilization and restoration projects are well needed in order to address some sources of sediment and turbidity. Turbidity was very low (4.4 FNU) in CD106 where it flows into Burnham Creek (see right photo below).

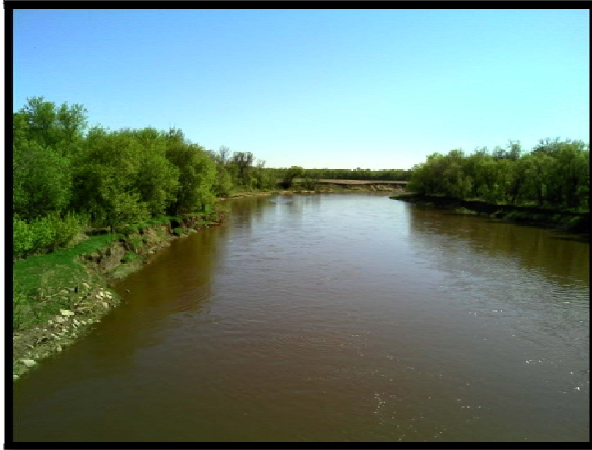
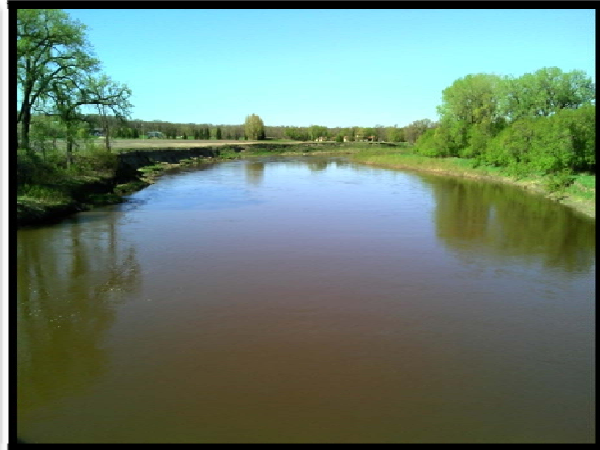
Longitudinal samples were collected along the main channel of the Red Lake River from Murray Bridge in East Grand Forks upstream to the CSAH 3 crossing near Huot.

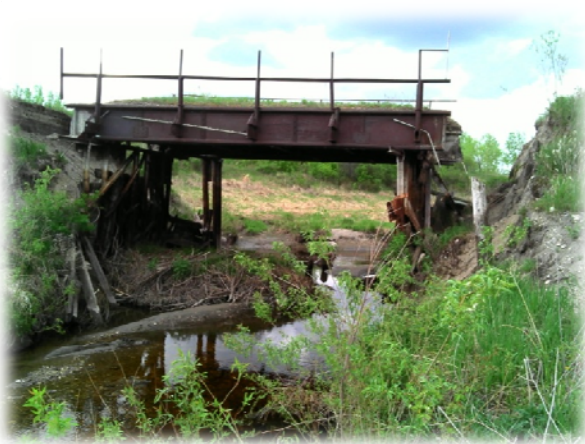
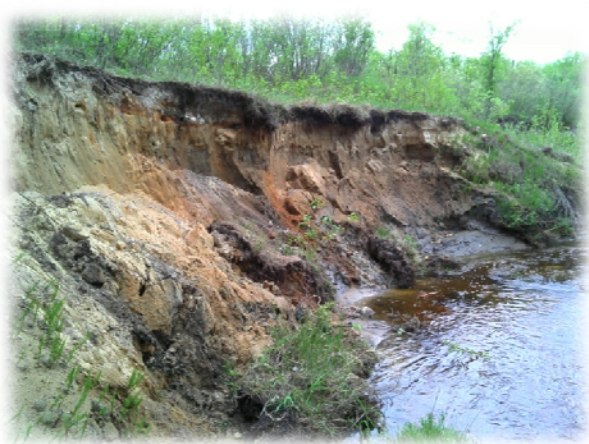
- The HOBO water level logger deployment (used in 2012) was removed from CD79 near the Spring Gravel Dam wash-out area. More of the road bed has washed away from around the old bridge at the site. There was some fresh erosion along the streambank downstream of the old dam, too.
