Thief River Watershed Assessment Project
(Watershed Restoration and Protection - WRAP)

RED LAKE WATERSHED DISTRICT
MONTHLY WATER QUALITY REPORT

August 2013

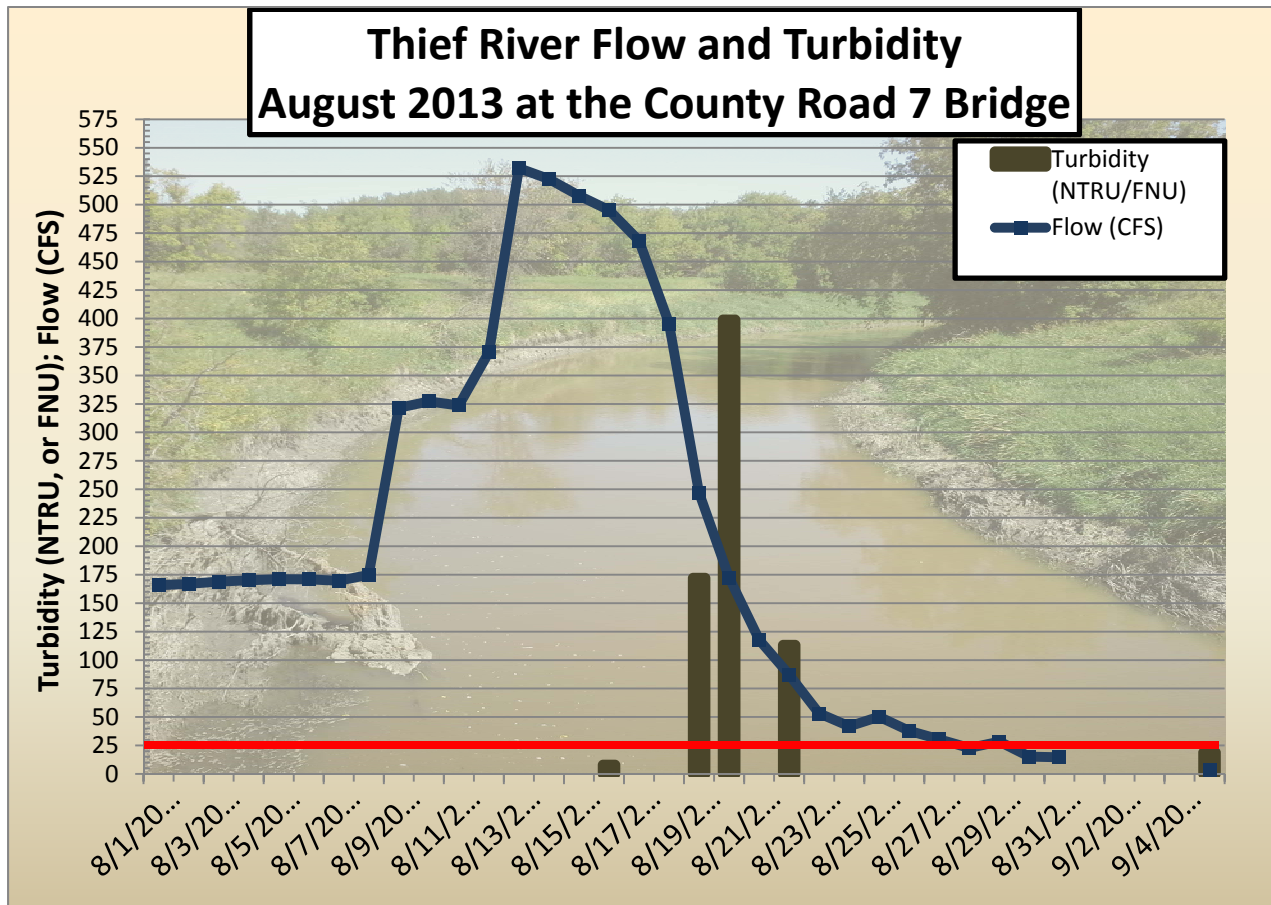
- Water quality in the Thief River was monitored during the Agassiz Pool drawdown. Water quality was actually okay when it was tested slightly after the peak flow level during the discharge period. However, it increased to record highs as water levels receded. On August 19th, turbidity levels were recorded at 398.8 FNU and transparency was only 2.5 cm. So far, the cause has not been verified. It may be attributed to increased movement of water within gullies and channels within the pool once water levels get low in the pool. It could also be attributed to excavation within the pool that may have been done to facilitate drainage. United States Fish and Wildlife staff at Agassiz National Wildlife Refuge have not responded to questions regarding this issue.

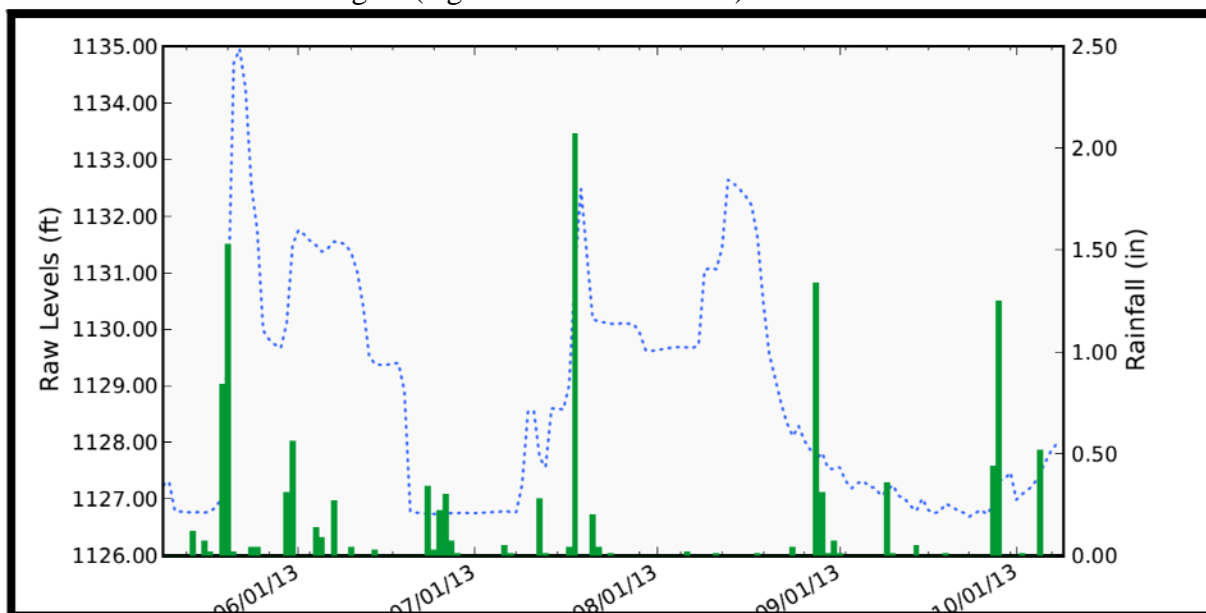
- Task 12 – Identification of Sources and Solutions
 - High flows and poor water quality in the Thief River have already caused one instance of high trihalomethanes (a potentially harmful disinfection byproduct) in Thief River Falls drinking water during a July runoff event. Flows in the Thief River reached similar levels in August. The Minnesota Department of Health has been assisting the City of Thief River Falls with an operational evaluation because the disinfection byproducts spiked to a level of imminent concern. High turbidity and high Total Organic Carbon (TOC) in source water after a rainfall event are considered to be significant factors that led to this drinking water quality issue. In the following hydrograph from CR7, near Agassiz National Wildlife Refuge, you can see the spikes in flow in late May (rainfall event), late July (rainfall event), and mid-August (Agassiz Pool drawdown).

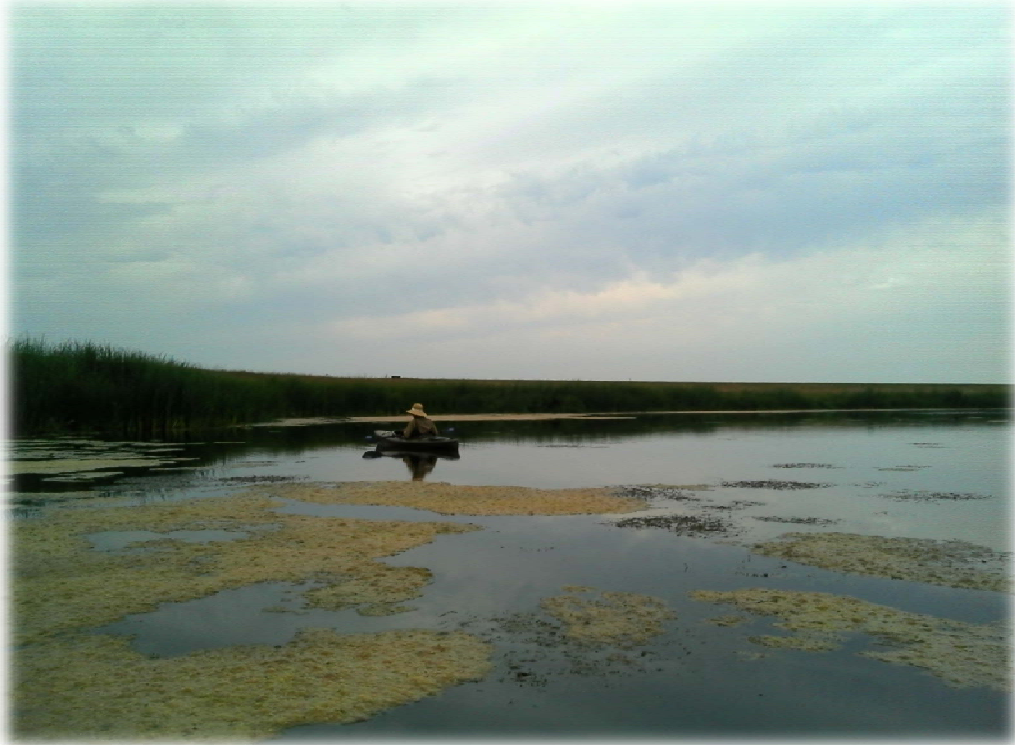
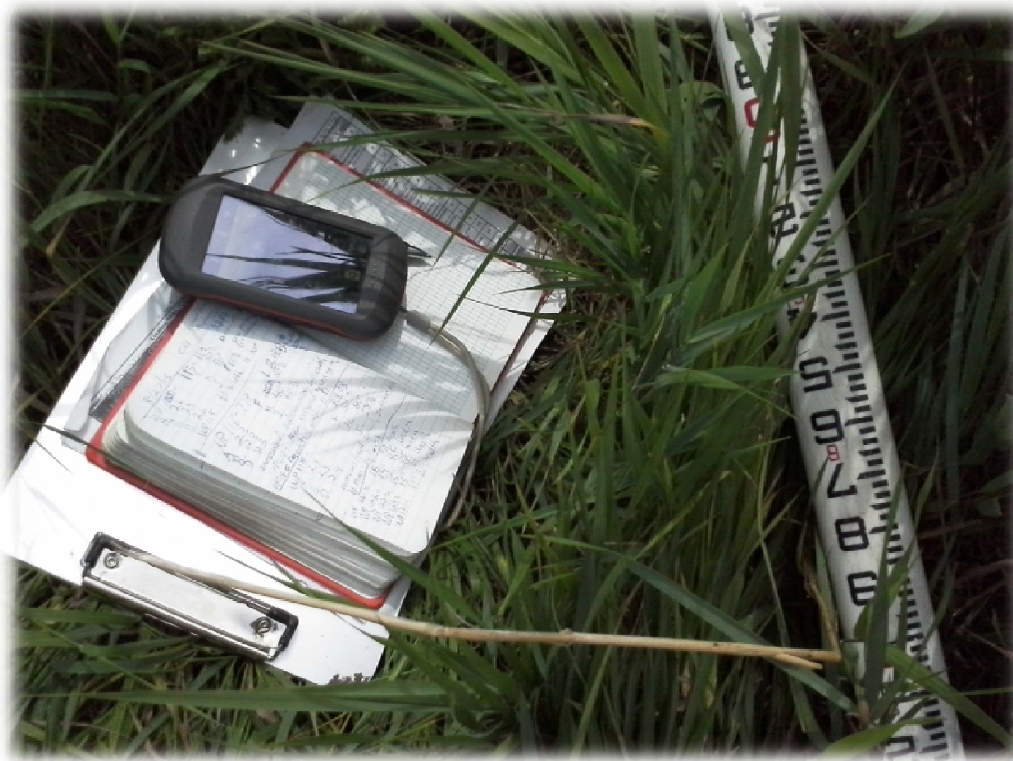
BEHI Ratings were conducted by kayaking a reach of Grand Marais Creek downstream of the Fisher Rest Area.

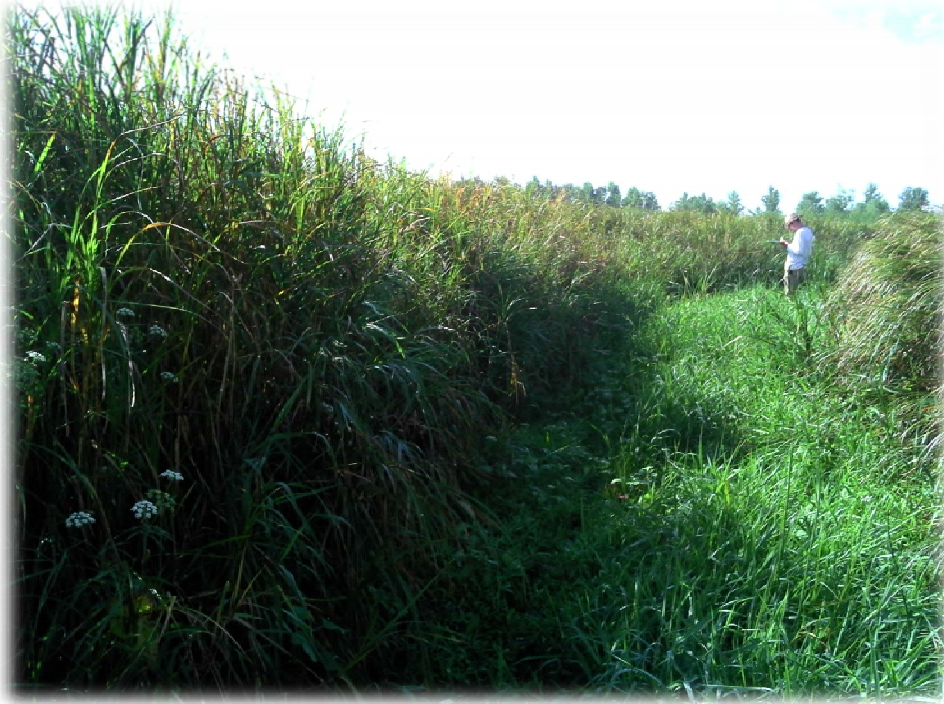
One of the Grand Marais stations was downstream of 110th St. SW, not far upstream of where the diversion structure will be constructed for the outlet restoration project.

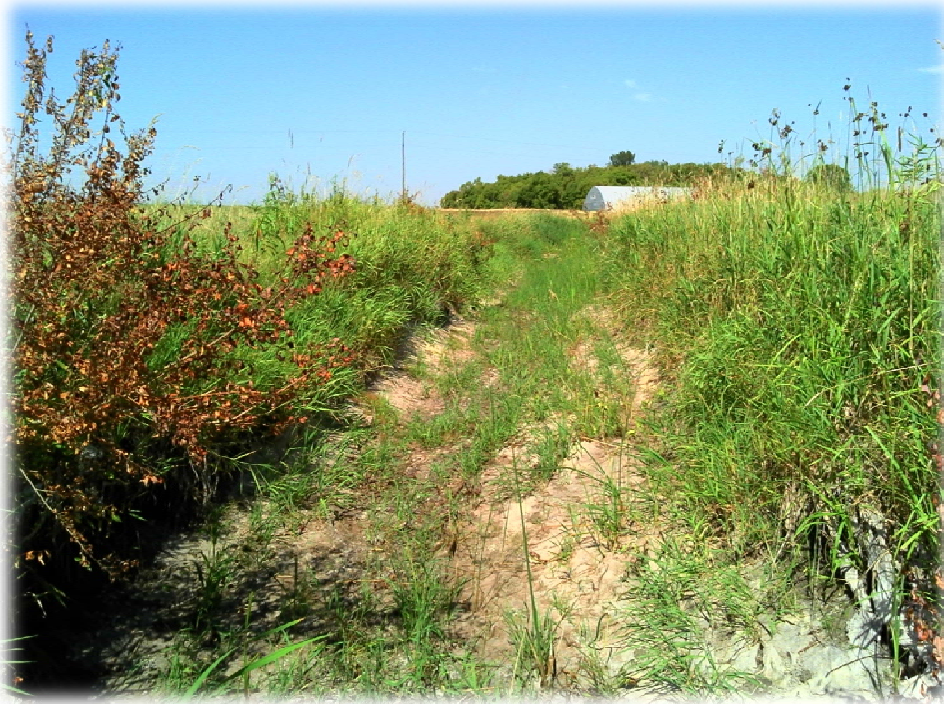
Thankfully, we didn't have to wear waders on these hot days because the channel was dry in the Brandt Channel and parts of Grand Marais Creek.

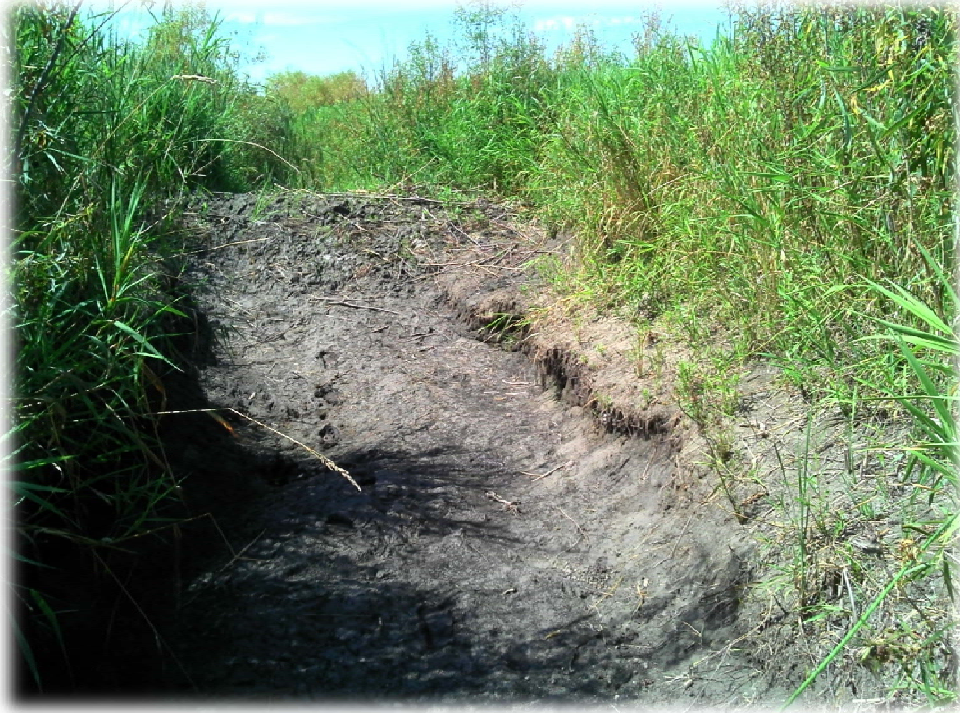
There are a couple of beaver dams in the Brandt Channel downstream of 270th Ave NW.

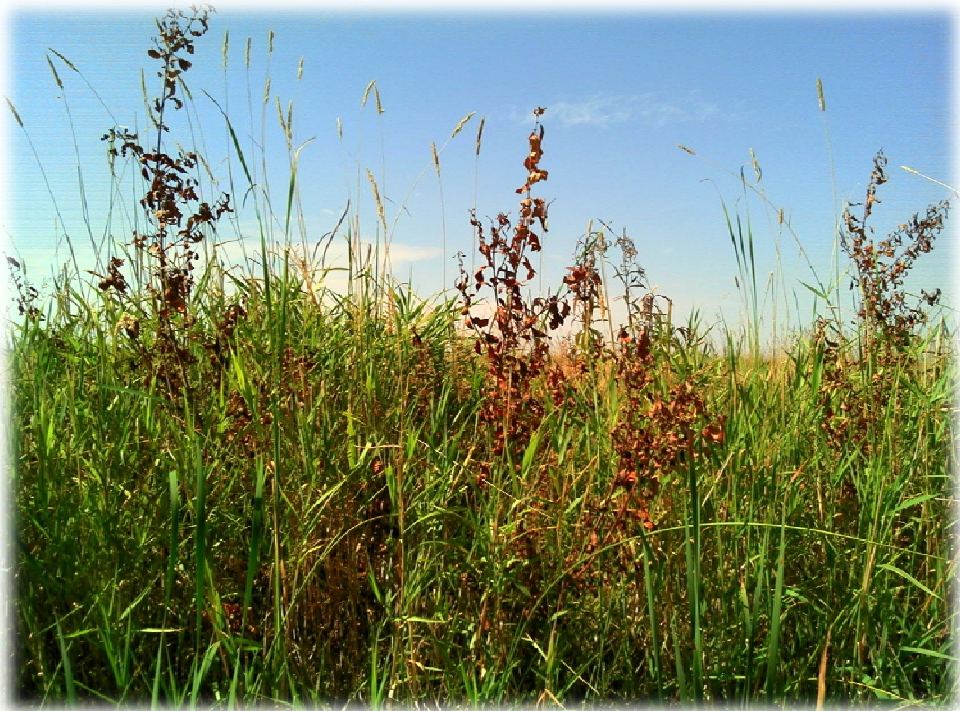
Parts of the Brandt channel appeared to have been sprayed with a broadleaf herbicide, killing willows that are important for keeping the banks stable and other broadleaf plants that are beneficial for wildlife habitat.
