By Corey Hanson, Red Lake Watershed District Water Quality Coordinator. 3/6/2017.

# RED LAKE WATERSHED DISTRICT MONTHLY WATER QUALITY REPORT

May 2016

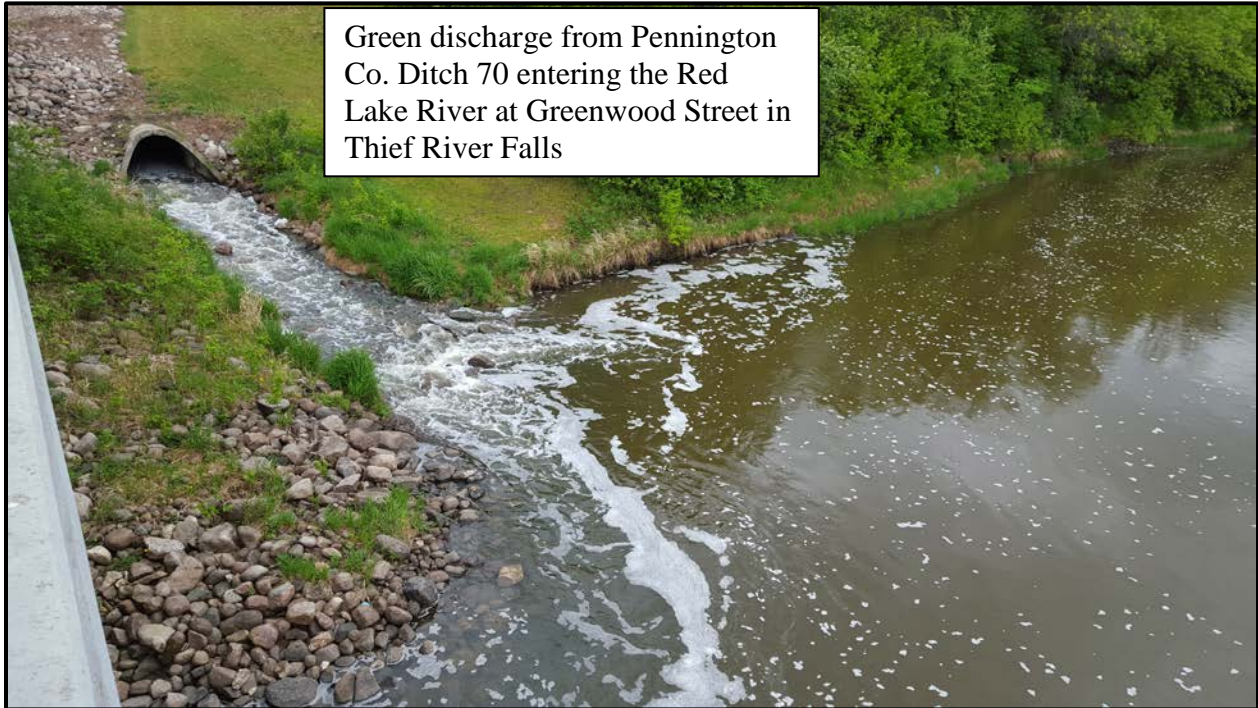
- Pennington County Ditch 70 (1.9 mg/L)
      - An investigative sample was collected because the ditch was discharging green water into the Red Lake River (see photo, below).

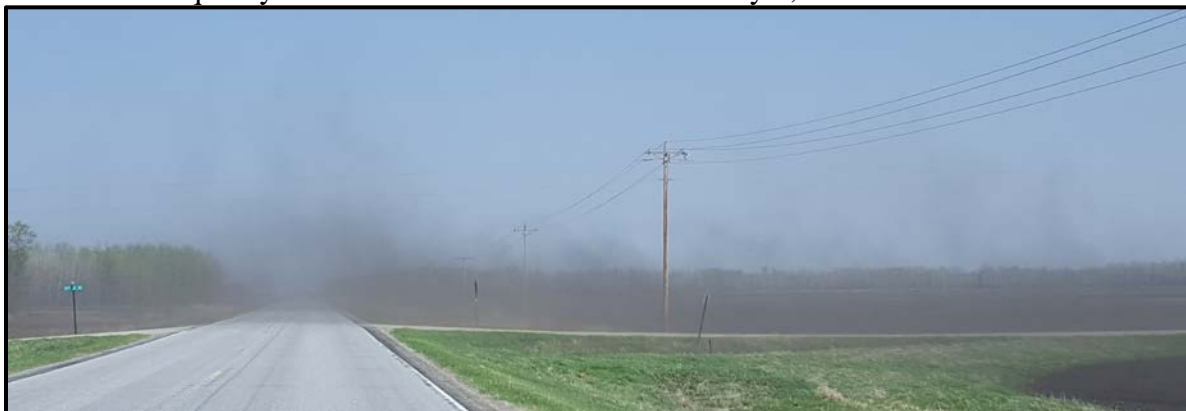
- A notably low total suspended solids (TSS) concentration was found at the CSAH 11 Bridge over the Red Lake River (on a reach that is impaired by high turbidity).
- High TSS concentrations (>30 mg/L) were found in:
  - Clearwater River at CR 127
  - Branch A of Judicial Ditch 21
- Low dissolved oxygen concentrations (<5 mg/L) were found in:
  - Chief's Coulee at Dewey Ave in the City of Thief River Falls
- High biochemical oxygen demand concentrations were found in:
  - Poplar River at CSAH 30, north of Fosston (143 mg/L)
  - Mud River at Hwy 89
  - Red Lake River at CSAH 219 (Highlanding)
- A large, 4-5 foot-high beaver dam was found at the 486<sup>th</sup> St. crossing of the Lost River, downstream of the Pine Lake outlet.
- Water quality staff encountered dust storms on May 9, 2016.

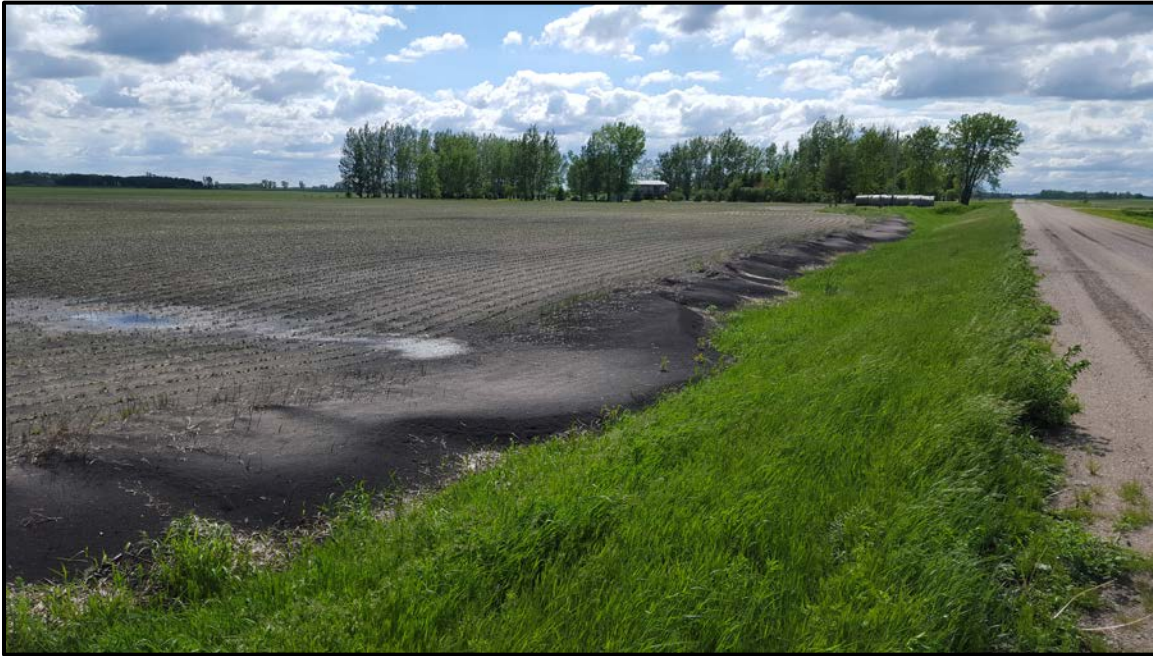
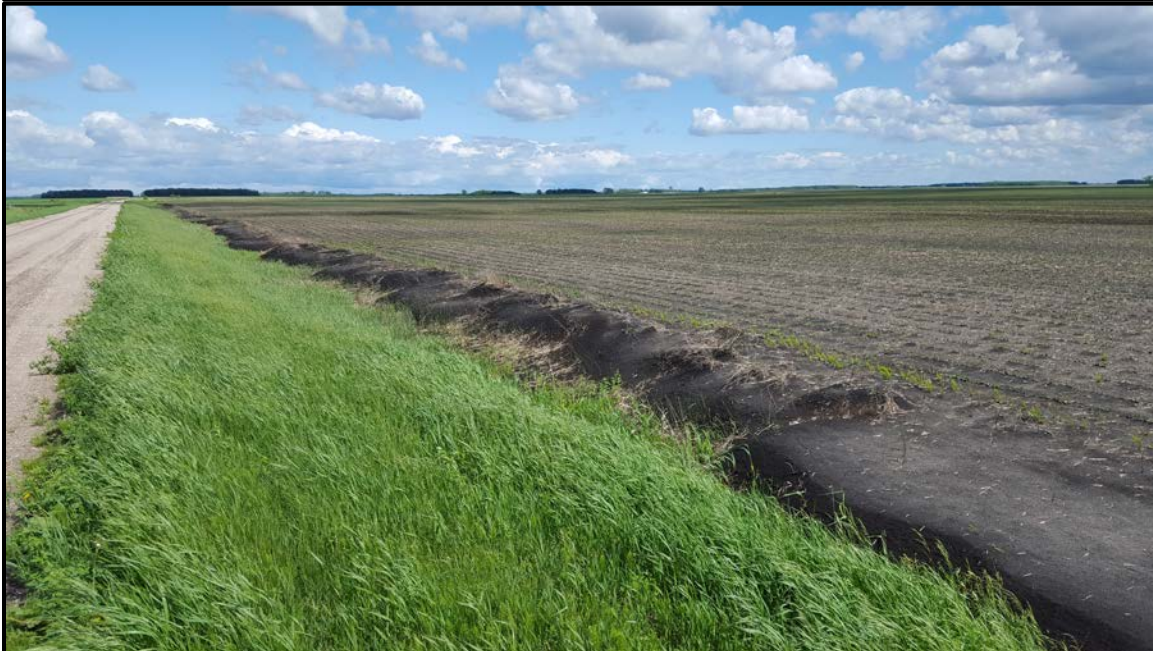
- High concentrations of total phosphorus were found in:
  - North River Nutrient Region (>0.05 mg/L):
  - Central River Nutrient Region (>0.1 mg/L):
    - Clearwater River, north of Plummer
    - Clearwater River at CSAH 20, south of Plummer
    - Clearwater River at CSAH 12, near Terrebonne
    - Poplar River at 310<sup>th</sup> St SE
- Objective 6 – Stressor and Pollutant Source Identification
  - Wind erosion and a lack of buffer strips remain problems in the watershed.

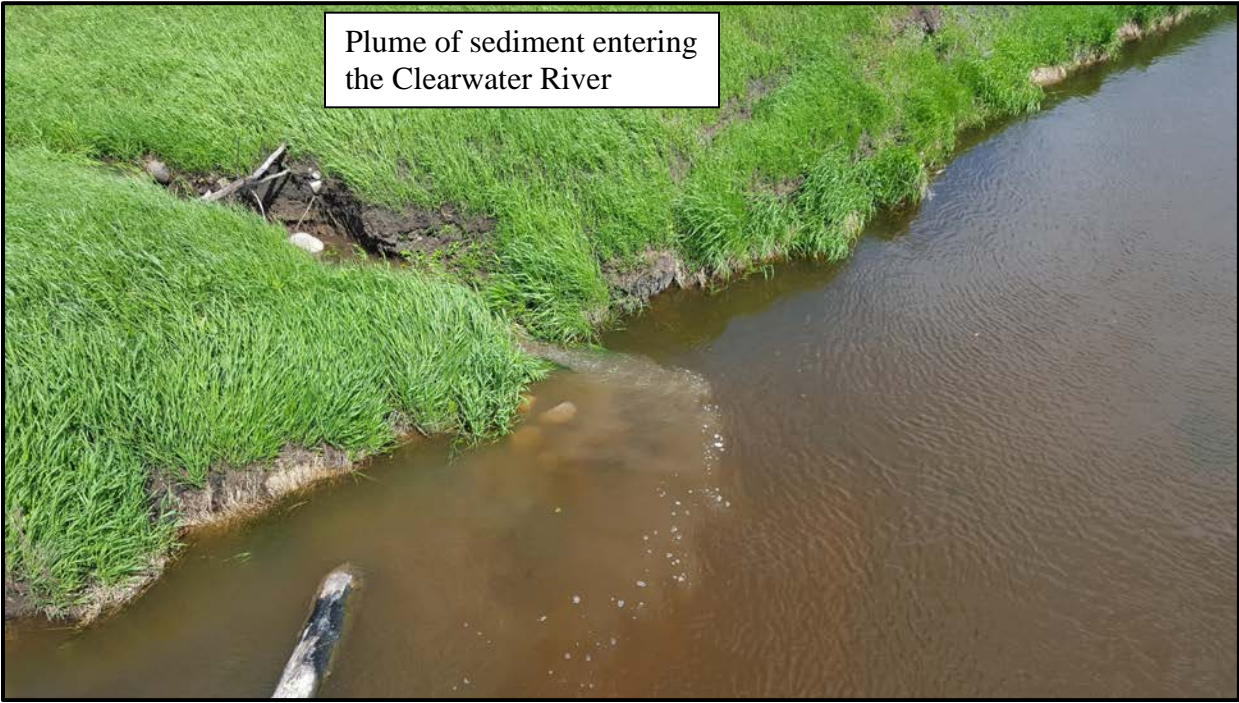
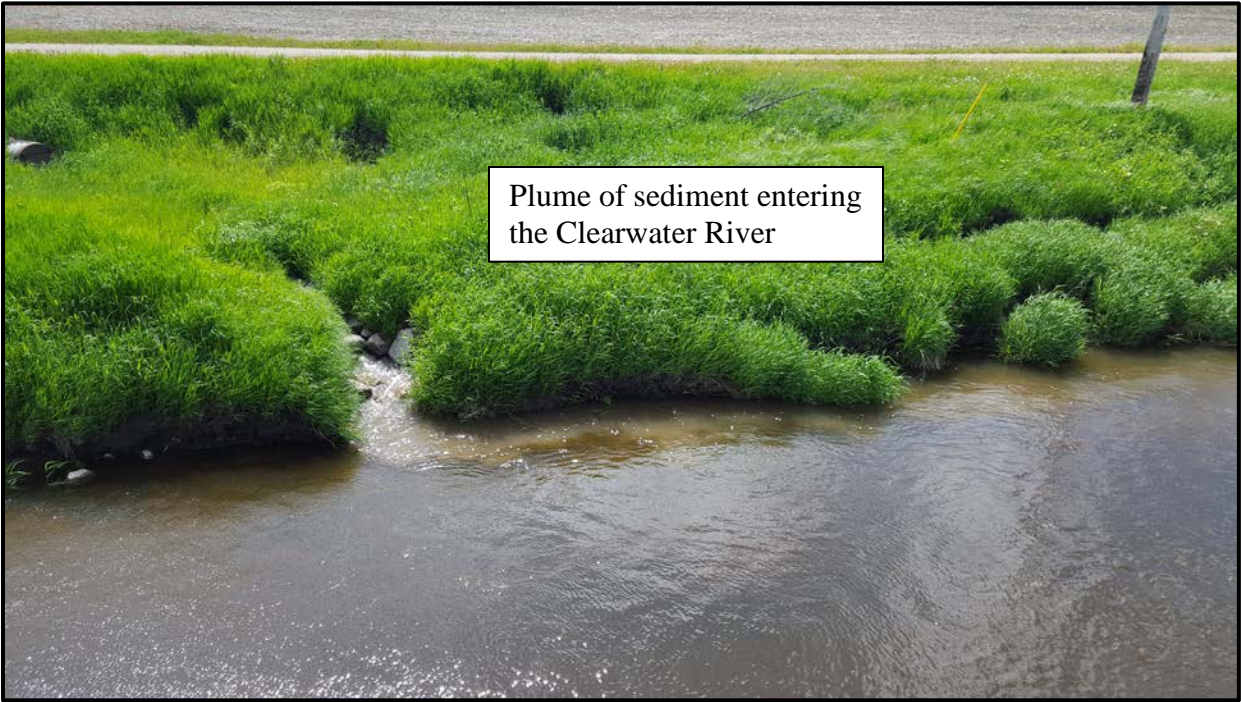
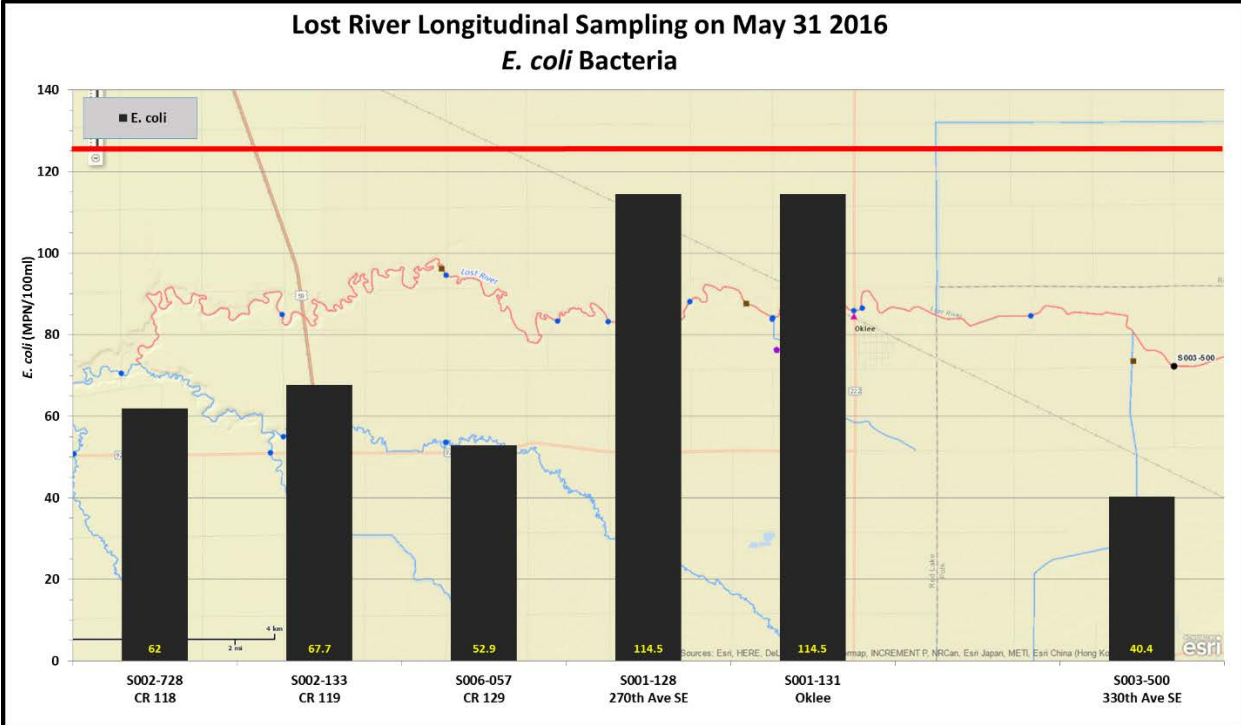
- Longitudinal samples were collected along the Clearwater River and the Lost River on May 31, 2016 after a runoff event. Higher concentrations of pollutants were found in the upstream portion of the Clearwater River that was sampled. Plumes of sediment-laden water were seen where drainage ditches emptied into the Clearwater River. The Lost River results, however, were unremarkable (a good thing). All of the samples met standards. The maximum total suspended solids concentration in the Lost River on this day was just 3 mg/L. The maximum *E. coli* bacteria concentration was 114.5 MPN/100ml and total phosphorus topped-out at 0.42 mg/L. The most significant increase in pollutants in the Lost River was an increase in *E. coli* bacteria from sources upstream of Oklee.

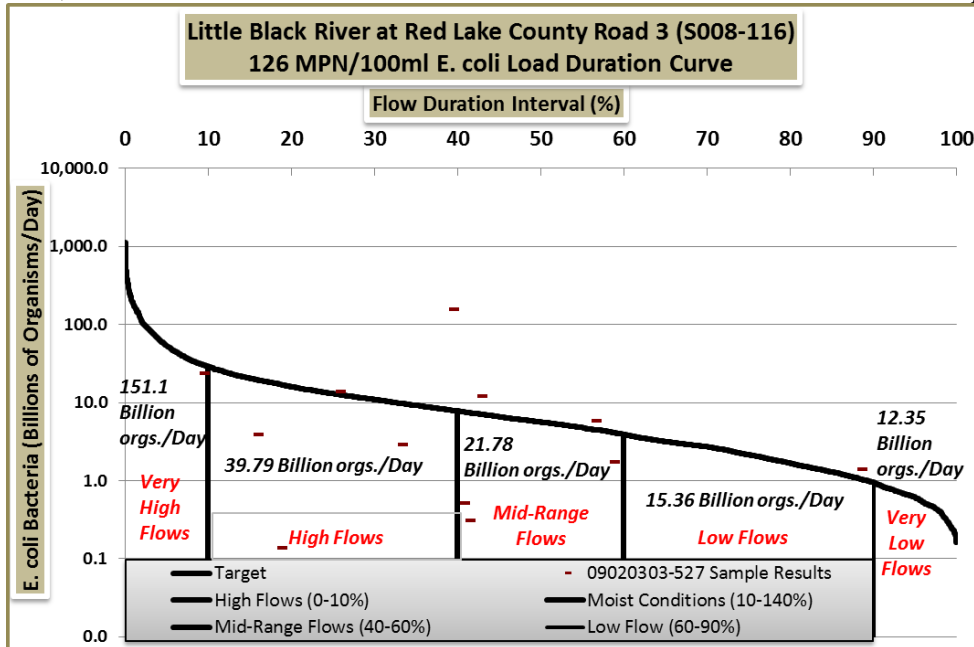
Drainage area delineation and area-weighted flow record calculations were completed for the E. coli-impaired reach of the Little Black River (09020303-527) using simulated 1996-2009 flow data from the Red Lake River HSPF model. A load duration curve and TMDL allocations were created and calculated for the monitoring site number S008-116 at the Red Lake County Road 3 crossing of the Little Black River. Because there was limited concurrence of flow and E. coli data, current loads could not be estimated and load reductions could not be prescribed.
