By Corey Hanson, Red Lake Watershed District Water Quality Coordinator. 3/21/2017.

RED LAKE WATERSHED DISTRICT
MONTHLY WATER QUALITY REPORT

August 2016

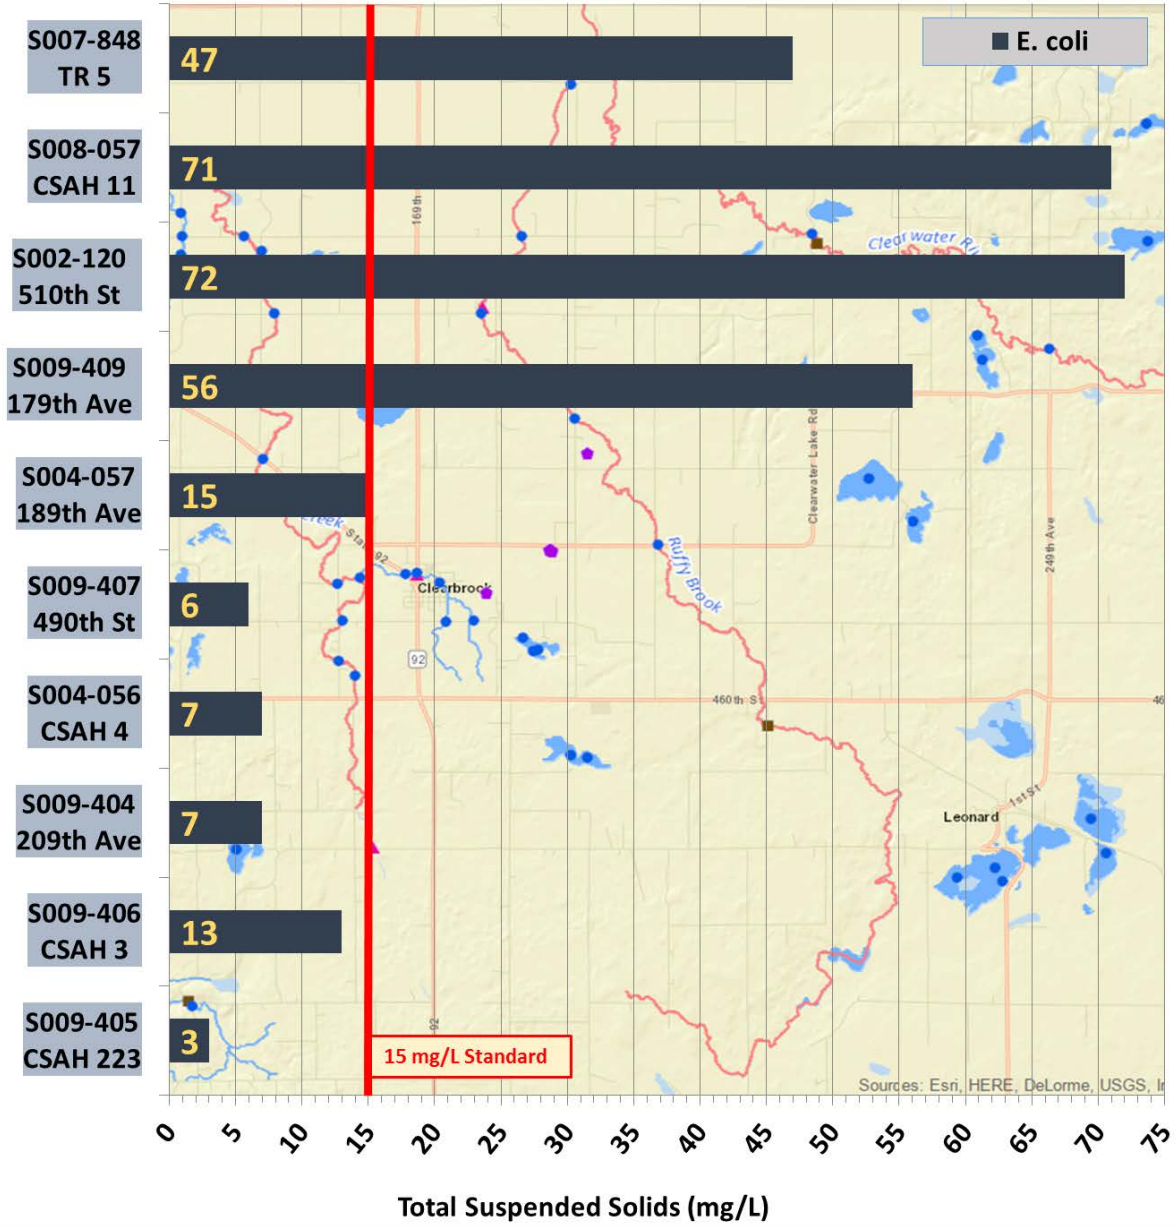
Ruffy Brook Longitudinal Total Suspended Solids on August 4, 2016

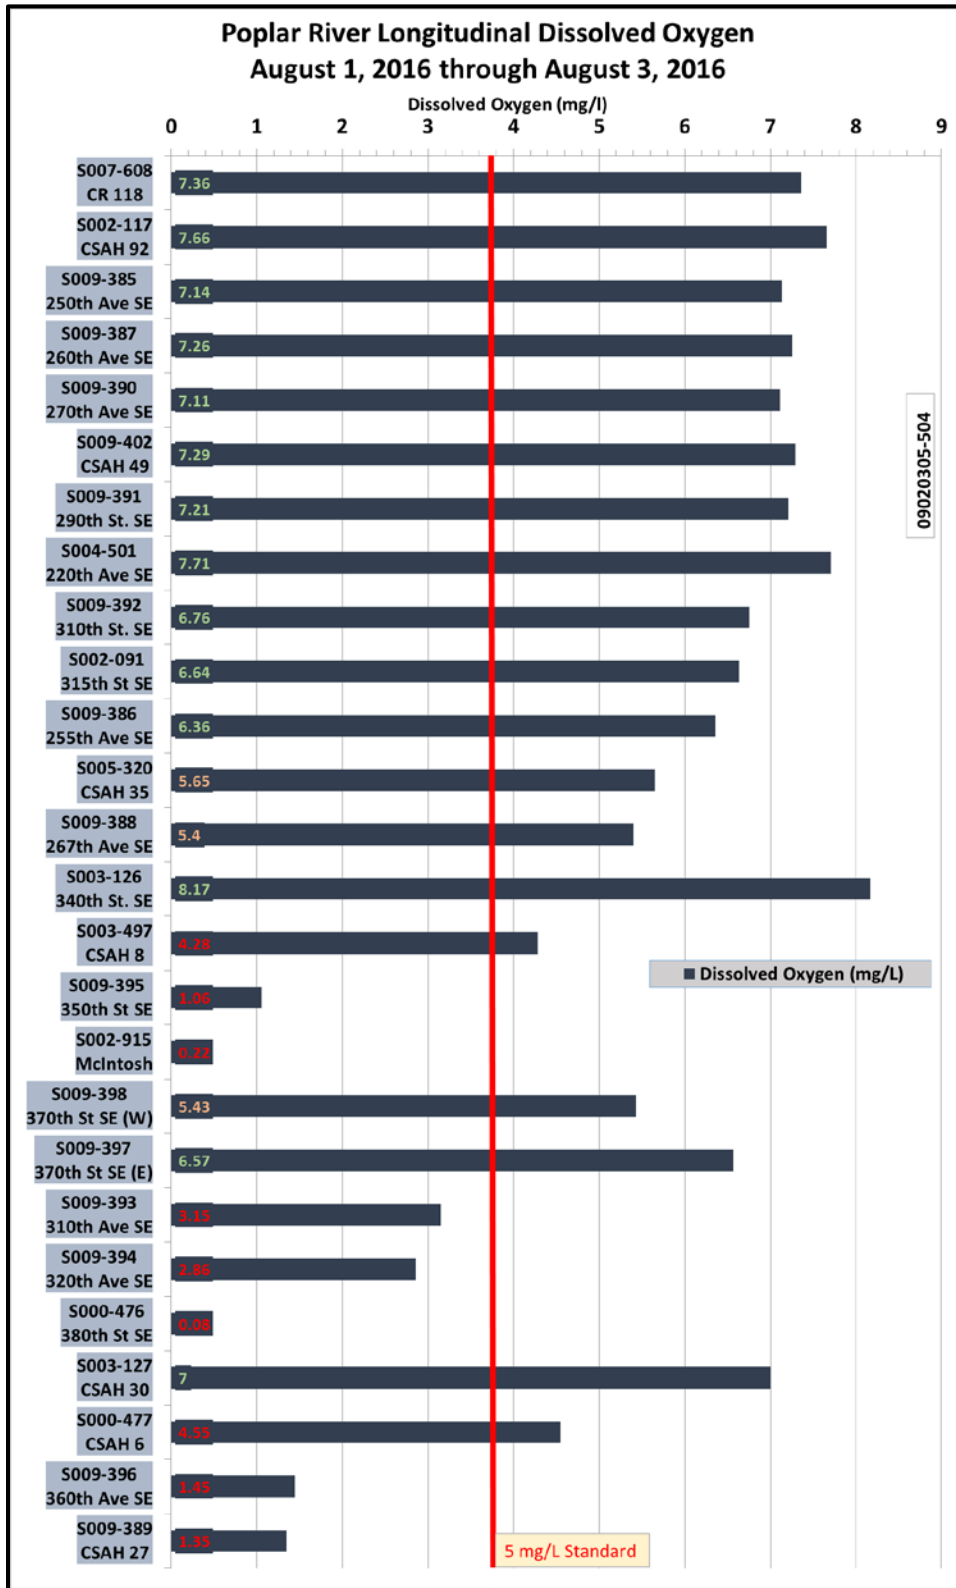
- The Water Quality Assistant completed a set of longitudinal water quality measurements and samples along the Poplar River on 8/2/16 and 8/3/16. Dissolved oxygen levels were low at many of the crossings in the headwaters of the Poplar River. The dissolved oxygen concentration at the Spring Lake Outlet was okay, but DO levels were low at all of the crossings between that location and the CSAH 30 crossing near Fosston (450th St. SE, 440th St. SE, 425th St. SE, CSAH 1, CSAH 27, 360th Ave SE, and CSAH 6). Downstream of a good DO concentration of 7 mg/l at CSAH 30, dissolved oxygen crashed down to 0.08 at the next crossing (380th St. SE). Dissolved oxygen concentrations were also low at all of the other crossings upstream of 255th Ave SE, with the exception of the east crossing of 370th St. SE and 340th St. SE.

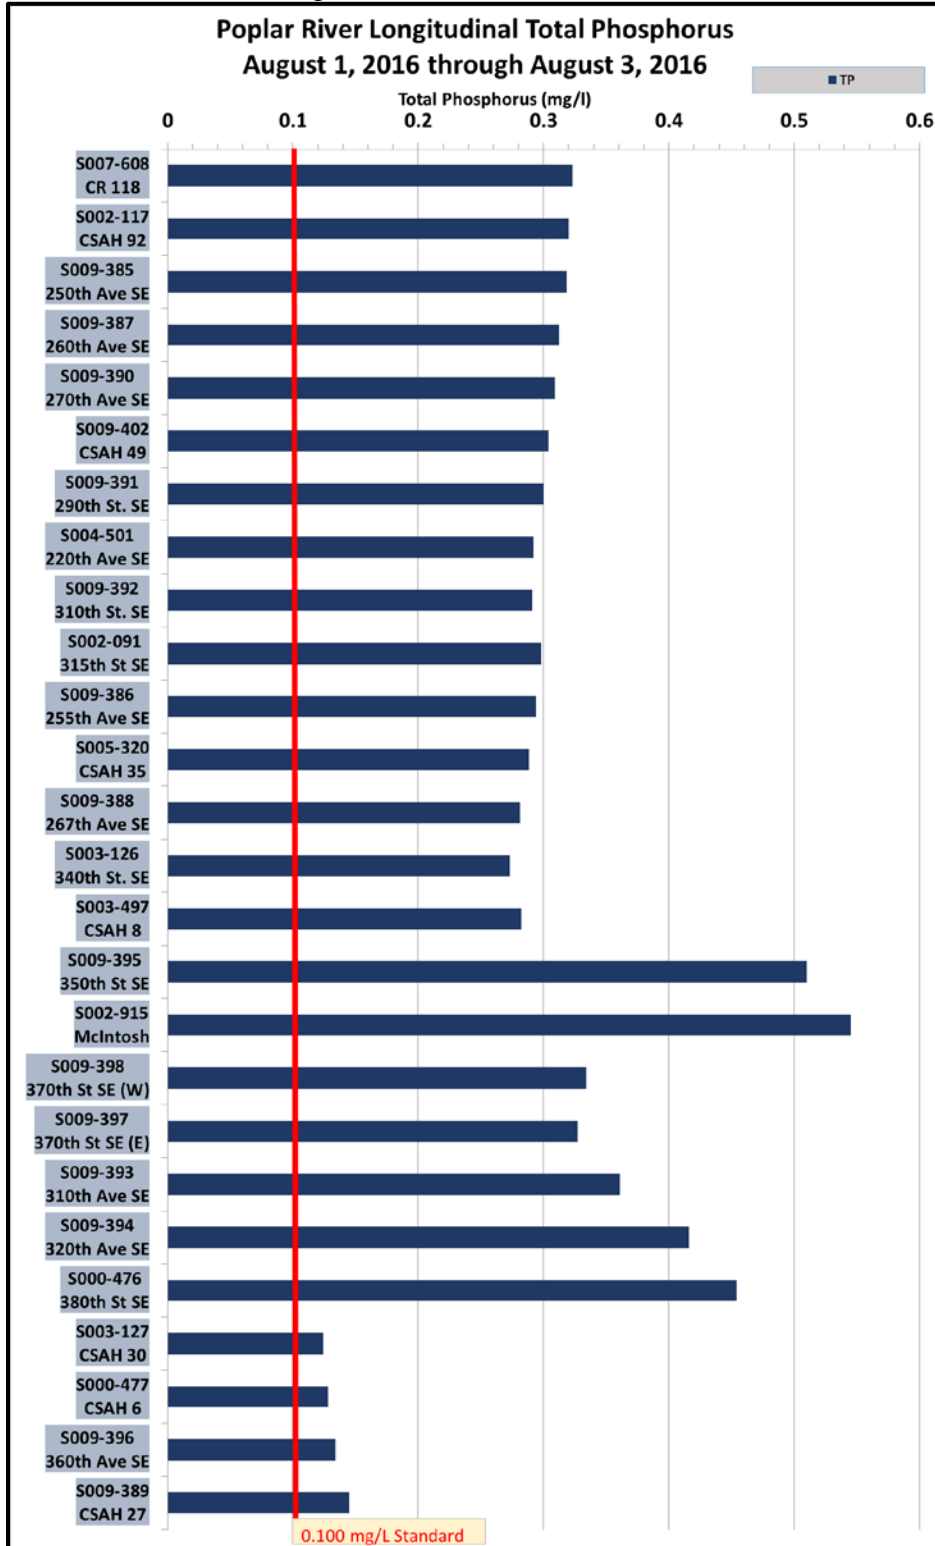
Total phosphorus concentrations exceeded the 0.100 mg/L river eutrophication standard throughout the entire reach that was sampled. There was a very significant increase downstream of the CSAH 30 crossing (near Fosston), however.

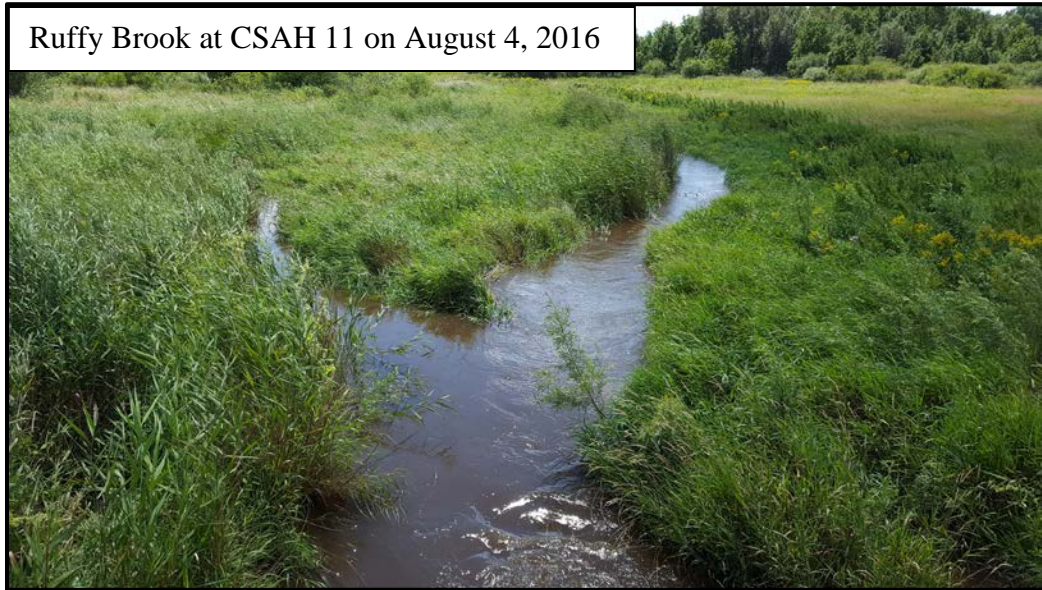
Ruffy Brook at CSAH 11 on August 4, 2016

- Microbial Source Tracking (fecal DNA) samples were collected on August 4, 2016. Flows were high in all of the streams and rivers that were sampled due to a 2.5” rainfall and runoff event. Water in the Clearwater River looked muddy.
 - Silver Creek (159th Ave, S000-712) – >2,419.6 MPN/100ml
 - Birds: Present (trace)
 - Humans: Present (trace)
 - Ruminants: Present (high concentration)
 - Dog: Present (low concentration)
 - Goose: Absent
 - Ruffy Brook (CSAH 11, S008-057) – >24,196 MPN/100ml
 - Birds: Absent
 - Humans: Absent
 - Ruminants: Present (moderate concentration)
 - Clearwater River (CSAH 10, S003-174) – 1,413.6 MPN/100ml
 - Birds: Absent
 - Humans: Absent
 - Ruminants: Present (low concentration)
 - Goose: Absent

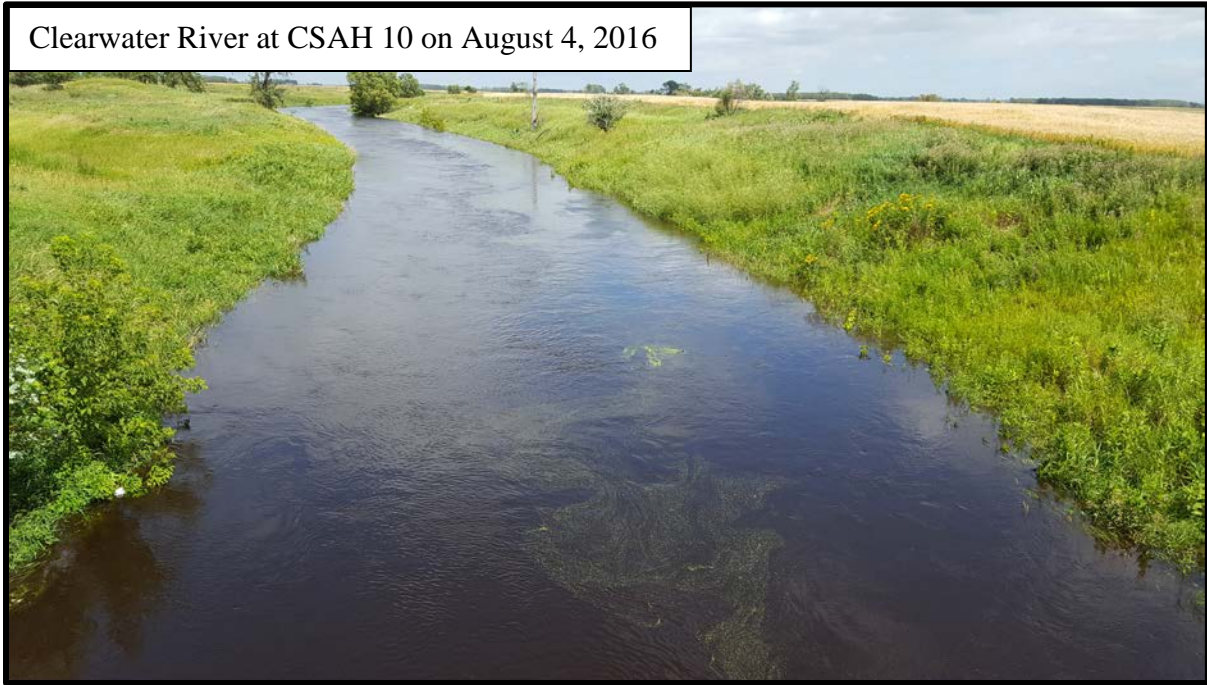
Clearwater River Longitudinal Sampling on August 5, 2016
Total Phosphorus

- Longitudinal water quality samples and in-situ measurements were collected along the Clearwater River and its tributaries upstream and downstream of wild rice paddies while the paddies were being drained in preparation for harvest. Dissolved oxygen levels in the Clearwater River were clearly being negatively impacted by drainage from the paddies. Dissolved oxygen concentrations in ditches were very low, despite high and “normal” flows. Turbidity and TSS are also increased in the river downstream of the paddies, but only one site exceeded the 30 mg/l TSS standard. Nitrogen and phosphorus concentrations increase significantly.

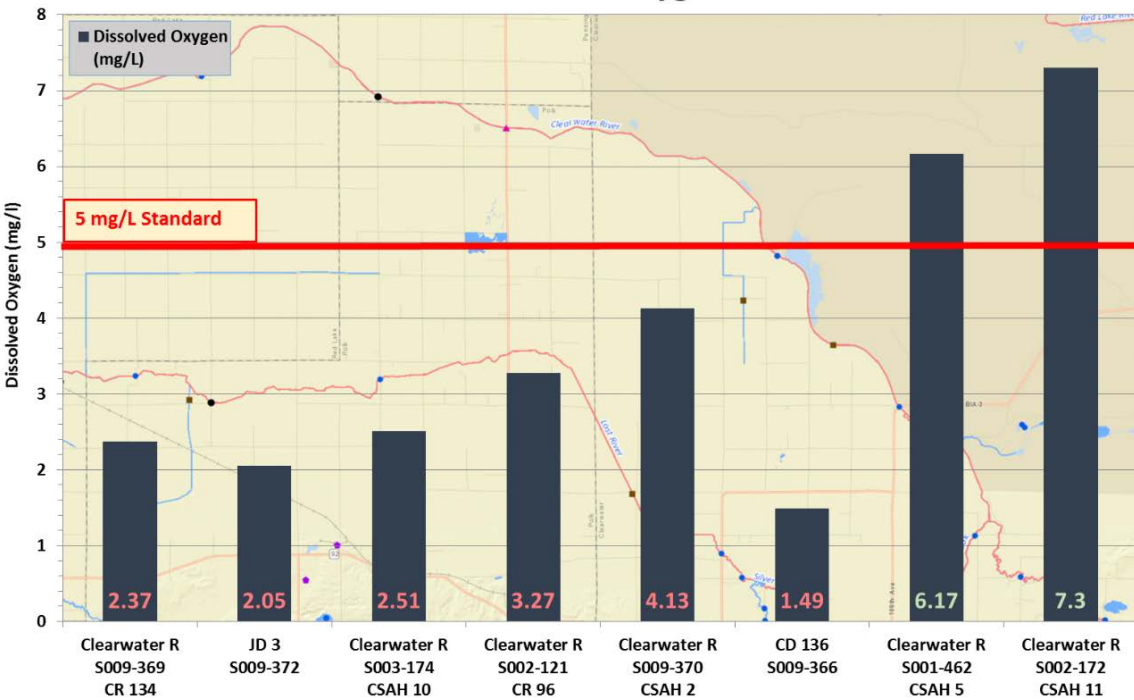
Clearwater River Longitudinal Sampling on August 5, 2016
Dissolved Oxygen

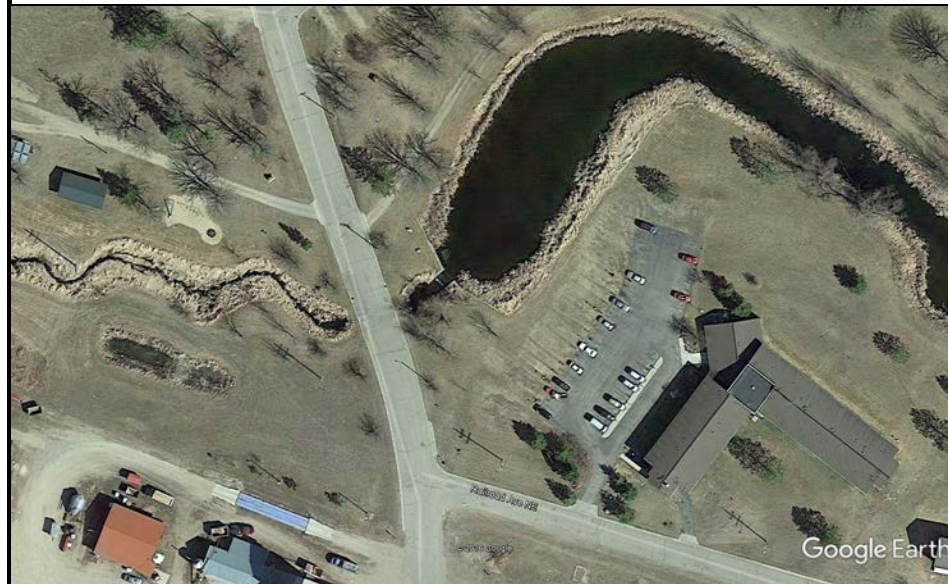
Aerial view of the pond along Clear Brook in the town of Clearbrook

- Photos of Clear Brook and the Clearbrook stormwater pond were taken after a 2.5” rain.
 - City employees stopped to visit and discuss Clear Brook. The city may be replacing the Main St. culverts because the current culverts are moving, failing, and damaging the street. They may also retrofit the dam on the pond near the Brookfield Apartments in Clearbrook (upstream of Main St.), possibly dredge the pond, and/or restore the stream channel by removing the dam. This sounds like a project for which the RLWD could provide assistance, with technical/ecological guidance from MN DNR staff.

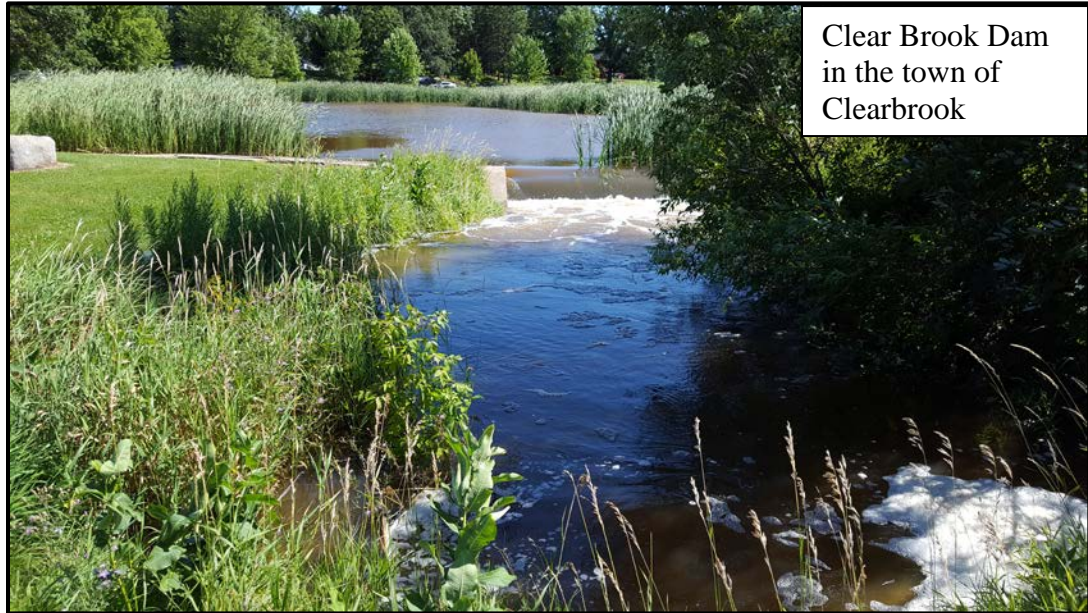
Clear Brook Dam
in the town of
Clearbrook

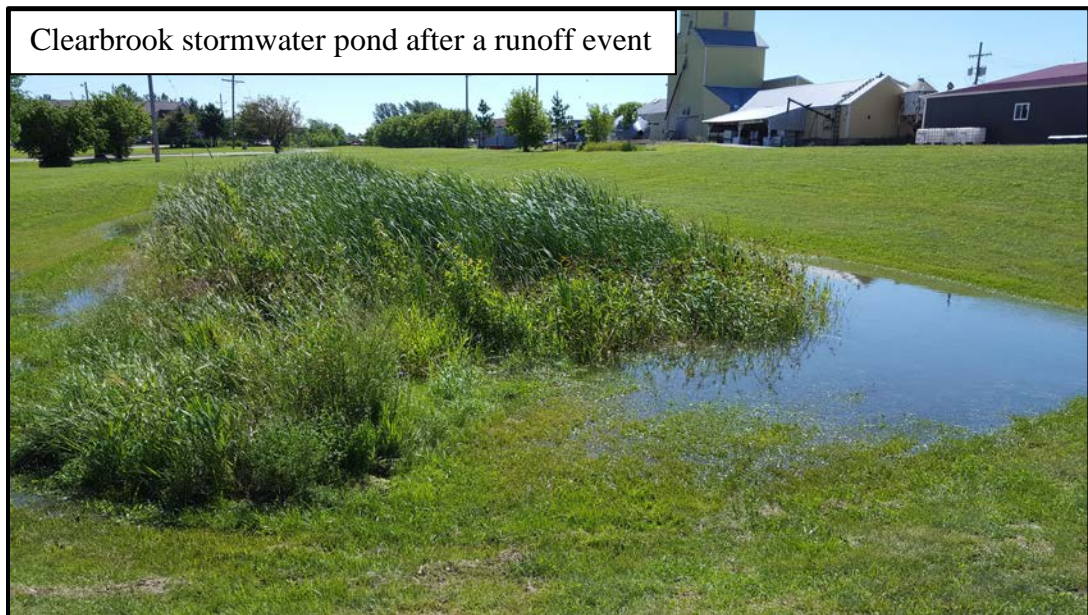
Clearbrook stormwater pond after a runoff event
