# THIEF RIVER WATERSHED SEDIMENT INVESTIGATION FINAL REPORT

Thief River Watershed Sediment Investigation Final Report

September 16, 2010

Corey Hanson  
Water Quality Coordinator  
Red Lake Watershed District  
1000 Pennington Ave S  
Thief River Falls, MN 56701  
218-681-5800

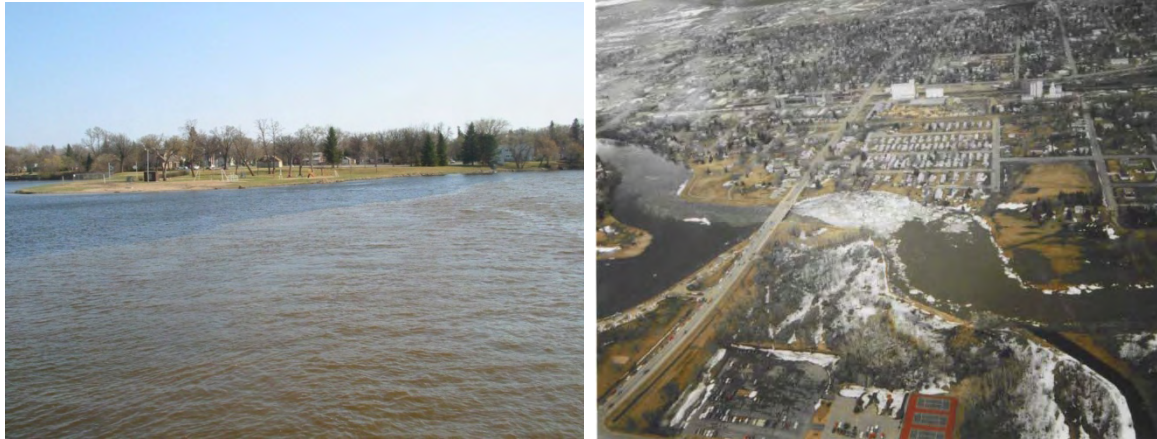
**Figure 7. Sediment plumes from the Thief River at its confluence with the Red Lake River in Thief River Falls**

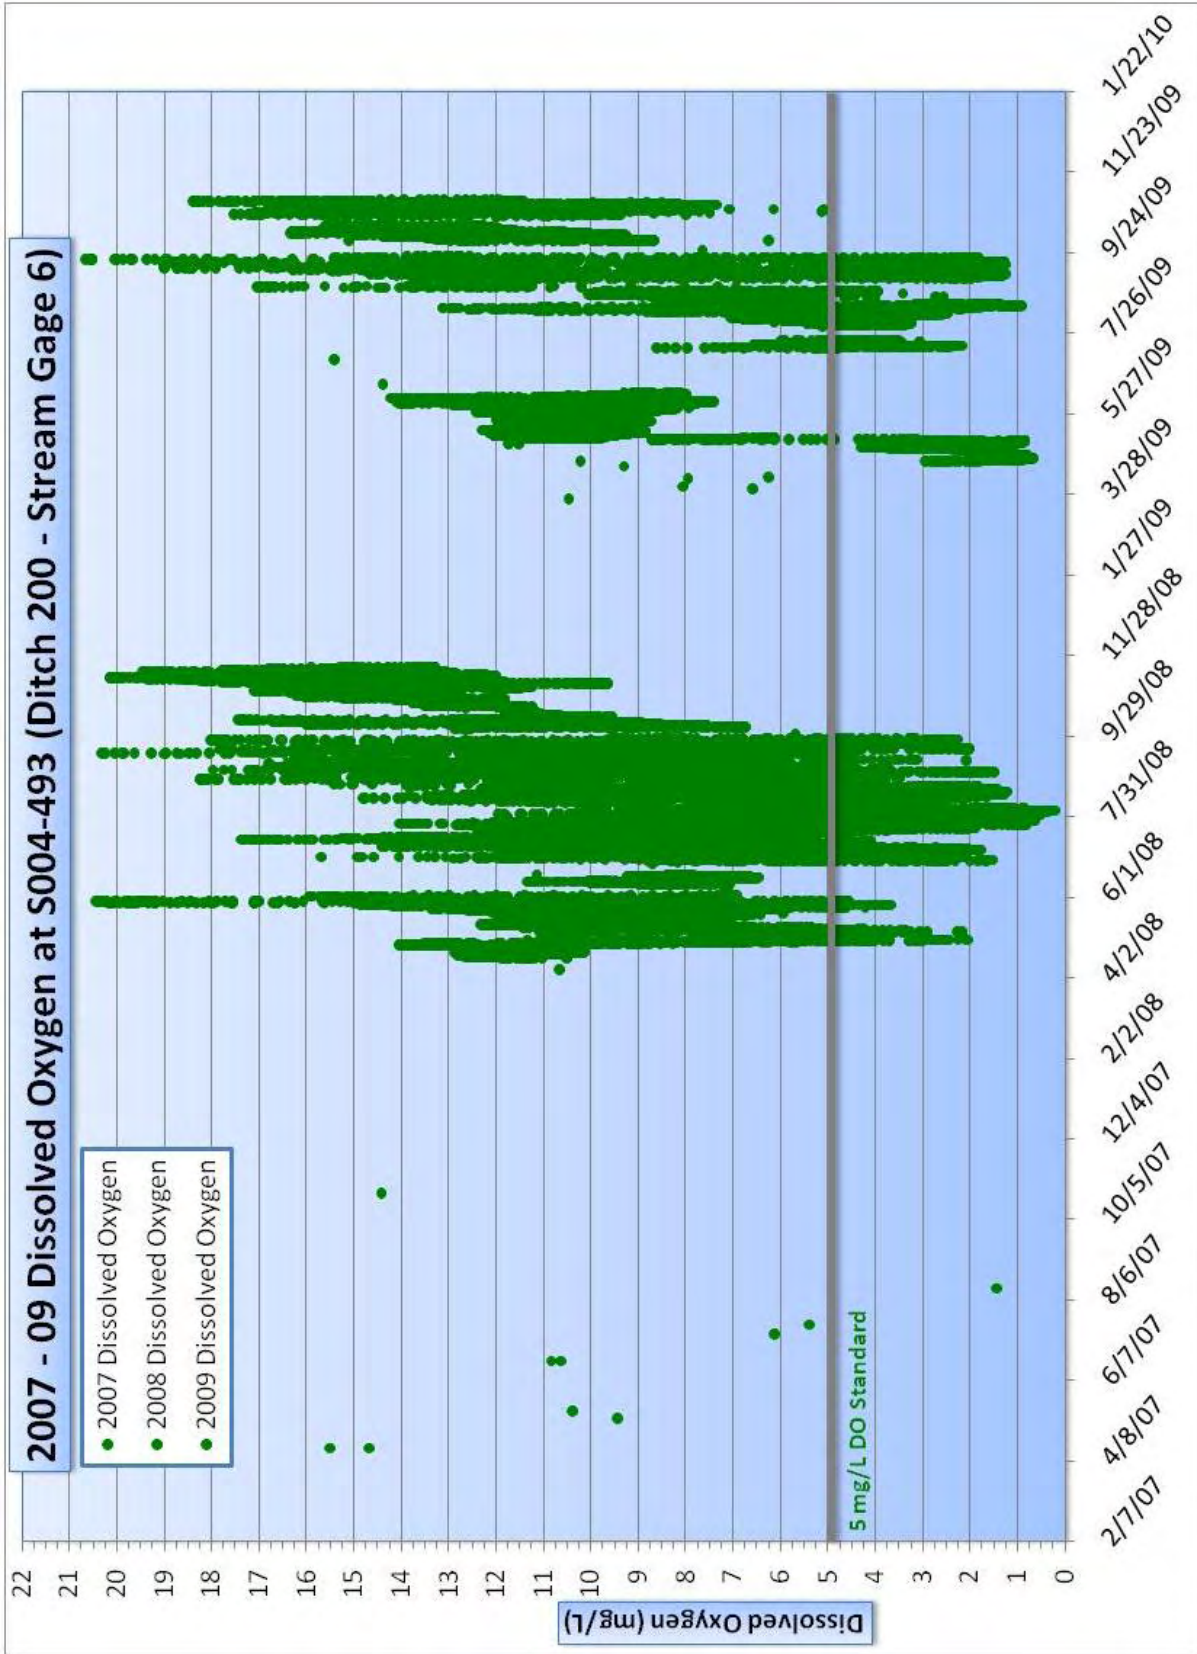
Figure 108. 2007 - 2009 complete dissolved oxygen record in Ditch 200 at Stream Gauge 6

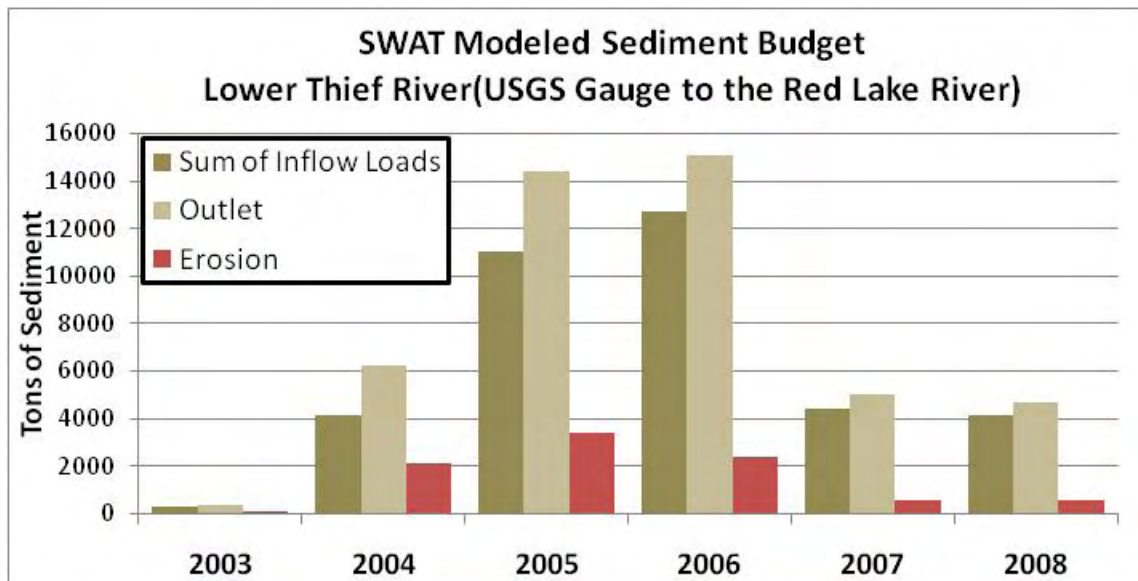
Erosion also contributes to sediment loads in the Thief River downstream of State Ditch 83. This shows up in SWAT modeling results. Stream bank failures and bad erosion problems were identified along this reach in real life during reconnaissance canoe trips down the river.

Figure 141. Lower Thief River Sediment Budget using SWAT data

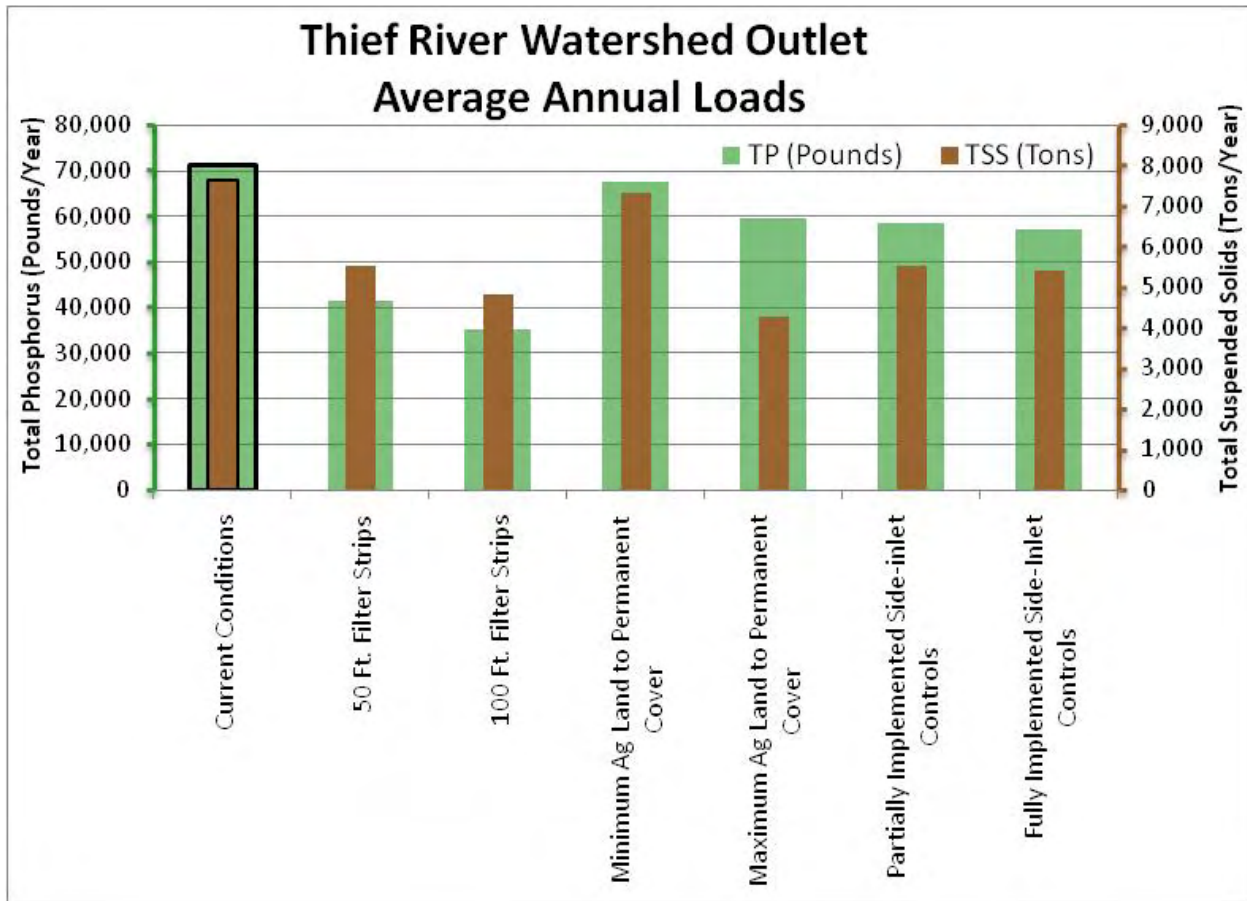
Figure 159. Average annual loads for baseline conditions and BMP scenarios

Scenario	Average Annual Streamflow (acre-feet)	Average Annual Sediment Load (Tons)	Average Annual Total Phosphorus Load (Pounds)	Average Annual Fecal Coliform Load (CFUs)
<b>Baseline: Existing Conditions (2003-2008)</b>	175,000	7,640	71,200	$2.89 \times 10^{15}$
<b>1a: 50 Foot Filter Strips</b>	175,000	5,510	41,600	$2.89 \times 10^{15}$
<b>1b: 100 Foot Filter Strips</b>	175,000	4,820	35,300	$2.89 \times 10^{15}$
<b>2 min: Minimum Ag land to permanent cover</b>	175,400	7,350	67,500	$2.72 \times 10^{15}$
<b>2 max: Maximum Ag land to permanent cover</b>	180,000	4,280	59,700	$1.98 \times 10^{15}$
<b>3a: Partially Implemented Side-Inlet Controls</b>	180,000	5,530	58,500	$1.51 \times 10^{15}$
<b>3b: Fully Implemented Side-Inlet Controls</b>	180,000	5,400	57,200	$1.43 \times 10^{15}$

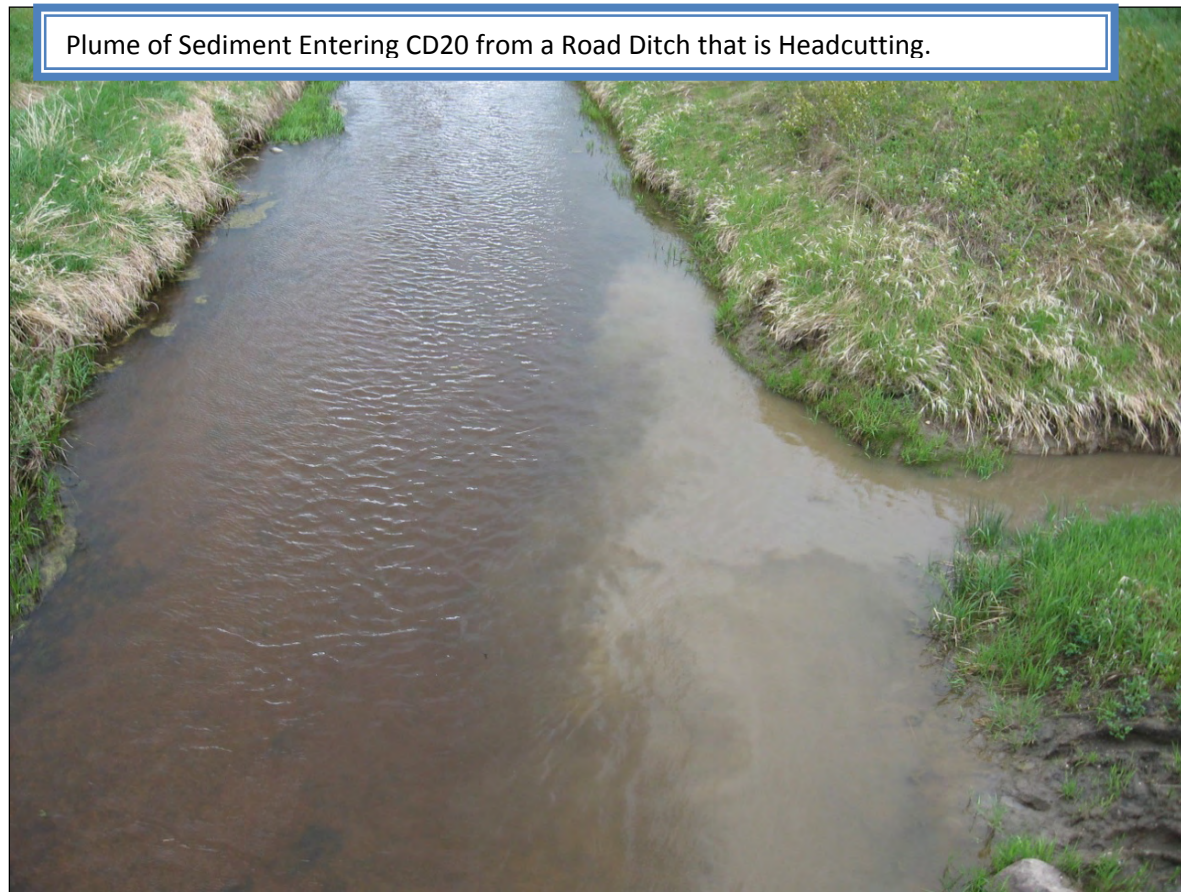
Plume of Sediment Entering CD20 from a Road Ditch that is Headcutting.

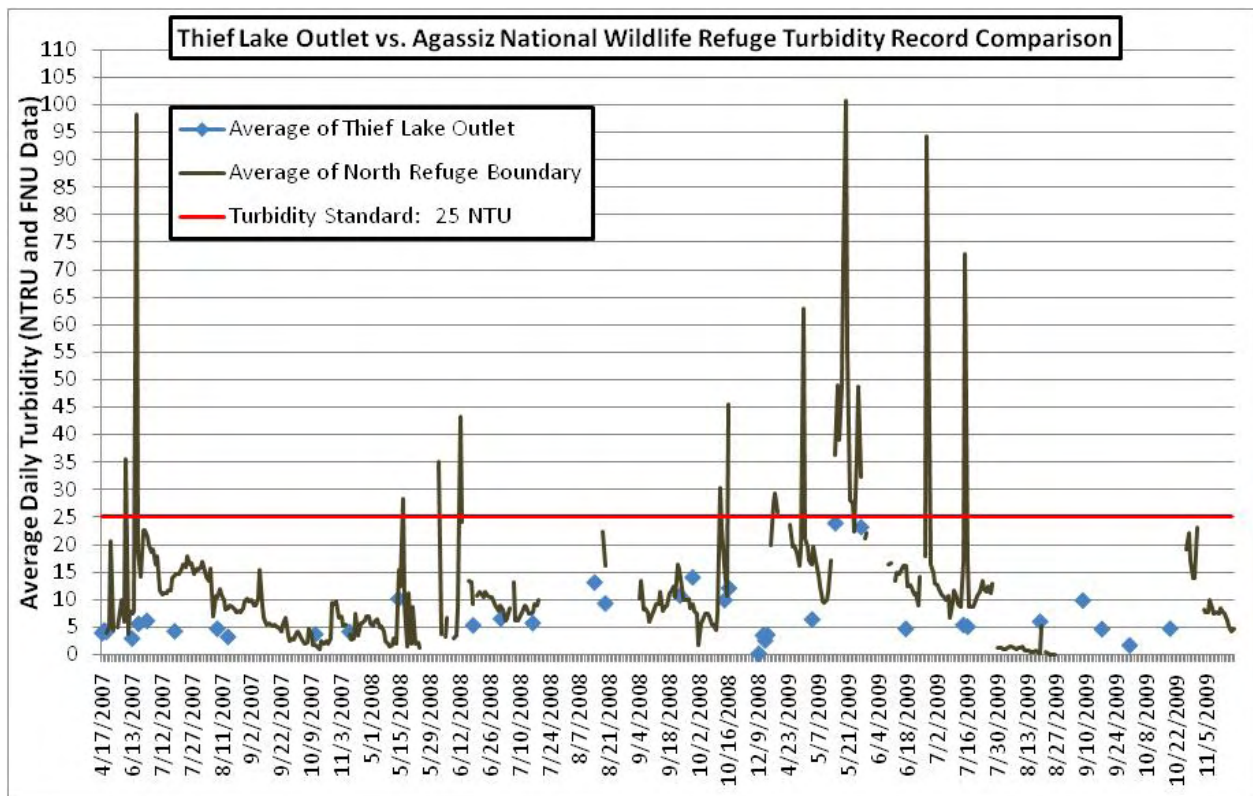
Figure 169. Turbidity at the Thief Lake Outlet vs. turbidity at the northern Agassiz NWR boundary

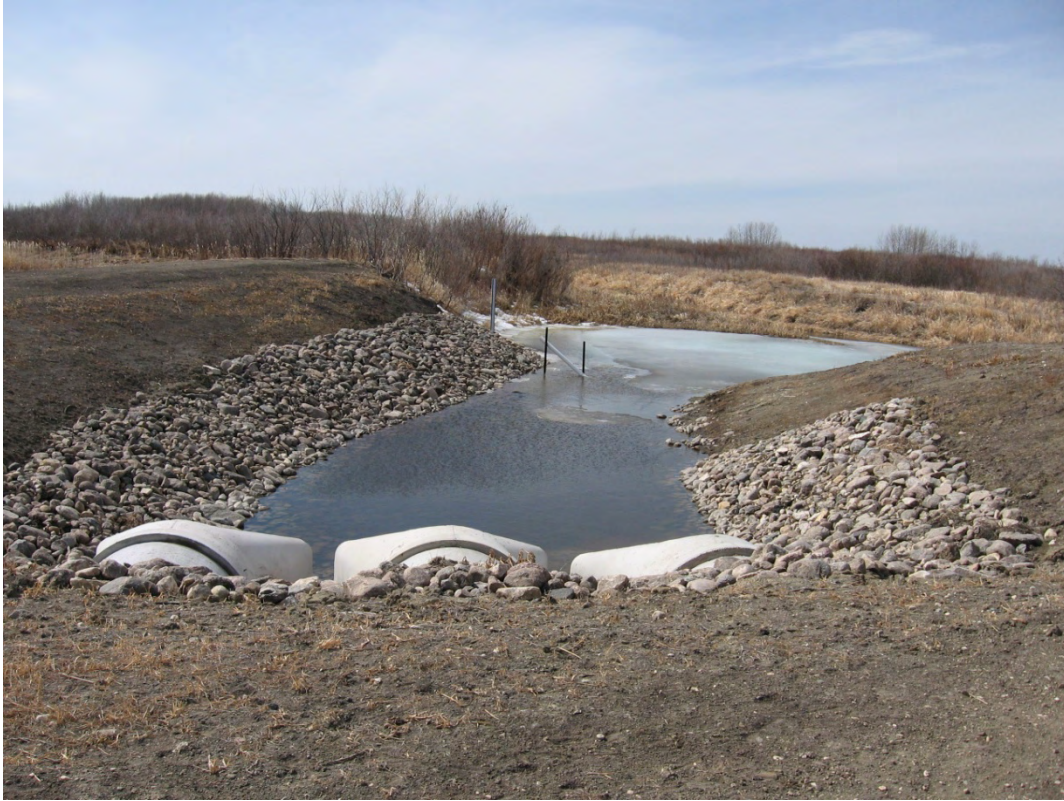
**Figure 176. New outlet for Agassiz Pool (Site A5)**

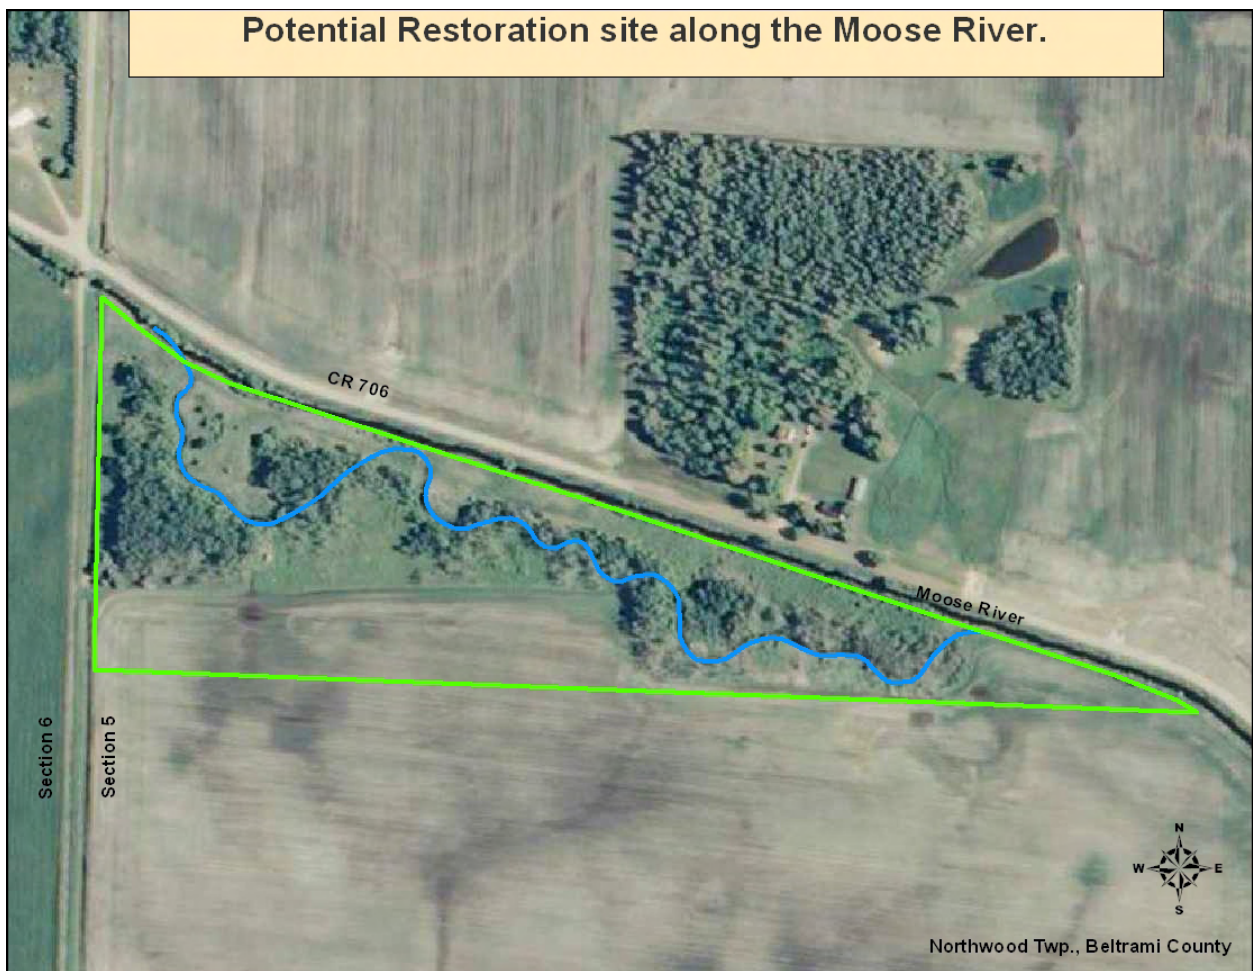
Figure 180. Example of a candidate area for stream channel restoration
