Cross Lake and Turtle Lake Water Quality Study

In June, 2000, the Red Lake Watershed District completed a study report on the water quality of the Cross Lake and Turtle Lake systems. One reason for the study was concern over excessive algae and nutrients, particularly on Cross To address this concern, data Lake. collection focused on establishing baseline water quality characteristics at six (6) in-pool locations. This collection included measurements of total phosphorus, chlorophyll-a, secchi disk readings and dissolved oxygen/water temperature profiles.

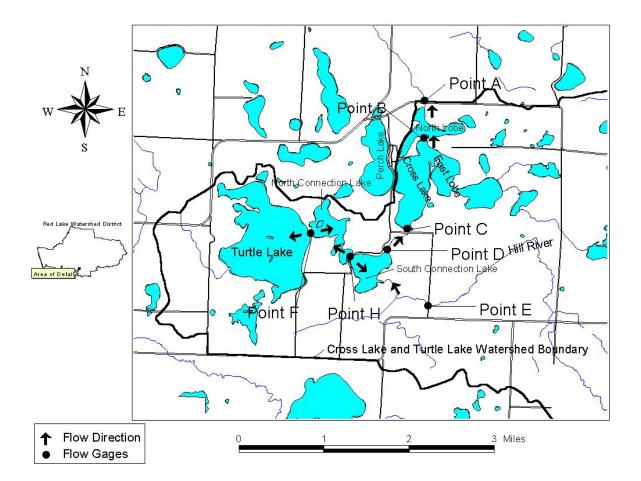
Map of the Cross Lake and Turtle Lake systems with flow direction and flow monitoring sites. The lake systems are located approximately 3 miles northeast of Fosston, MN.

Another reason for conducting the study was concern about the effects of constructed dams (located on Cross Lake. Turtle Lake, and South Connection Lake) on hydrology of the To determine the lake systems. hydrology of the lake systems, depth recorders were set up at six (6) locations. The information from the recorders was used to determine lake system inflows and discharges (i.e. a hydrologic budget) and to display flow direction in the lake systems.

Determining hydrologic budgets and flow direction on the Cross Lake and Turtle Lake systems was difficult due to instrument problems and errors. Rough determinations of the flow direction revealed that during higher runoff events, water actually flows from South Connection Lake into Turtle Lake. As inflow into the Turtle Lake system decreases, flow then switches direction and flows from Turtle Lake to South Connection Lake.

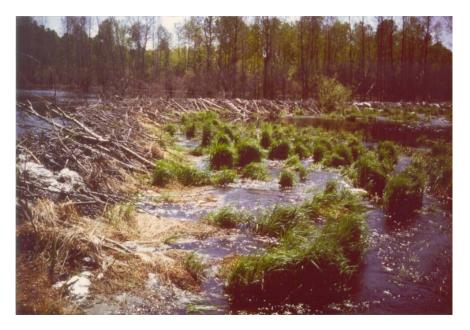
Picture of the Moose River Beaver Dam, Section 7 and 8, T157N R57W, Beltrami County

The RLWD identified two beaver ponds on which to conduct the study. The first was located on the Moose River in Beltrami County, Township 157 North and Range 57 West. The second was located on the Clearwater River in Sinclair Township, Clearwater County, of Clearwater downstream Lake. Monitoring focused on taking samples upstream, downstream and in the pool of the beaver ponds. Data collection was performed in 1995 and 1996. А comparison of the upstream and downstream water quality parameter concentrations was made using a statistical test.

Results from the Moose River beaver pond indicated greater total phosphorus, nitrates and alkalinity concentrations downstream compared to upstream of the beaver pond. The results also indicated the beaver that pond contributed the additional concentration Statistical of each parameter. differences were not found between concentrations of other water quality parameters.

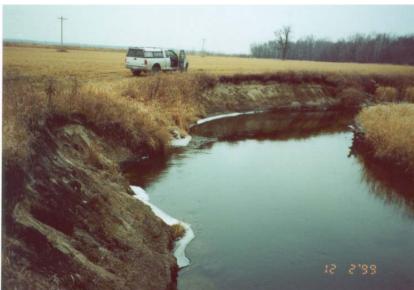
Stream bank erosion site on the Clearwater River, Section 27, Greenwood Township, Clearwater County.

In 2000 the RLWD continued work on the Clearwater River Stream Bank Stabilization and Revitalization Project. The project is being performed through a Section 319 grant from EPA, grants which are dedicated to making nonpoint source water pollution improvements. The work performed during 2000 was focused on bank stabilization, grade stabilization and floodplain improvements on the Clearwater River in Section 27, Greenwood Township, Clearwater County.

The project includes stabilizing stream bank erosion sites through bank reshaping. rock riprap and bioengineering techniques. Other facets include installing rock riffles across the channel of the Clearwater River for grade stabilization and re-establishing the function of the floodplain using clay fill and rock riprap. Another aspect of the Greenwood 27 project is applying for wetland banking acres due to restoration of the floodplain. The RLWD owns approximately 25 acres in the project area, some of which may quality for the wetland banking program.
